INSPECTION REPORT

ChArUco target · ceramic · 200 × 150 mm

Part number	CT-CHA-C-200150-6X6
Description	ChArUco calibration target, ceramic, 200 × 150 mm
Serial number	000311
Lot	L-2611-0382
Datasheet	CT-DS-CHA-C · Rev A
Pattern	ChArUco 12 × 17 · 10 / 7 mm DICT_6X6_250
Marker ID range	0–101 (102 markers)
Start ID	0

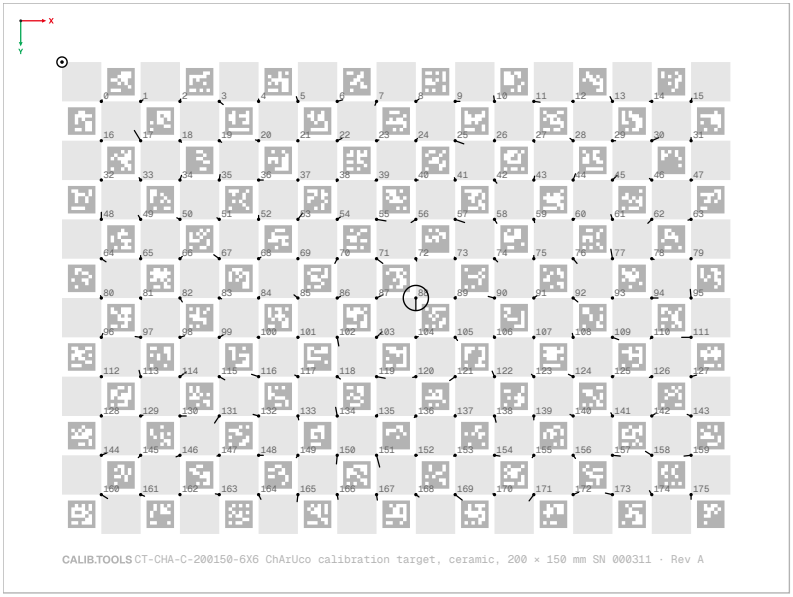
5 Feature map

◯ Largest deviation: id 88, 1.6 µm
