INSPECTION REPORT

ChArUco target · ceramic · 185 × 110 mm

Part number	CT-CHA-C-185110-6X6
Description	ChArUco calibration target, ceramic, 185 × 110 mm
Serial number	000311
Lot	L-2611-0382
Datasheet	CT-DS-CHA-C · Rev A
Pattern	ChArUco 7 × 12 · 14 / 10.5 mm DICT_6X6_250
Marker ID range	0–41 (42 markers)
Start ID	0

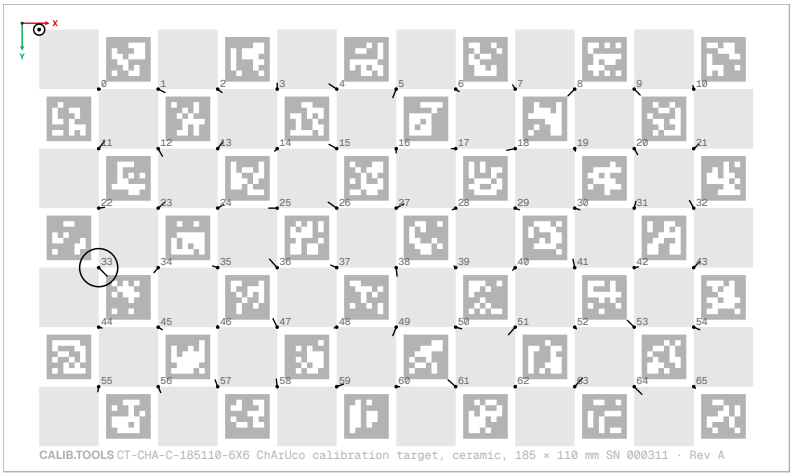
5 Feature map

◯ Largest deviation: id 33, 1.4 µm
