INSPECTION REPORT

ChArUco target · ceramic · 200 × 150 mm

Part number	CT-CHA-C-200150-6X6
Description	ChArUco calibration target, ceramic, 200 × 150 mm
Serial number	000311
Lot	L-2611-0382
Datasheet	CT-DS-CHA-C · Rev A
Pattern	ChArUco 12 × 17 · 10 / 7 mm DICT_6X6_250
Marker ID range	0–101 (102 markers)
Start ID	0

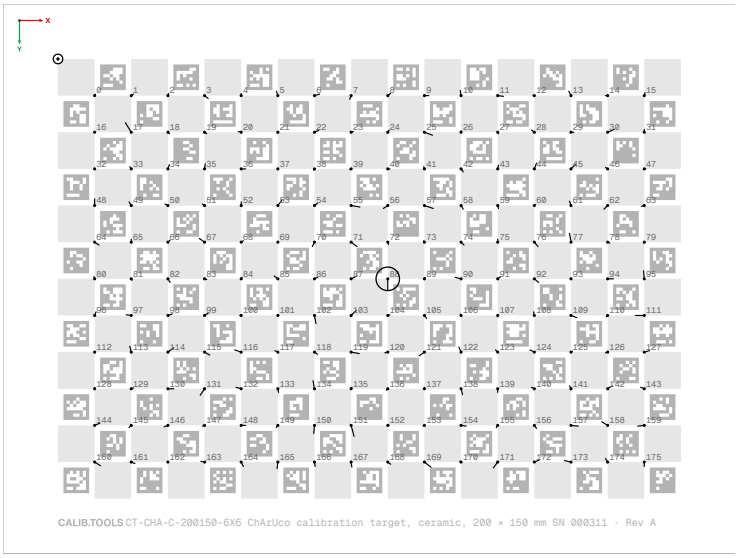
5 Feature map

—— Deviation vector, magnified × 2000 (1 µm = 2 mm on the board)

◯ Largest deviation: id 88, 1.6 µm
