INSPECTION REPORT

ChArUco target · ceramic · 200 × 150 mm

Part number	CT-CHA-C-200150-6X6
Description	ChArUco calibration target, ceramic, 200 × 150 mm
Serial number	000311
Lot	L-2611-0382
Datasheet	CT-DS-CHA-C · Rev A
Pattern	ChArUco 12 × 17 · 10 / 7 mm DICT_6X6_250
Marker ID range	0–101 (102 markers)
Start ID	0

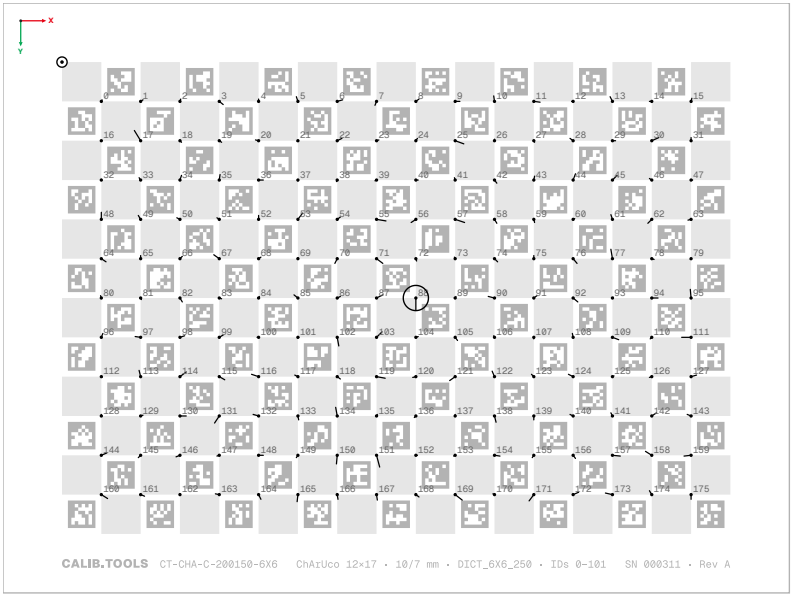
3 Flatness

MEASURED FLATNESS (µm)	TOLERANCE (µm)	METHOD	RESULT
12	≤ 20	25 points, 5 × 5 grid, least-squares plane	PASS
