INSPECTION REPORT

ChArUco target · ceramic · 185 × 110 mm

Part number	CT-CHA-C-185110-6X6
Description	ChArUco calibration target, ceramic, 185 × 110 mm
Serial number	000311
Lot	L-2611-0382
Datasheet	CT-DS-CHA-C · Rev A
Pattern	ChArUco 7 × 12 · 14 / 10.5 mm DICT_6X6_250
Marker ID range	0–41 (42 markers)
Start ID	0

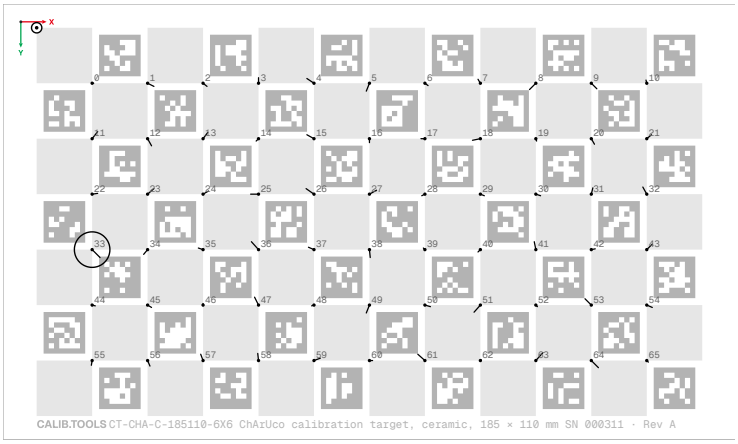
5 Feature map

Largest deviation: id 33, 1.4 µm
