PSC Functional Test Report

PSC Functional Test Results	
Power Supply Controller Configuration	
Serial Number	0008
Number of Channels	3
Resolution	MS (18bit)
Bandwidth	F
Polarity	Bipolar

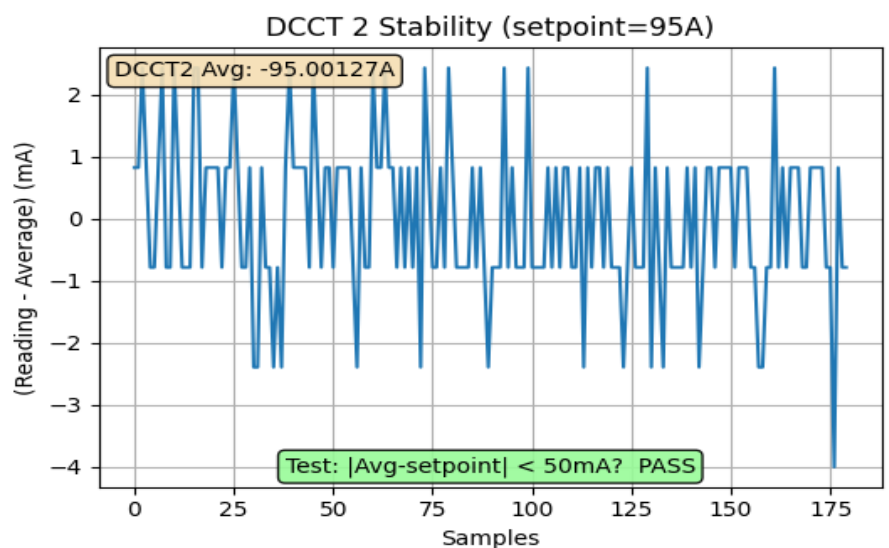
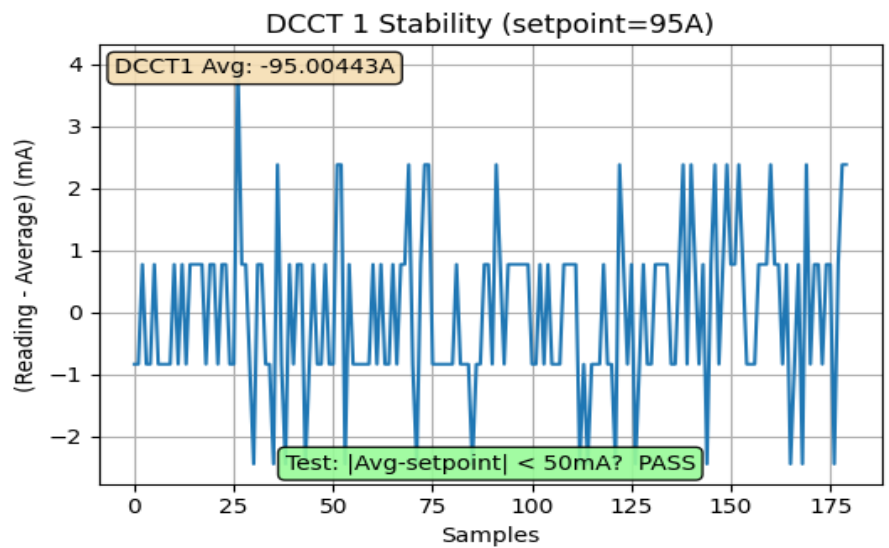
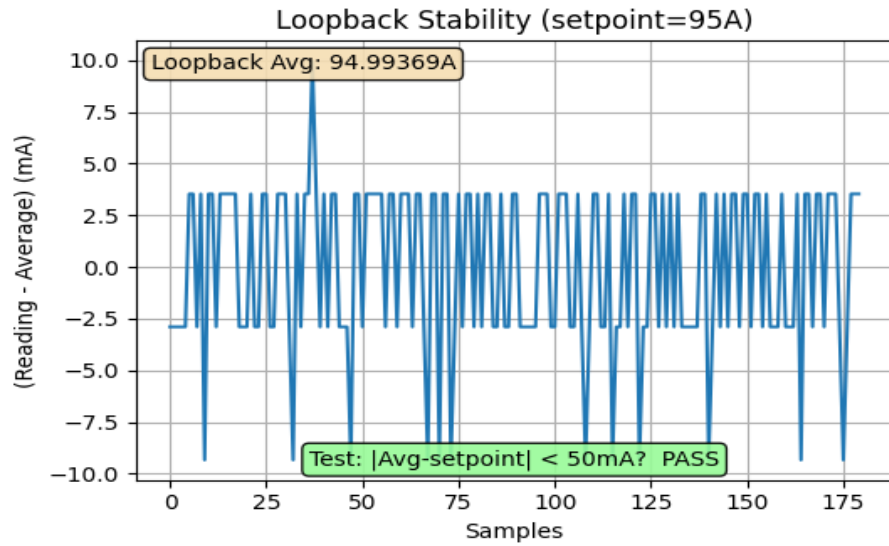
ATE Fault Tests for Channel 1	
Fault #1 Generated and Cleared	PASS
Fault #2 Generated and Cleared	PASS
Fault SPARE Generated and Cleared	PASS
Fault DCCT Generated and Cleared	PASS

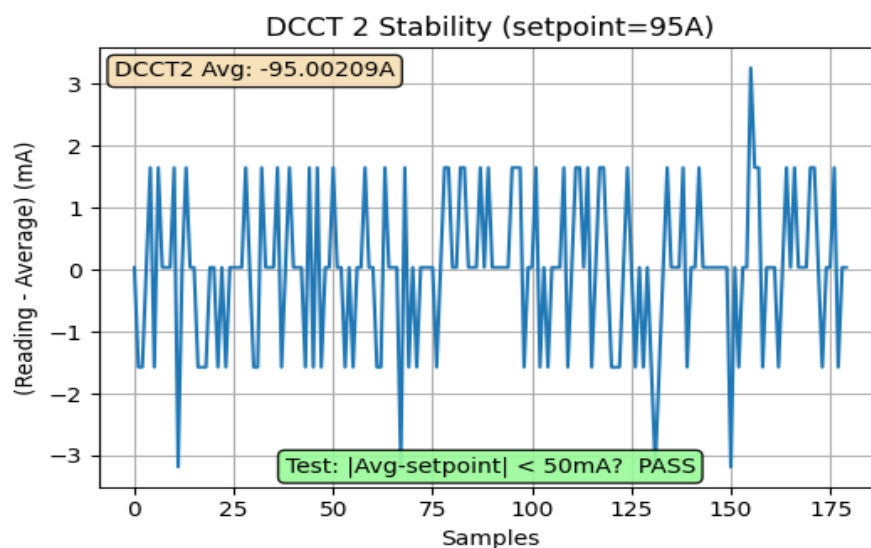
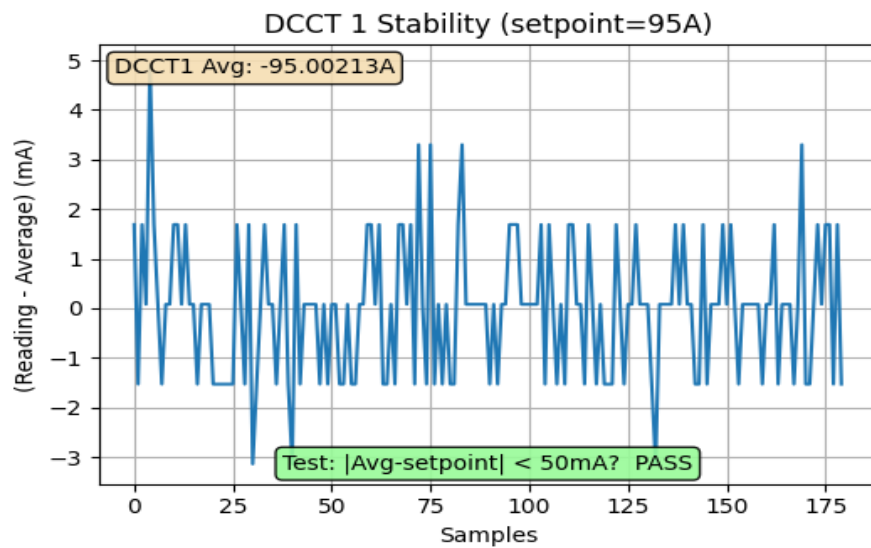
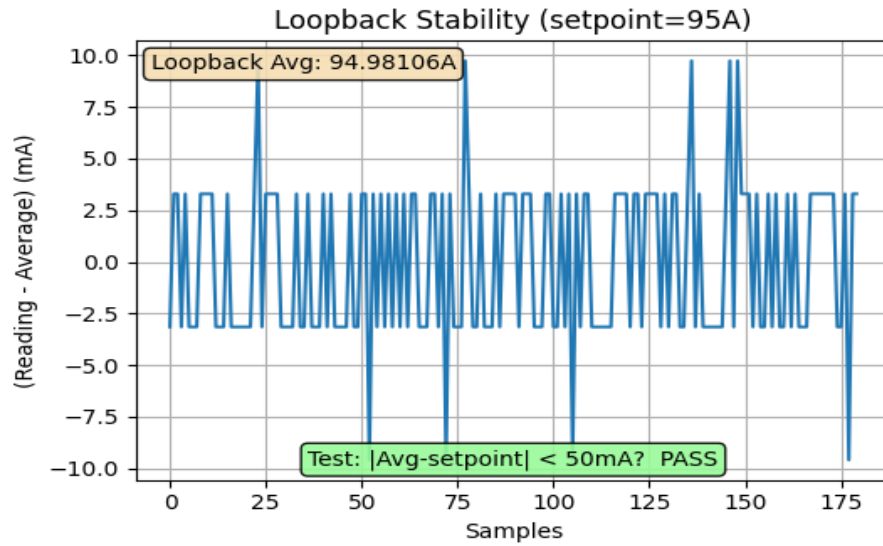
ATE Fault Tests for Channel 2	
Fault #1 Generated and Cleared	PASS
Fault #2 Generated and Cleared	PASS
Fault SPARE Generated and Cleared	PASS
Fault DCCT Generated and Cleared	PASS

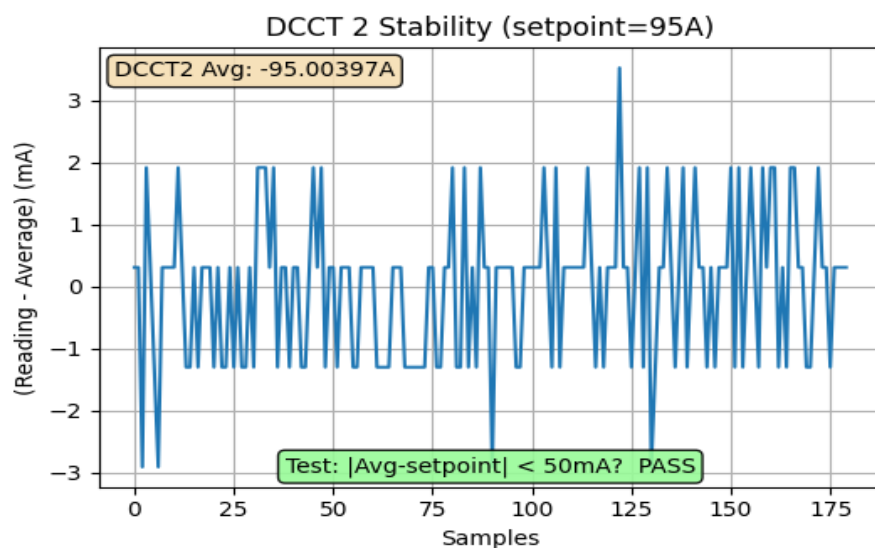
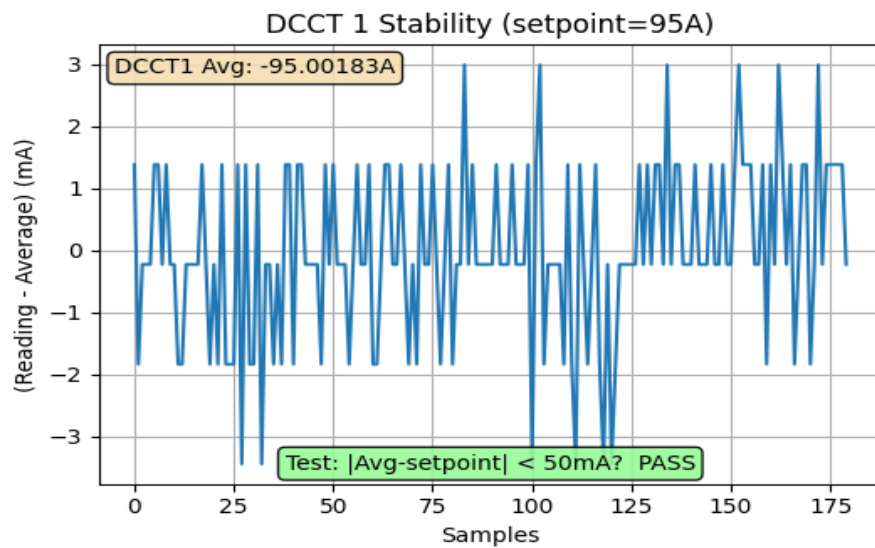
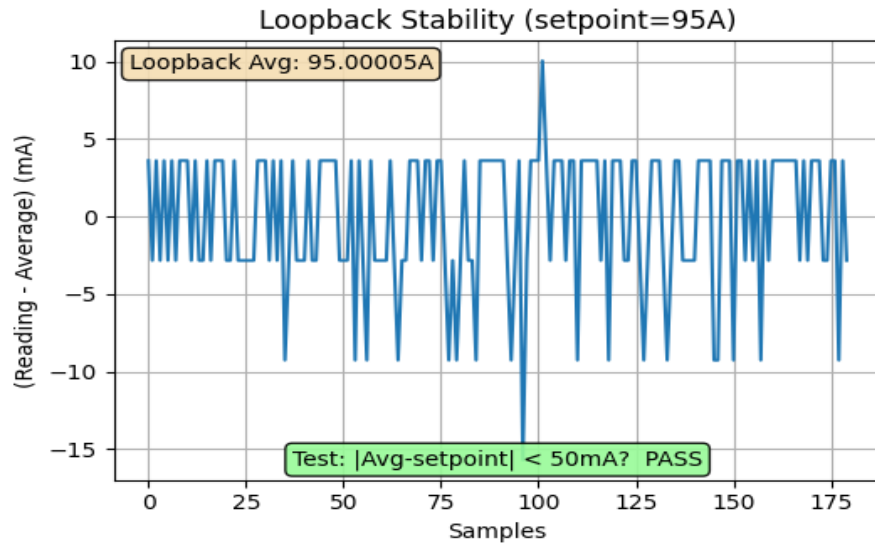
ATE Fault Tests for Channel 3	
Fault #1 Generated and Cleared	PASS
Fault #2 Generated and Cleared	PASS
Fault SPARE Generated and Cleared	PASS
Fault DCCT Generated and Cleared	PASS
