PSC Functional Test Report

PSC Functional Test Results	
Power Supply Controller Configuration	
Serial Number	1036
Number of Channels	4
Resolution	MS (18bit)
Bandwidth	S
Polarity	Bipolar

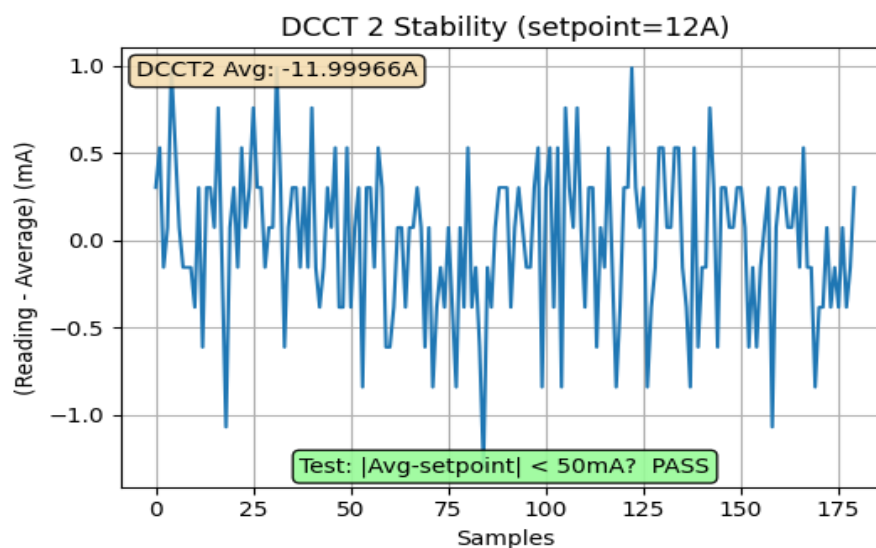
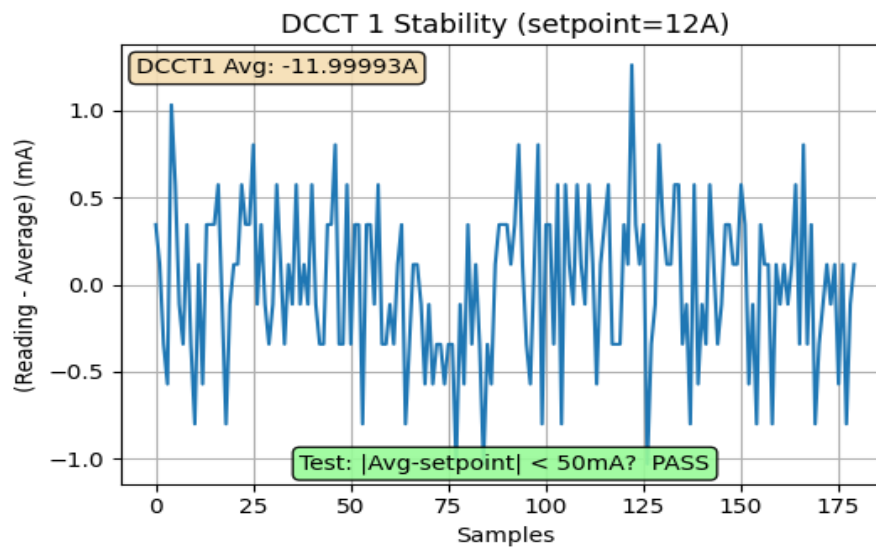
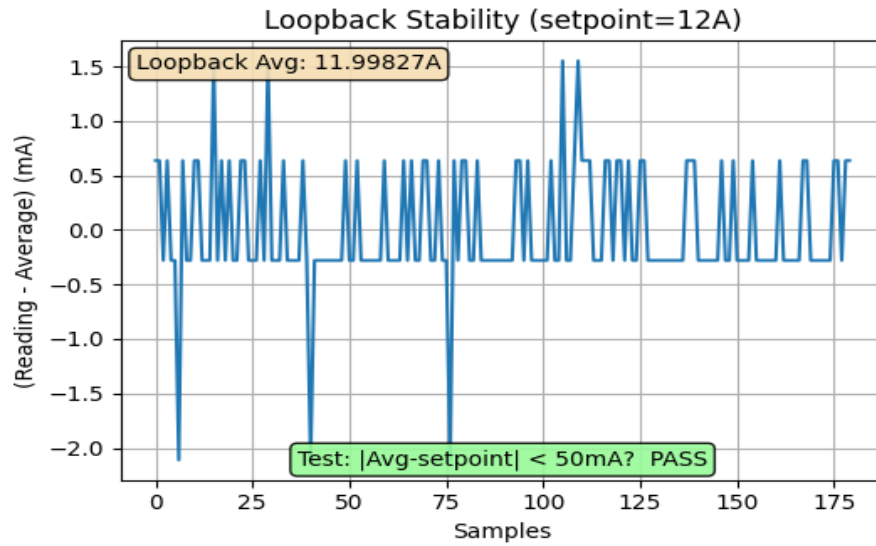
Power Supply Regulation for Channel 1:

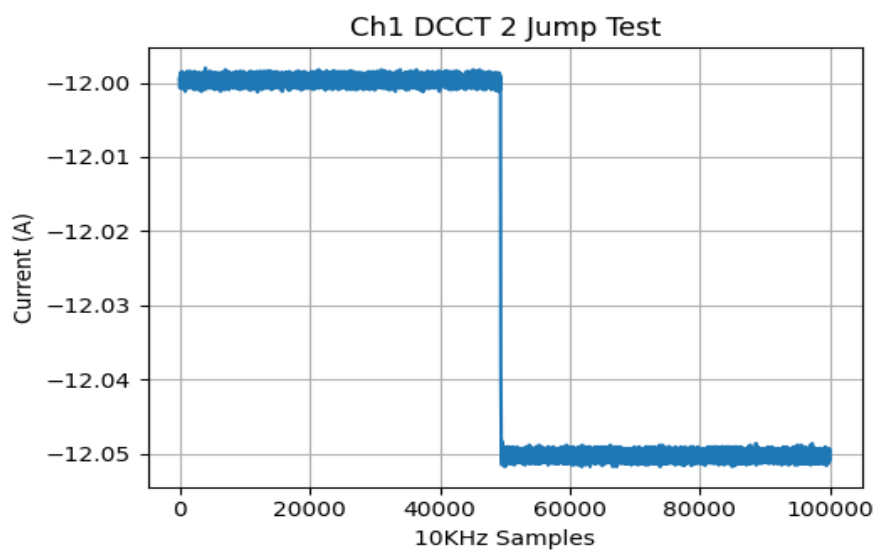
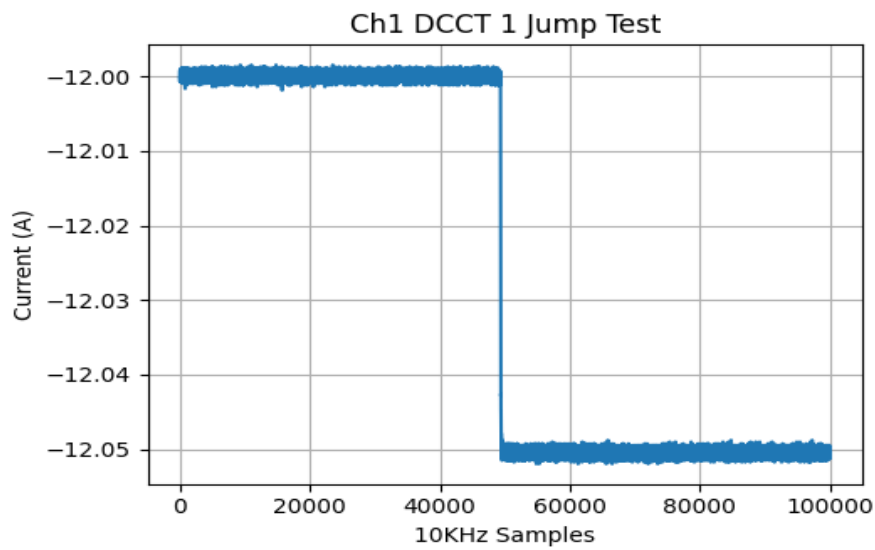
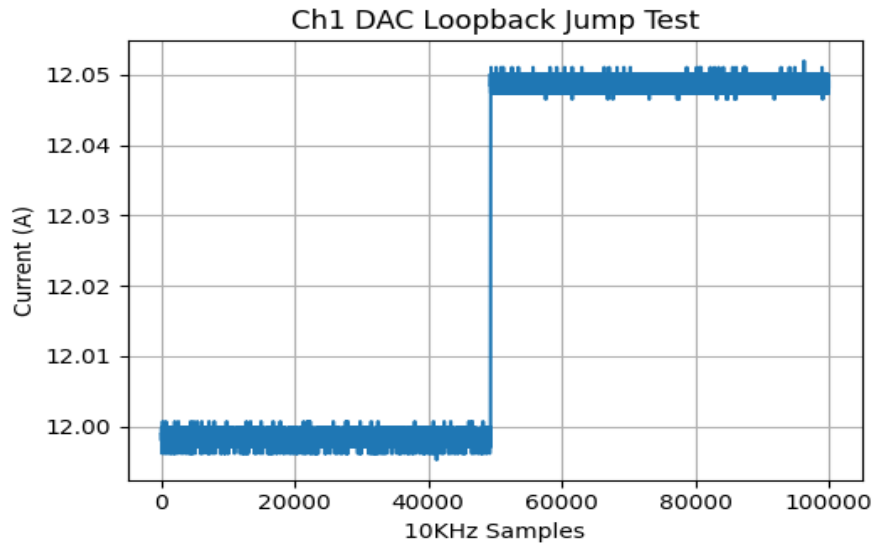
Jump Test Results: CH1

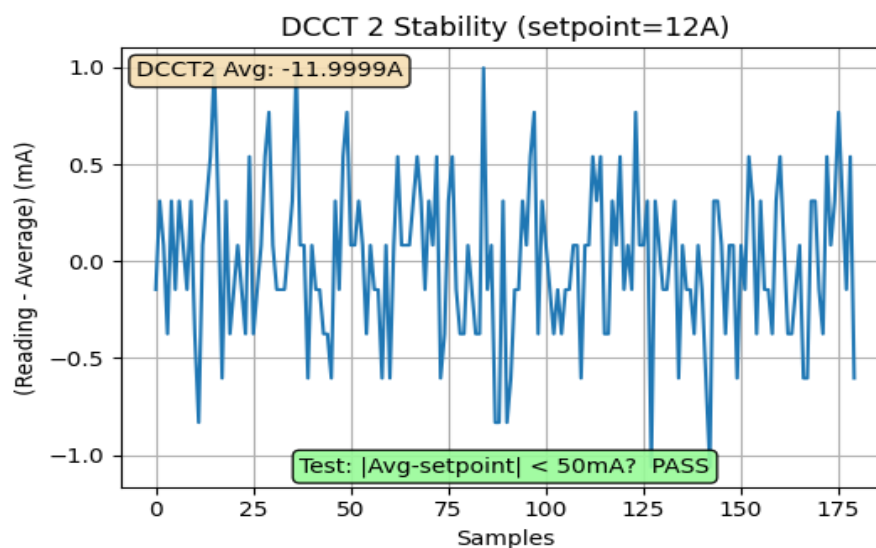
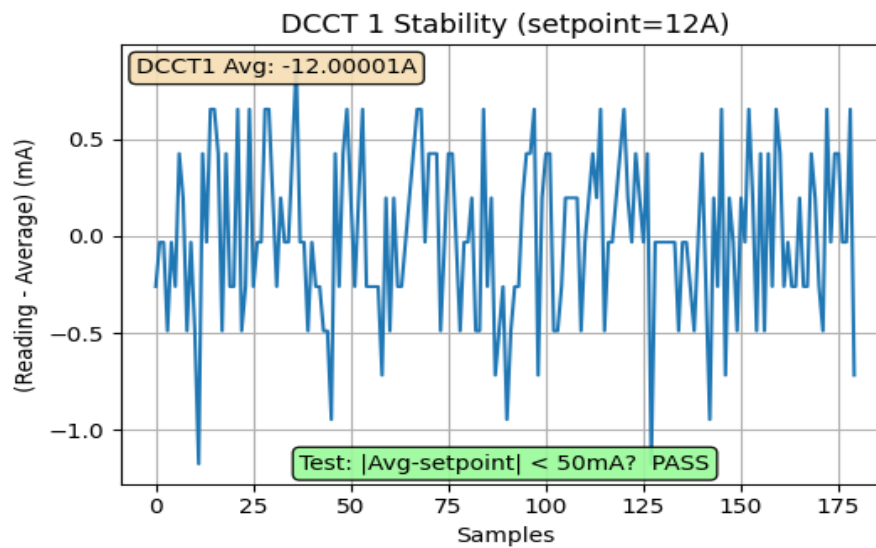
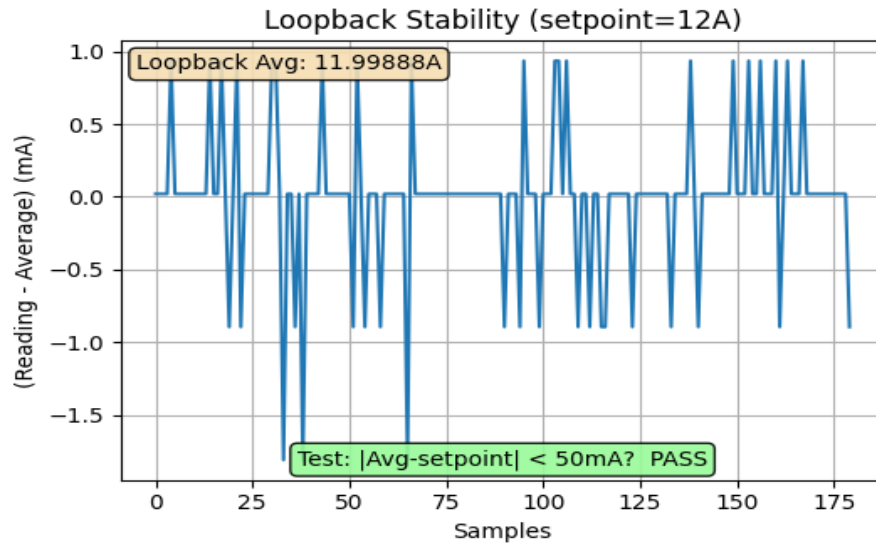
Power Supply Regulation for Channel 2:

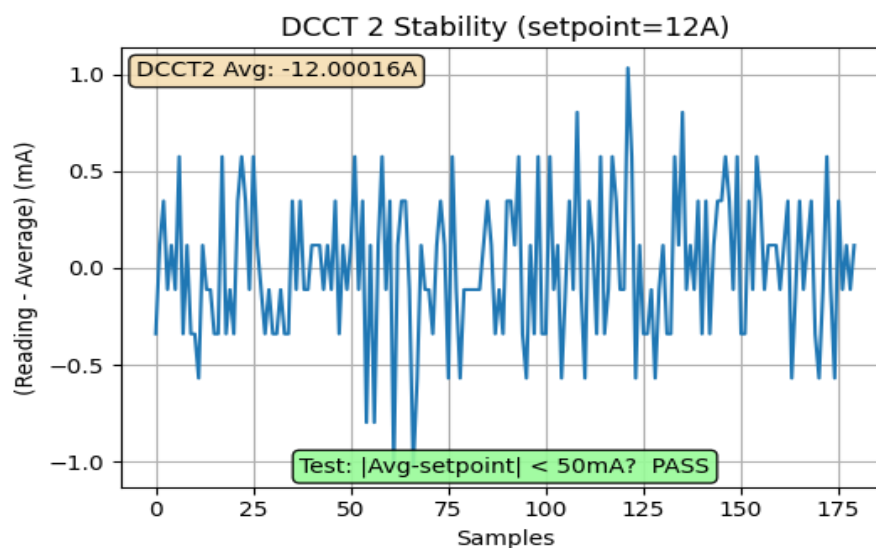
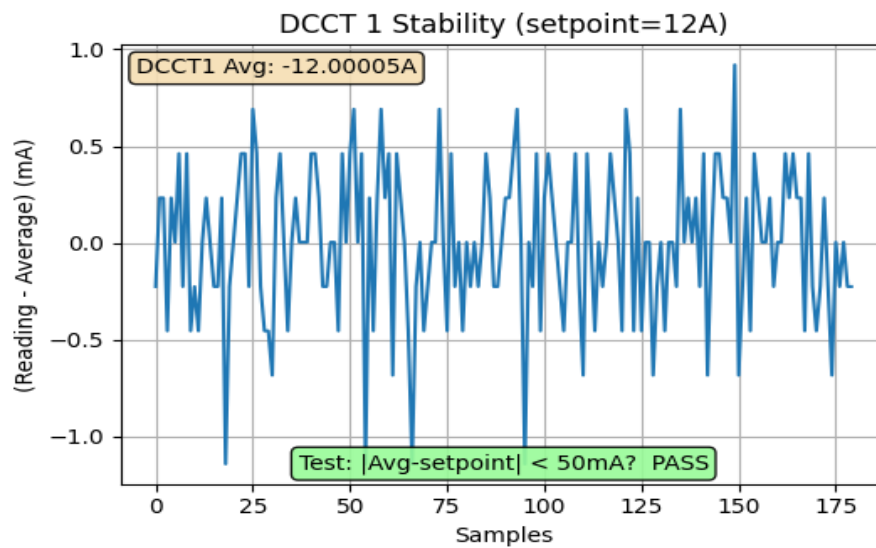
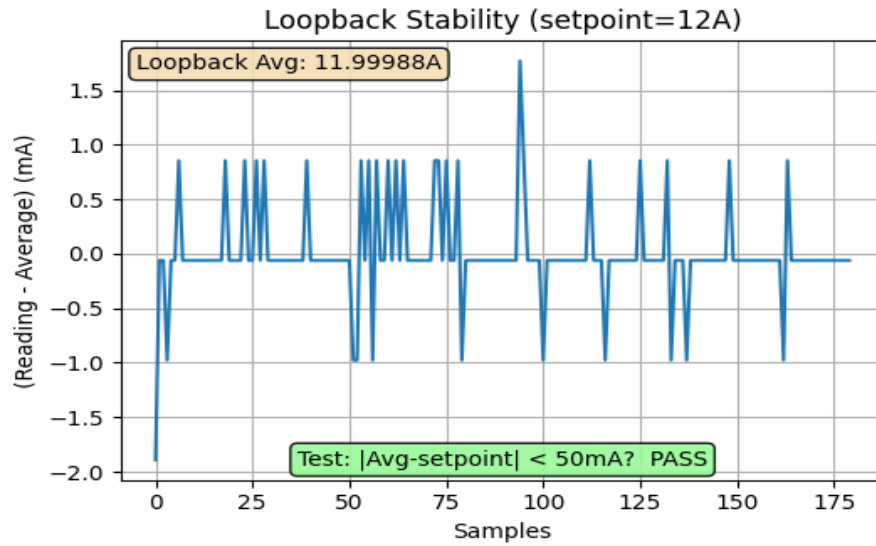
Power Supply Regulation for Channel 3:

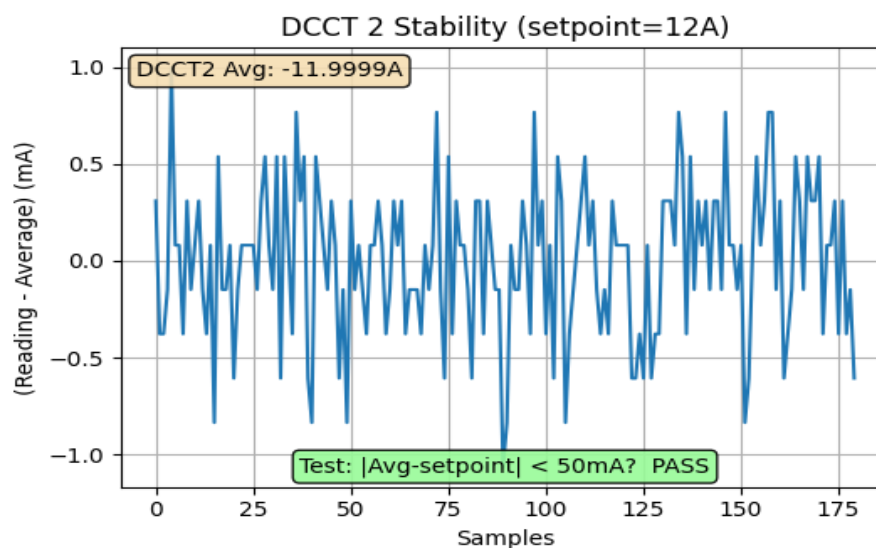
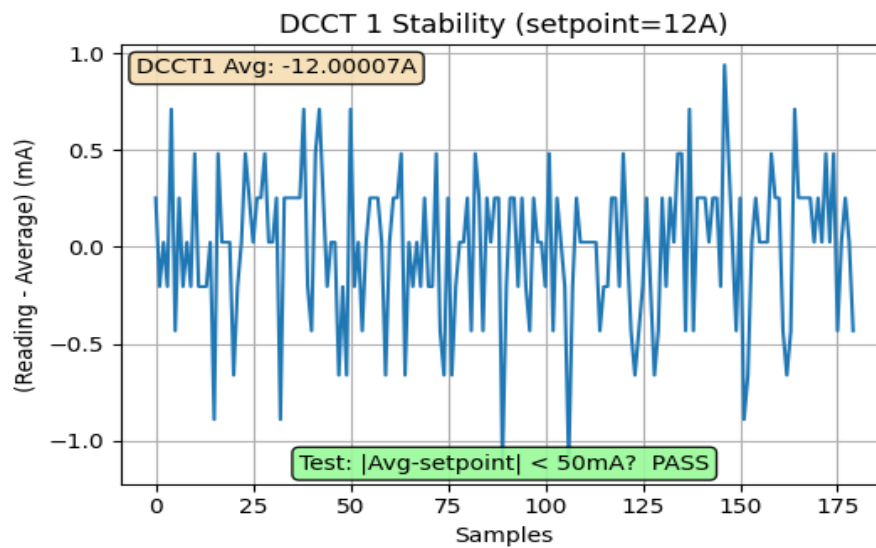
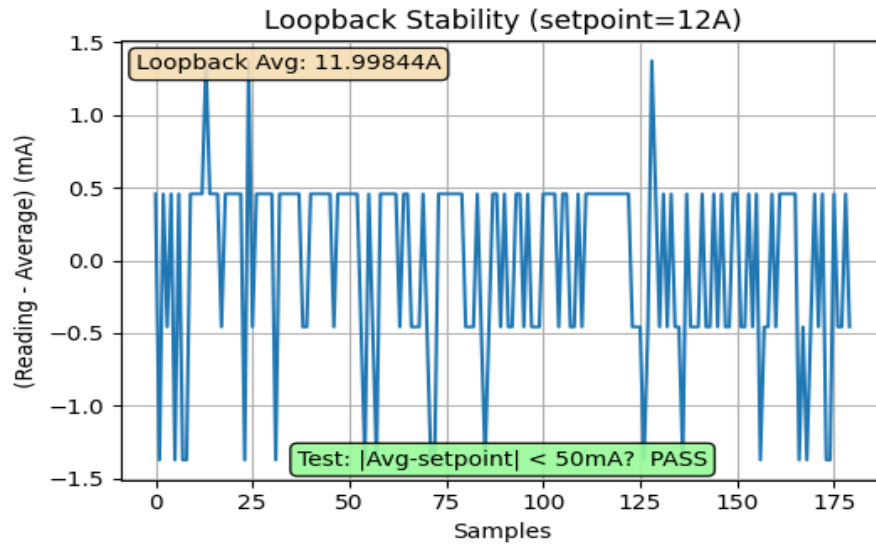
Power Supply Regulation for Channel 4:
