SITE INVESTIGATION FACTUAL REPORT

Mapletree Cottage, Pebmarsh, Halstead, CO9
2NA.

GHG
06/03/2026

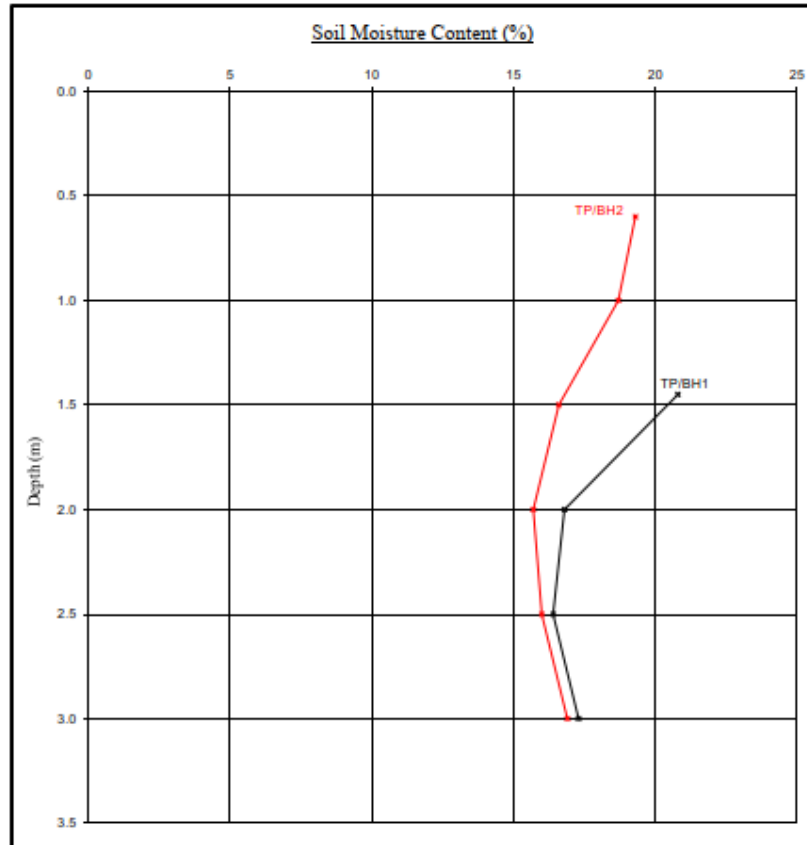
Moisture Content Profiles

1. If plotted, 0.4 LL and PL+2 (after Driscoll, 1983) should only be applied to London Clay (and similarly overconsolidated clay) at shallow depths.
2. Unless specifically noted the profiles have not been related to a site datum.

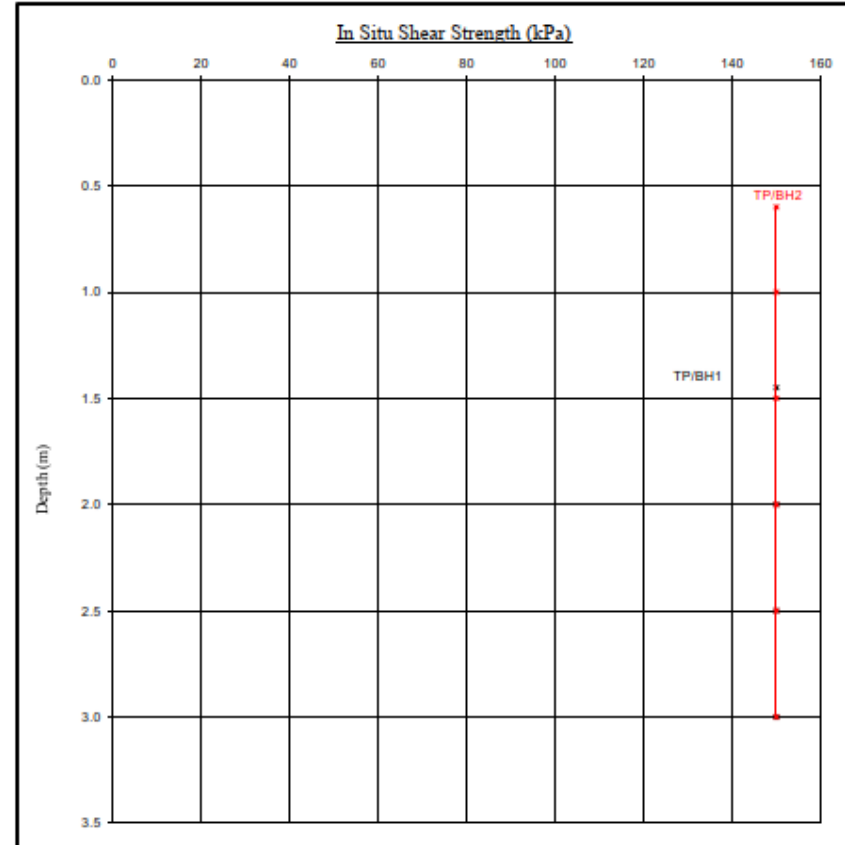
Shear Strength Profiles

1. Unless otherwise stated, values of Shear Strength were determined in situ by CTS using a Pilcon Hand Vane the calibration of which is limited to a maximum reading of 130 kPa.
2. Unless specifically noted the profiles have not been related to a site datum.
