### RK3399Pro\_NPU\_上电及启动介绍 RK3399Pro\_NPU\_Power\_Up\_and\_Boot\_Introduction

文件标识: File No.:	RK-SM-YF-258
文件状态: Status:	当前版本: Current Version:	V1.22
[]草稿 []Draft	作 者: Author:	周为新 Zhou Weixin
[]正在修改 []Modifying	完成日期: Finish Date:	2019-10-09
[√] 正式发布 [√] Released	审 核: Auditor:	黄祖芳 Huang Zufang
	审核日期: Finish Date:	2019-10-09

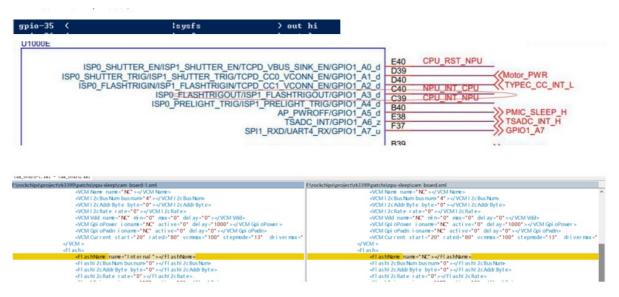
最新版本是不需要连接 32k 的

The latest version does not require clkout-32k

npu\_fw/npu\_pcie\_fw: npu sleep with pvtm 32k in stead of external 32k

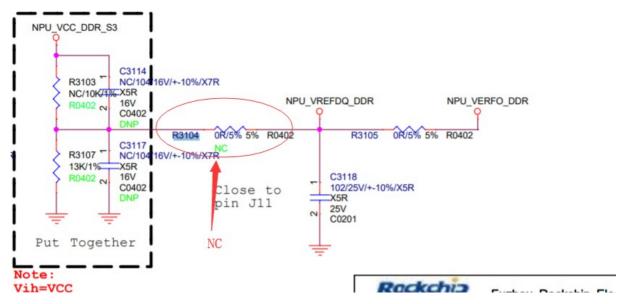
#### 3.3 DDR 初始化失败 DDR initialization failure

DDR Version V1.02 20190404\_no\_atag\_soc\_info\_dbg col error Returning to boot ROM...

Modification: R3104 should be NC
