Fabric Article#: EJ161330MS1

Fabric code: Stretch Sheer Solid - F0672

Phenomenon:

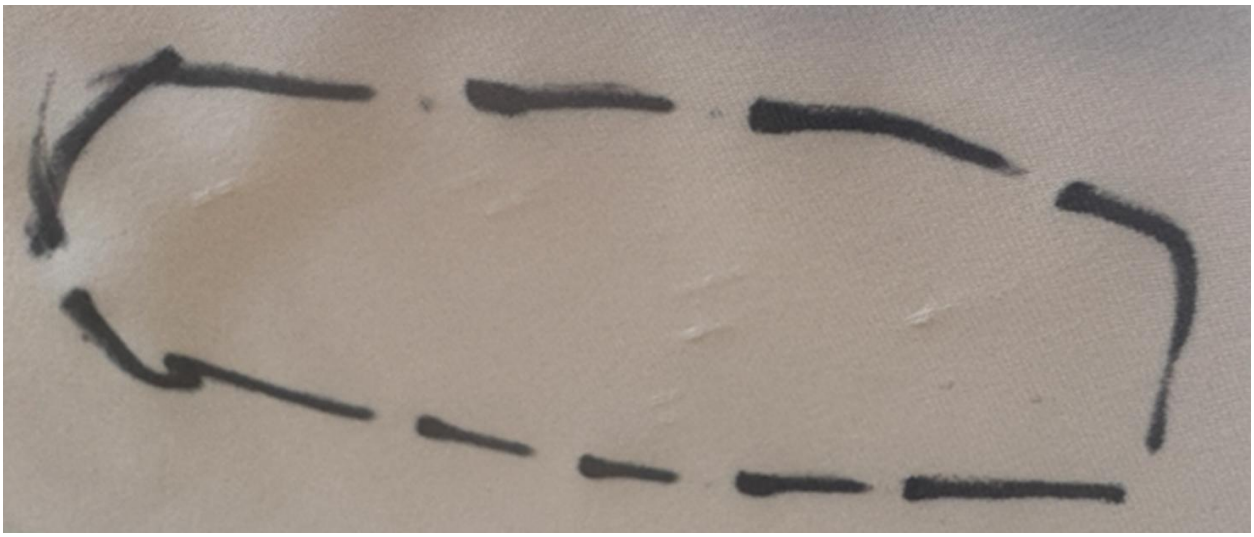
T2: To clarify the development background regarding the defects noted on the approved hanger.

This fabric is a fine-gauge, fine-yarn single jersey. It is sheer, lightweight, and soft, yet delivers strong stretch and compression. Unlike loop-locked interlock fabrics, this single jersey construction is highly sensitive.

It is prone to cosmetic yarn slippage (snagging) rather than actual yarn breakage. As we observed during the meeting, if a yarn snags, the surface can easily be massaged and reshaped by hand—very similar to delicate hosiery.

From the photo – could not identify whether such phenomenon is caused by Yarn twisted? Yarn overstretched/displacement/overlapping, etc----

The yarn size (40D/34F) alone does not justify the level of cosmetic snagging observed. The issue appears to be driven by a combination of fabric construction and finishing conditions, with the white colorway indicating a clear process-related amplification rather than a purely inherent material limitation.

Stock Re-inspection: We are re-inspecting our current stock yardage to check for similar cosmetic defects.

Vendor Alignment: We are contacting Youngone to align on garment manufacturing perspectives. Given the fabric's delicate nature, we strongly recommend "white glove" handling, low stacking heights to avoid pressure marks, and careful management of its inherent rolled edges.

Slower Production: We will slow down our setting and self-inspection processes to minimize handling risks before shipment.

Finishing Adjustment: We highly recommend a slight adjustment to reduce the bulk softness, which would effectively minimize the risk of snagging.
