Background:

T2 = Fabric Supplier: Yu Yuang

Fabric Article#: KP04570JA0

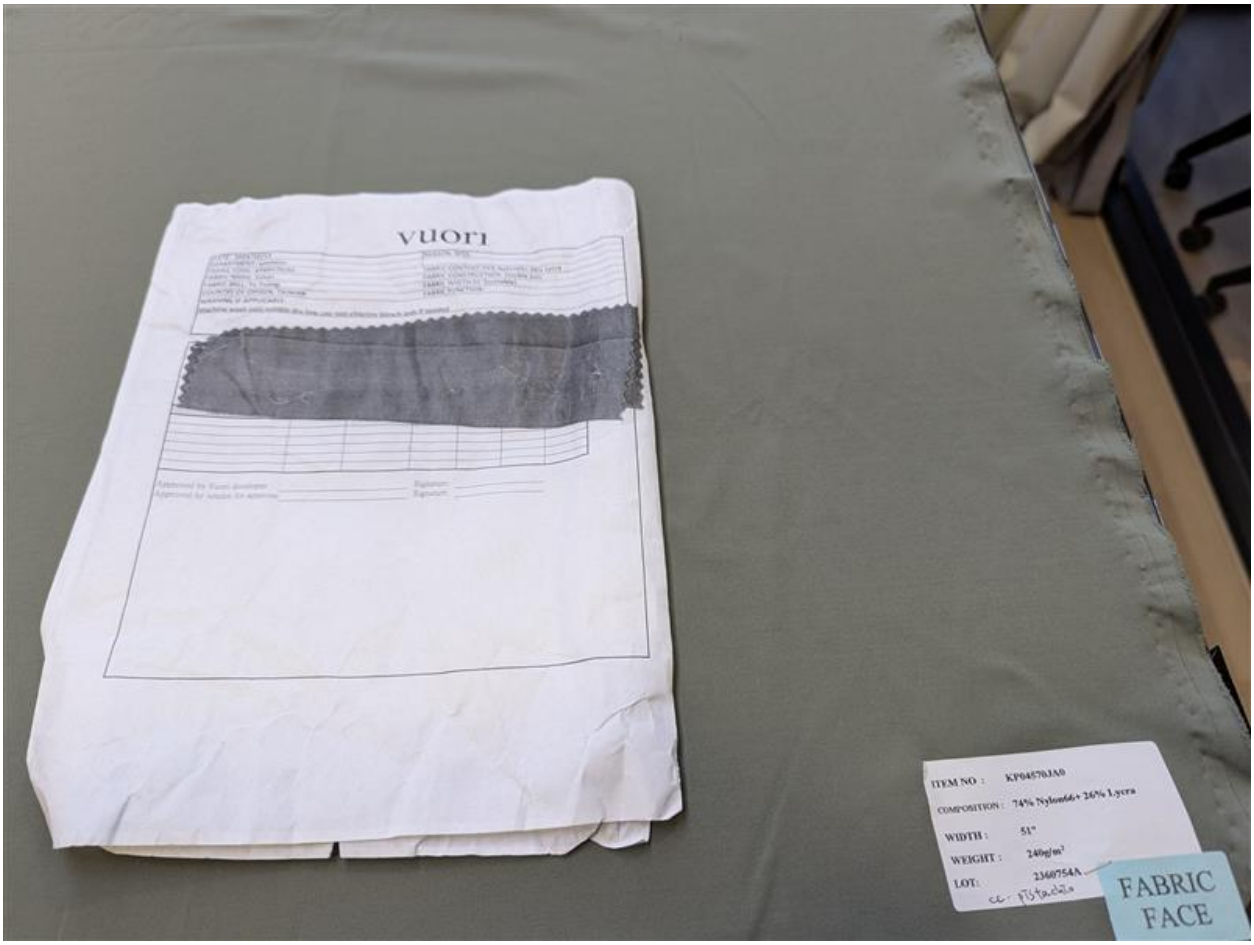
Easy causing crease marks as below photo showed:

Nylon 66 is a thermoplastic with low moisture regain. Under pressure, even room temperature pressure such as hang tag stacking over the time, fibers can take a temporary set which is a visible pressure marks, called “Crease Marks” or “Folding Marks” partially.

26% Lycra = High content of Spandex, means the fabric is very elastic, if not properly heat-set, the fabric will store mechanical strain and show creases after packing, tagging, or light pressing.

If steaming could remove the crease marks and folding marks and do not reappear, then these marks should be considered as acceptable.

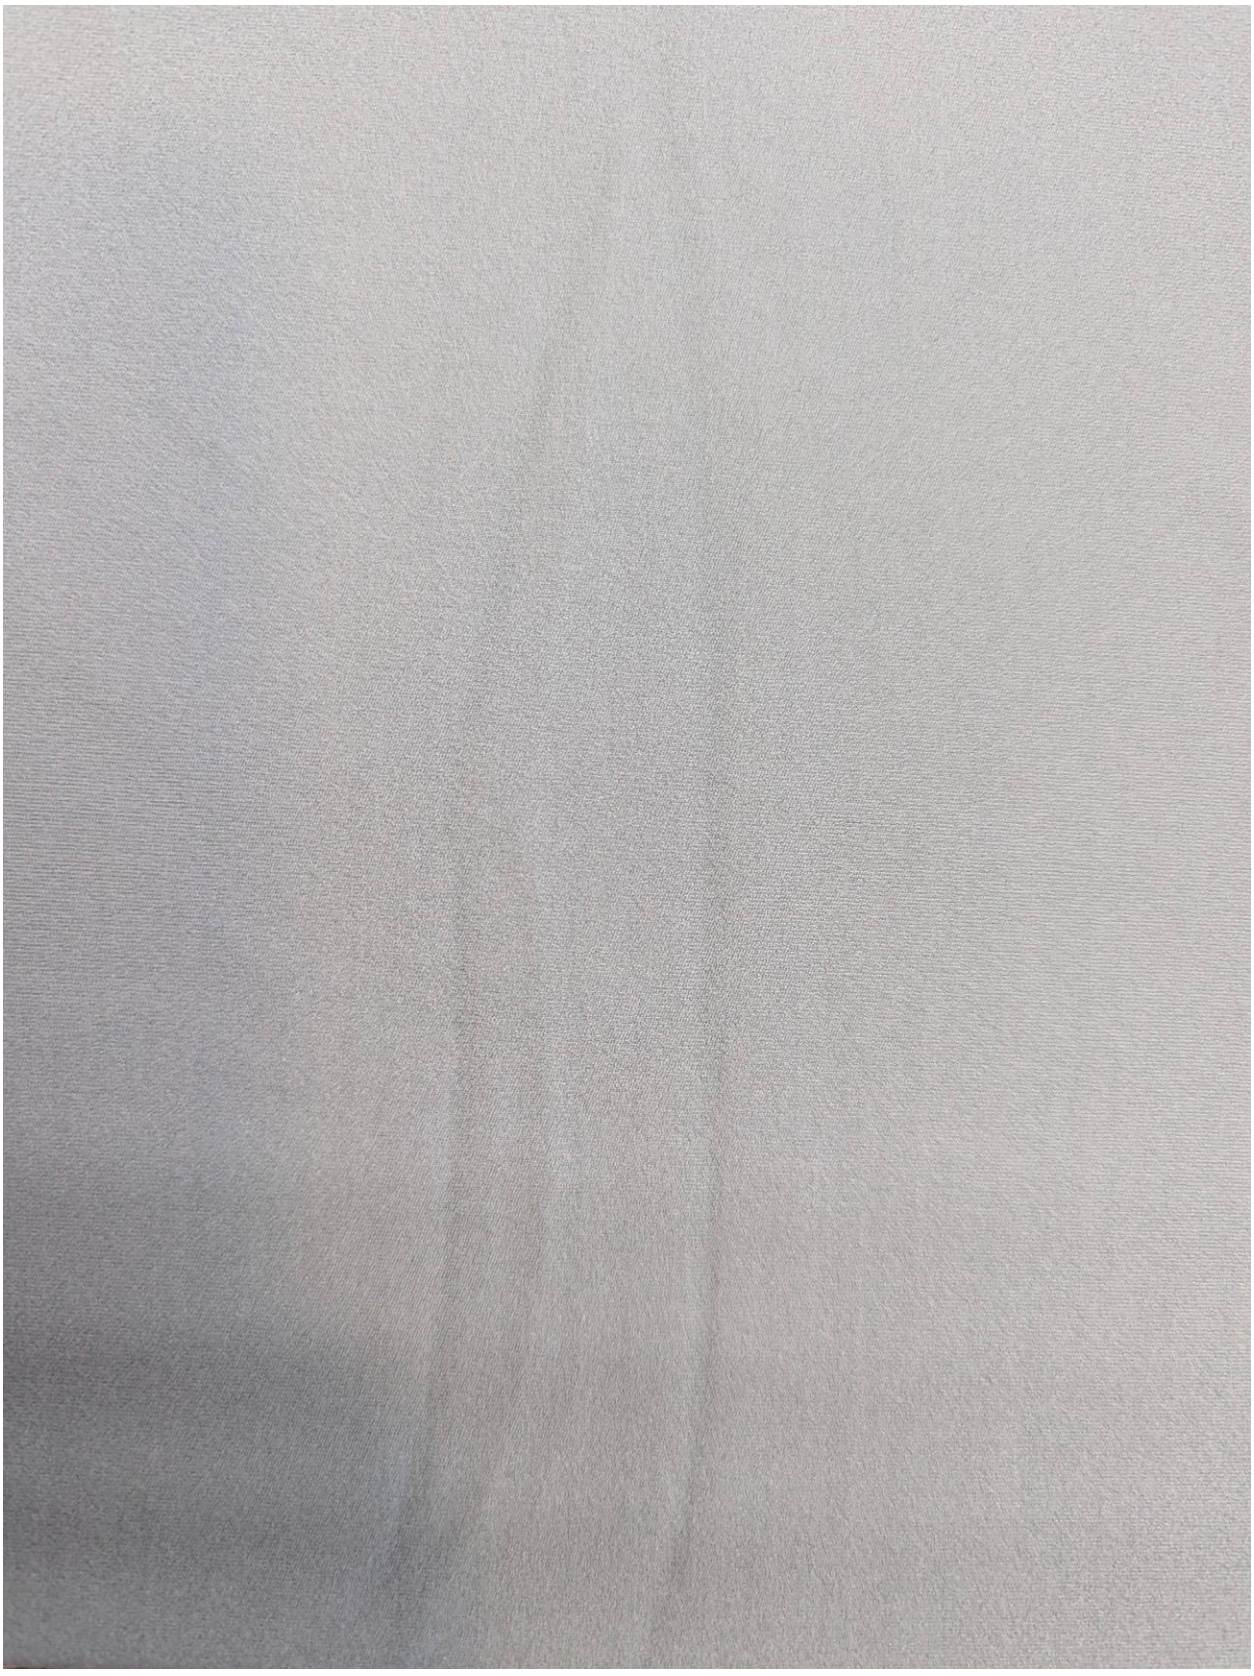
Below photos under fabric mirror and microscope:
