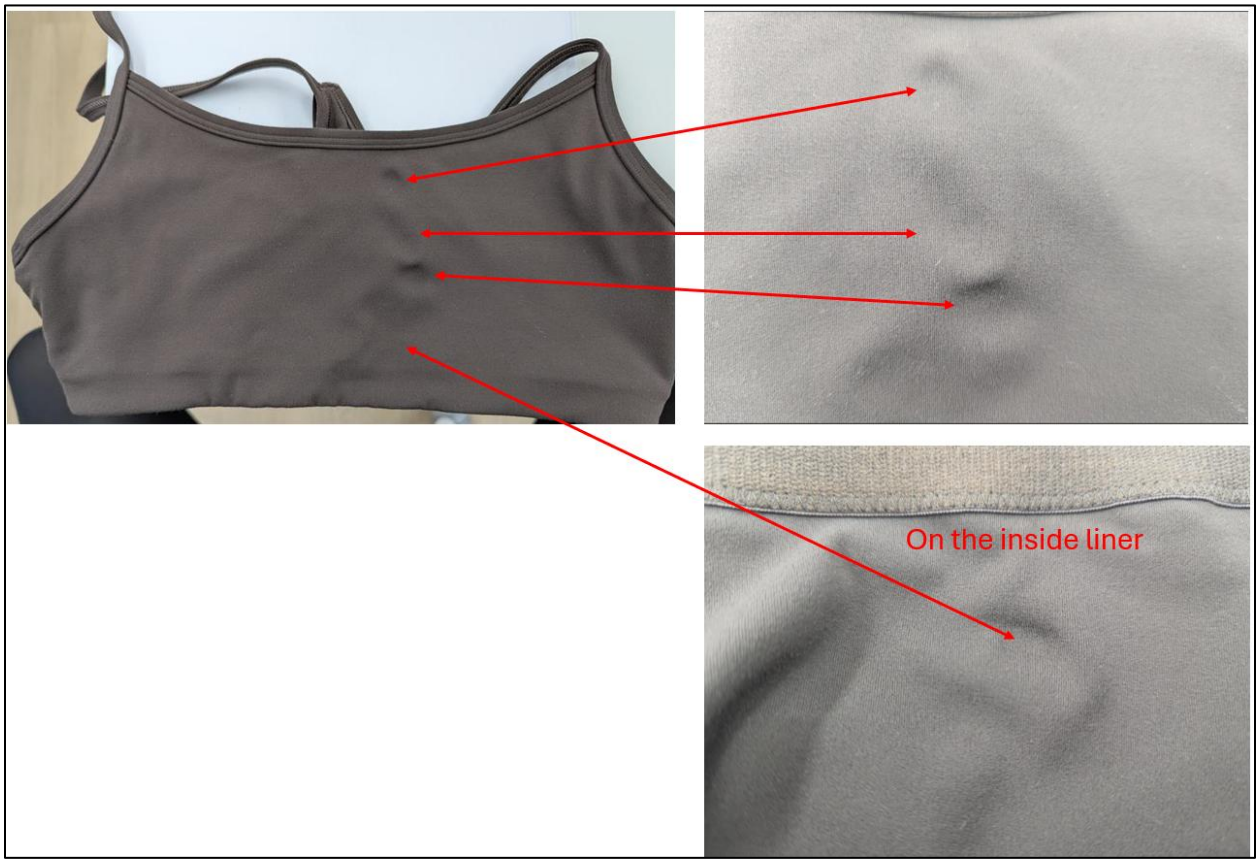
The sample was received with noticeable localized indentations and uneven wrinkles, observed at the same positions on both the outer and inner layers.

收到的樣品在局部位置出現明顯的凹痕與不平整皺紋, 且內外層同位置均有此現象.

The sample showed on the photo has wrinkle pattern that highly consistent with localized point pressure, and the fact that it appears in the same position on both the outer and inner layers aligns with the behavior of hanging force through the double-layer fabric or hanging marks formed during drying, where the weight of the garment and the suspension points may create similar indentations. 照片中樣品的 "凹痕形態" 與 "局部點壓" 一致, 且內外層同位置出現, 與外力施力穿透雙層布的行為相符, 外力來源是晾乾過程中的吊痕, 衣物重量與吊掛點可能形成類似的凹痕.

If this were a material or manufacturing defect, we'd typically observe more extensive and uniform ripples or deformation, and majority of Bulk will have the same issue after wash & dry. The distribution of flaws on this sample appears much more consistent with damage caused by external force. 若此為材料/製程本身缺陷, 通常會看到更廣泛, 還有規律性的波紋或沿縫線分布, 且大部分的大貨在水洗晾乾後可能都有這樣的問題, 為什麼只有這件? 這件樣品瑕疵的分布比較像是外力所造成.
