# **Pavement Edge Treatment**

**WA-RD 798.1**

#### **Post-Construction Report**

**Experimental Feature WA 11-01**

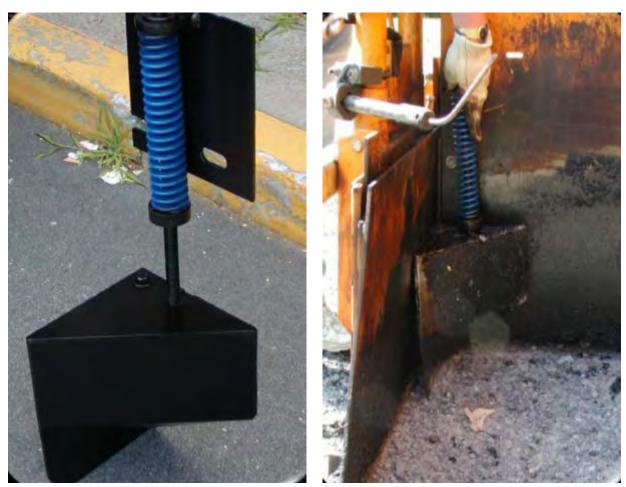
Figure 8. TransTech Shoulder Wedge Maker<sup>TM</sup> (SWM). Note compound angle of the wedge face. (FHWA, Madison Co., WI)
