## Report: Tolerance exceeding

Line, Track: ,  
 Km: -21.500 - 64.000  
 Track class: 80 - 120 km/h

Work: Maintenance  
 Date: 16/05/2026  
 Filename: MFI57123,16,05,2026.drp

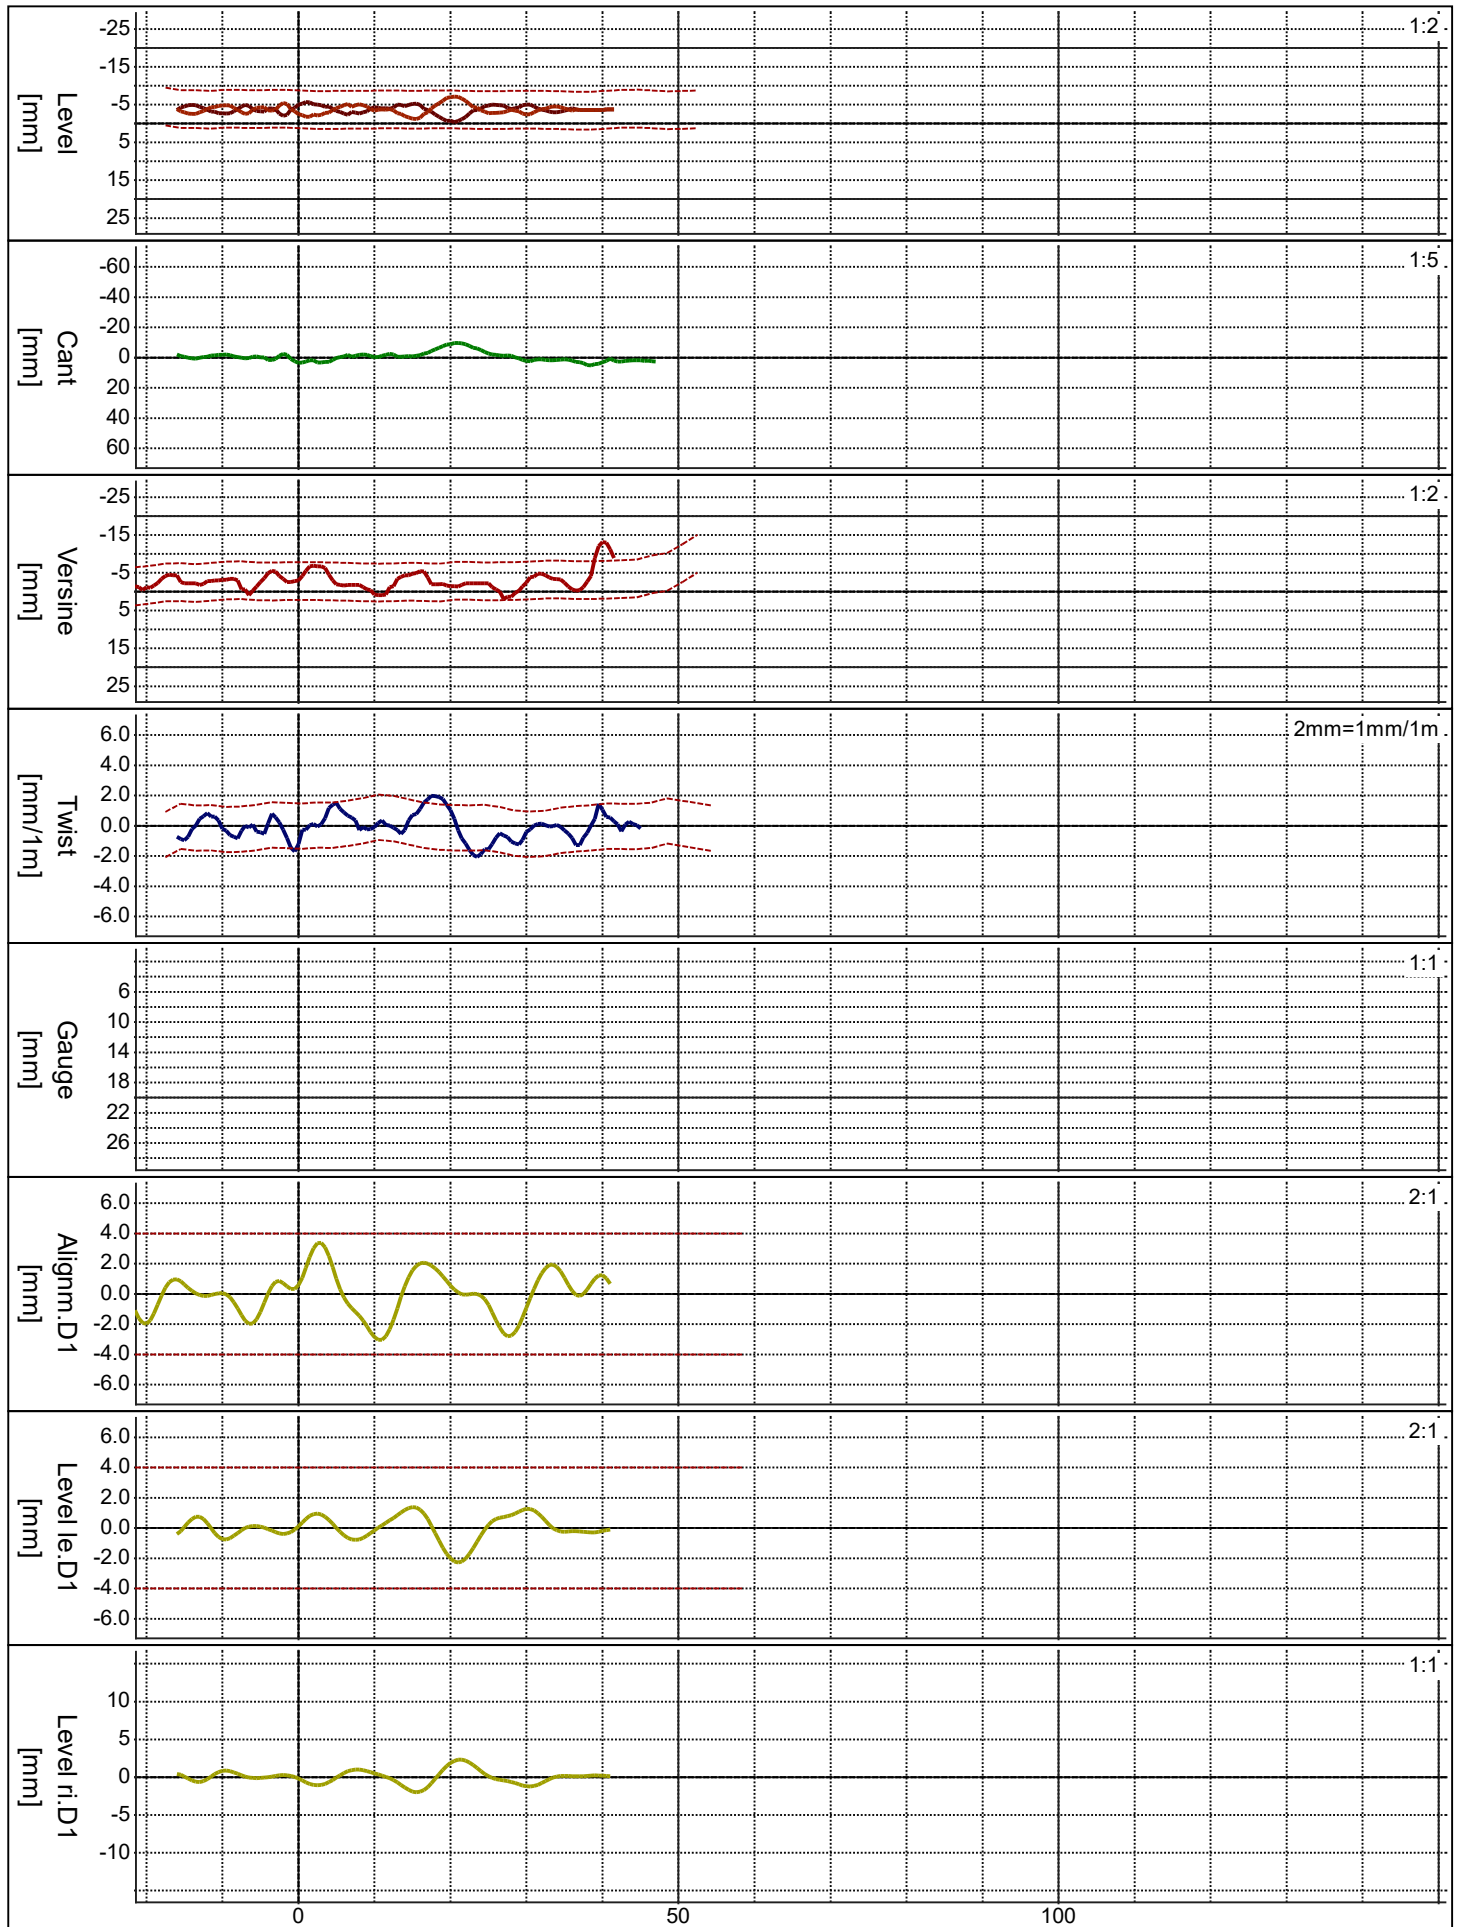
| km | Alignm.D1 | Cant diff. | Twist | Level D1 |
| | ±4.0 mm | ±4.0 mm | ±1.5 mm/1m | ±4.0 mm |
| -0,000.5 | | | 1-1.7 | |
| 0,018.0 | | | 2+2.0 | |
| 0,023.5 | | | 2-1.9 | |
| 0,039.5 | | | 1+1.5 | |
