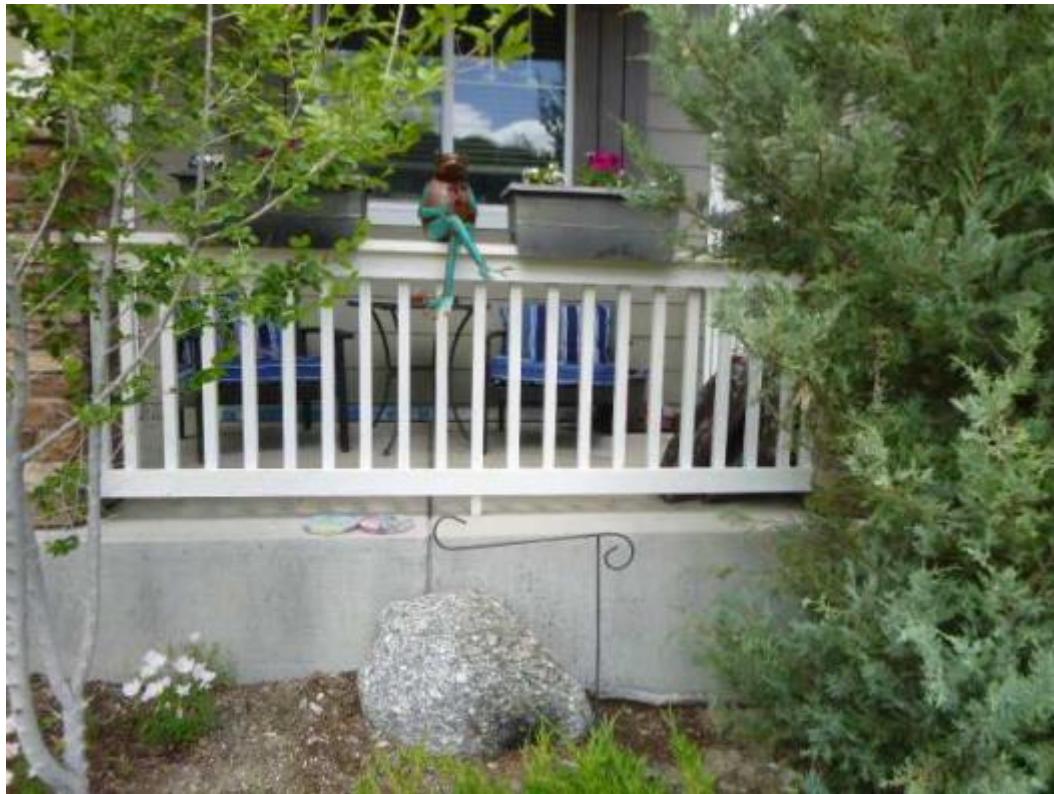
Dwelling/Exterior - 7-Front elevation

No peril related damage

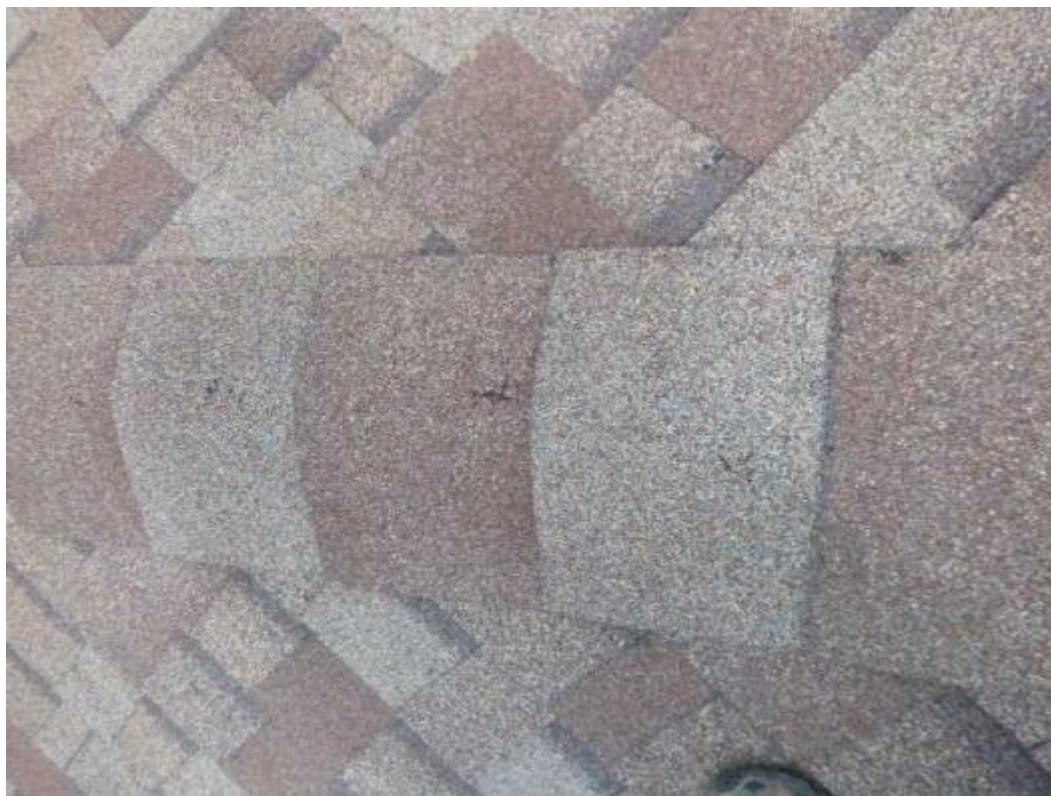
Dwelling/Exterior/Roofing/Dwelling roof - 73-Right slope

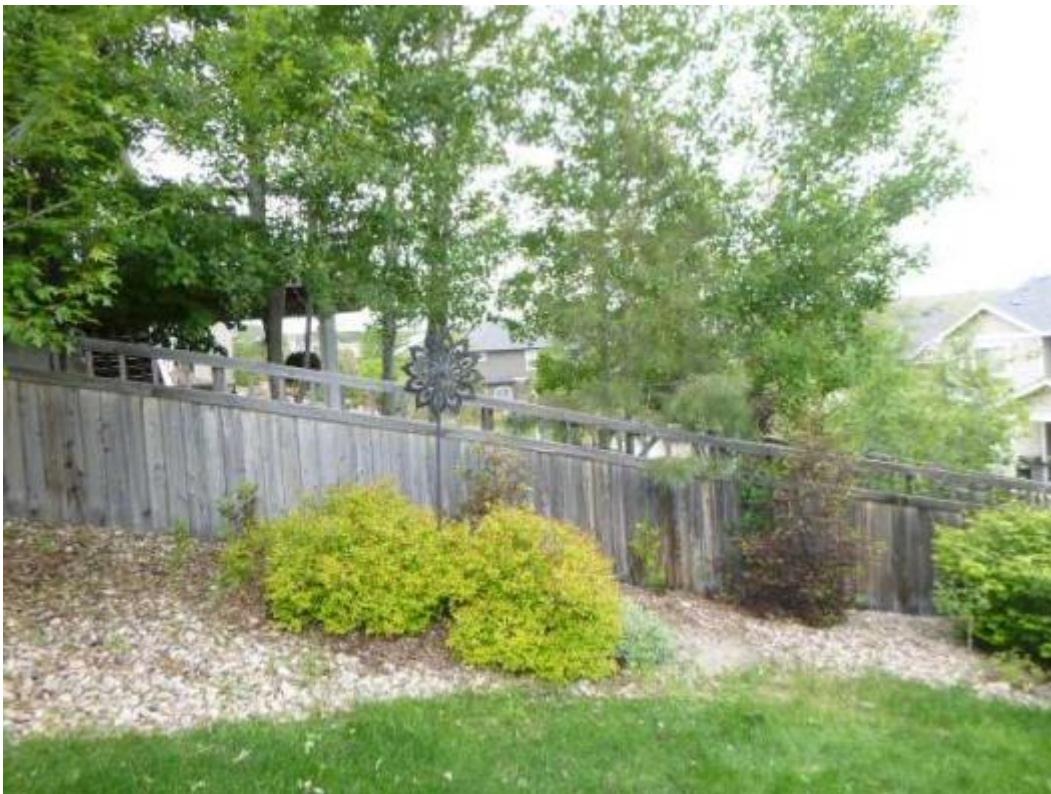
Unscheduled Other Structures/Fencing - 21-No damage - splatter only
