INSPECTION REPORT
111 Chase Water Dr
Mooreville NC

INSPECTED BY
Alex Parr 3692
Above Parr Home
Inspections

INSPECTION DATE
📅 8/14/2023
🕒 09:00:00 AM

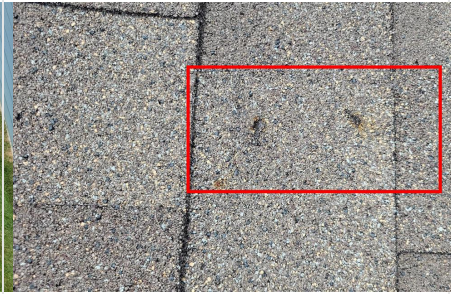
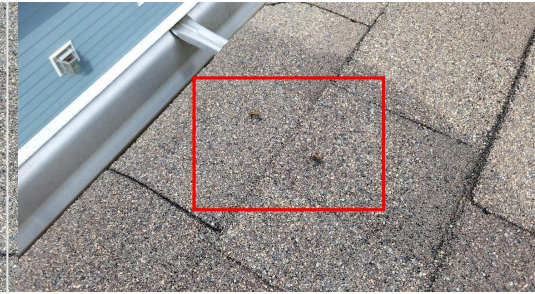
2.0 ROOF COVERINGS

1. The roof shingles are damaged in areas. This damage should be repaired or replaced. Unable to determine if this area will leak. Further investigation and repairs are needed.

A qualified person should repair or replace as needed.

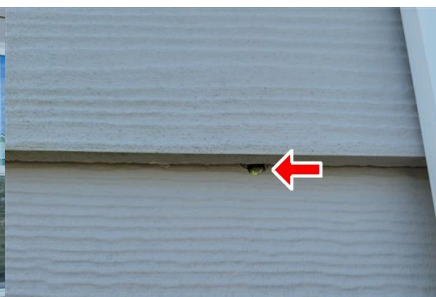
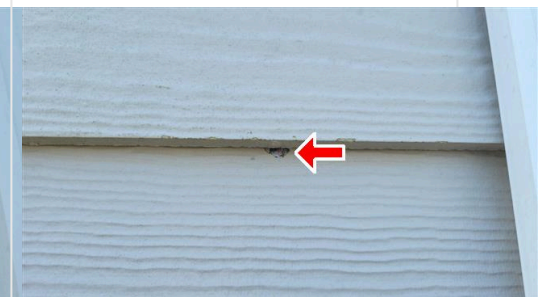
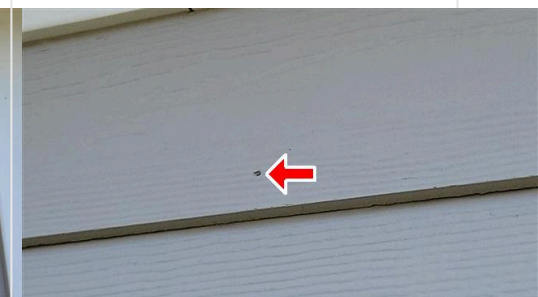
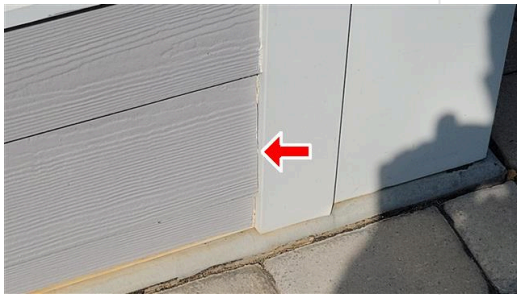
3.0 WALL CLADDING FLASHING AND TRIM

1. The Cement board at the exterior in areas installed improperly or not according to standard workmanlike practices. Deterioration can eventually occur if not corrected. Further investigation and repairs are needed.

1. The cement board at the exterior is damaged. Deterioration can eventually occur if not corrected.

A qualified person should repair or replace as needed.

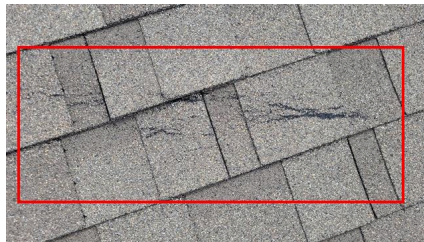
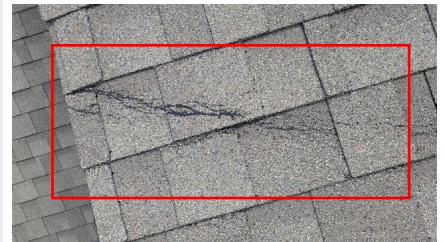
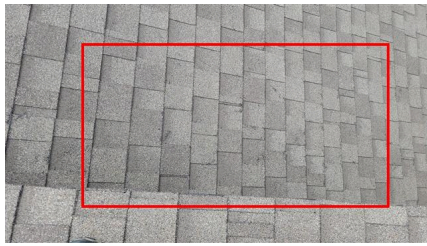
2.0 ROOF COVERINGS

1. The roof shingles are damaged in areas. This damage should be repaired or replaced. Unable to determine if this area will leak. Further investigation and repairs are needed.

A qualified person should repair or replace as needed.

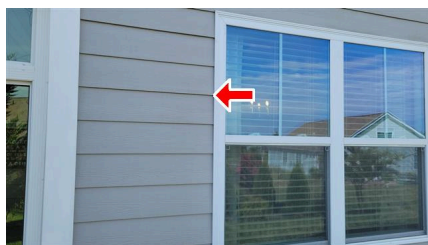
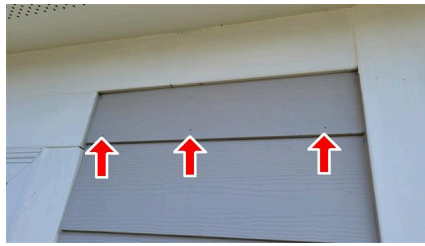
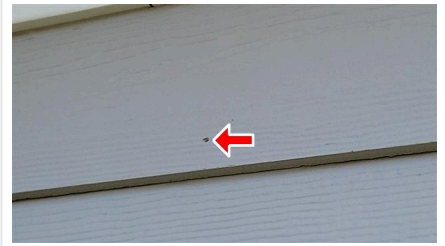
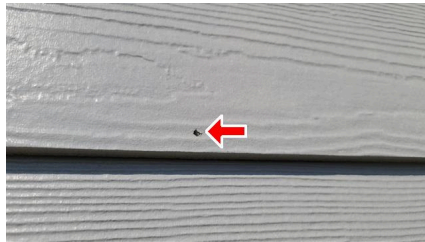
3.0 WALL CLADDING FLASHING AND TRIM

1. The Cement board at the exterior in areas installed improperly or not according to standard workmanlike practices. Deterioration can eventually occur if not corrected. Further investigation and repairs are needed.

A qualified person should repair or replace as needed.

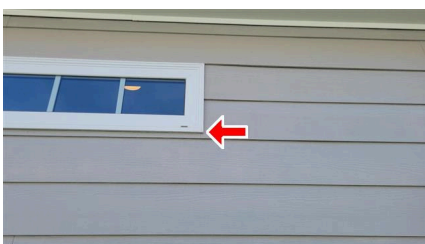
1. The cement board at the exterior is damaged. Deterioration can eventually occur if not corrected. Further investigation and repairs are needed.

A qualified person should repair or replace as needed.

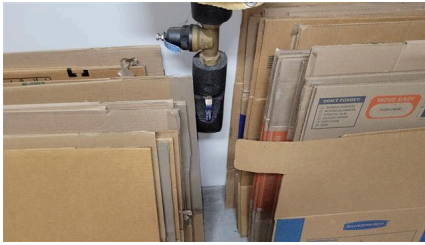
5.0 Item 1 (Picture)

The main shut off is the blue lever located in the garage. This is for your information.

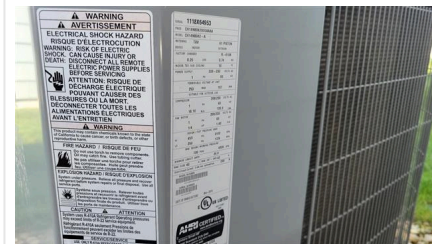
Complimentary photo of the heat pump
