INSPECTION REPORT
117 Holsworthy Dr
Mooresville NC 28115

INSPECTED BY
Alex Parr 3692
Above Parr Home
Inspections

INSPECTION DATE
📅 7/21/2023
🕒 09:00:00 AM

Inspection Date: 7/21/2023
Report ID: 072123AP1

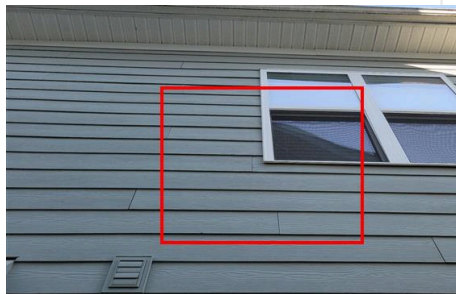
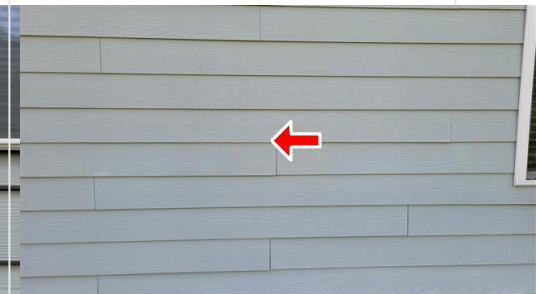
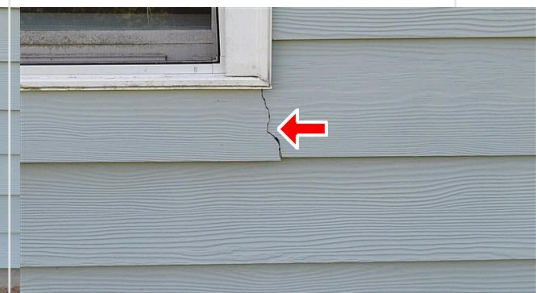
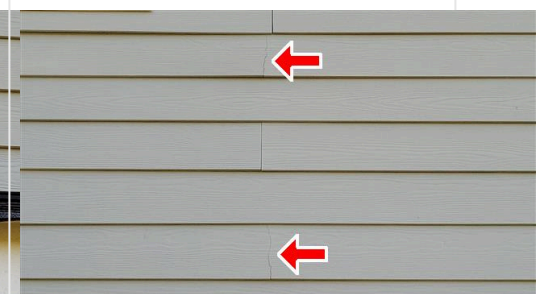
1. The cement board at the exterior is damaged and installed improperly or not according to standard workmanlike practices. This could allow water damage to occur to the home. Further deterioration can

occur if not corrected. Further investigation and repairs are needed.
A qualified contractor should inspect and repair as needed.

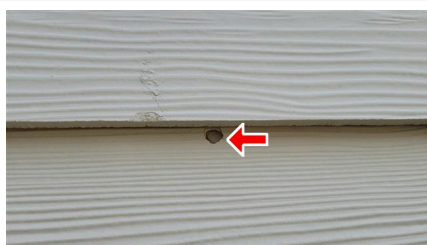
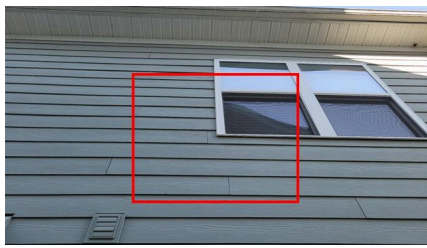
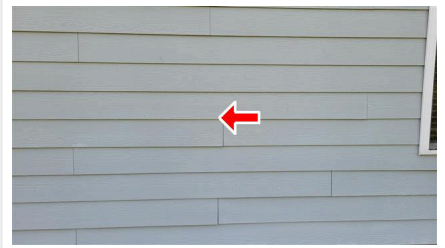
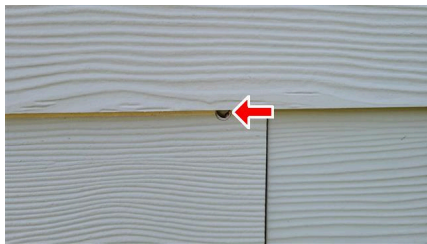
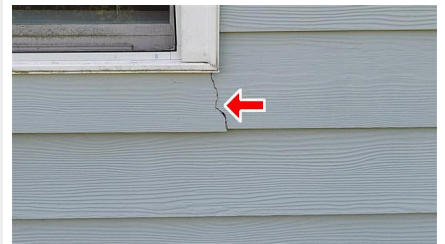
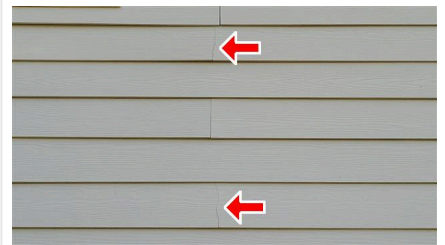
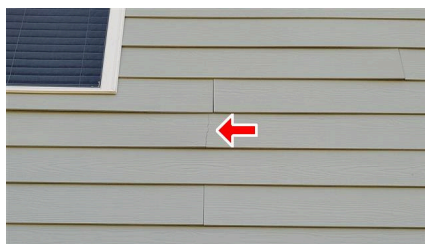
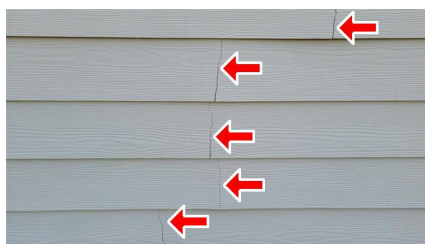
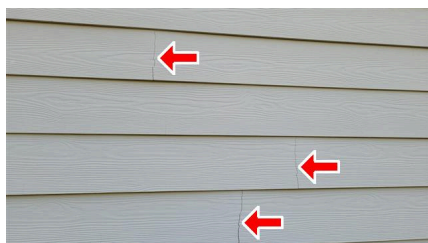
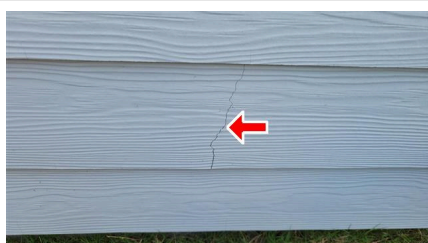
1. The cement board at the exterior is damaged and installed improperly or not according to standard workmanlike practices. This could allow water damage to occur to the home. Further deterioration can occur if not corrected. Further investigation and repairs are needed.

A qualified contractor should inspect and repair as needed.

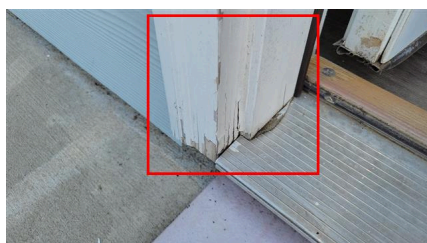
3.3 Item 1 (Picture)

1. The entry door at rear of home deteriorated at bottom of jamb (s). Further deterioration may occur if not repaired. Repairs are needed.

A qualified person should repair or replace as needed.

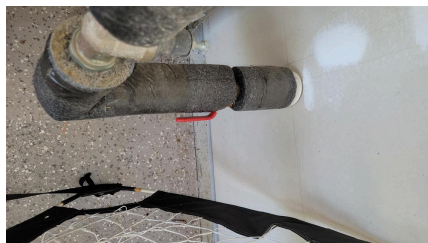
5.0 Item 1 (Picture)

The main shut off is the red lever located in the garage. This is for your information.

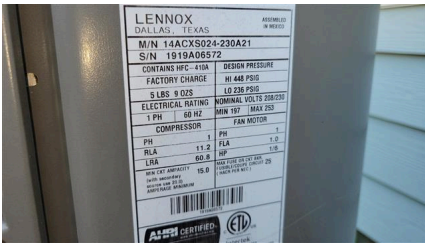
Complimentary photo of the AC units

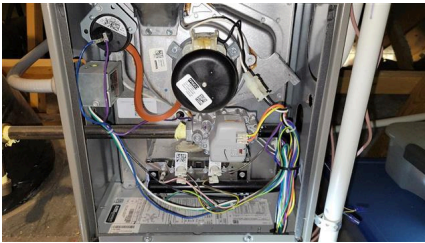
Complimentary photo of the gas furnace with the cover off
