INSPECTION REPORT
117 Synandra Dr
Unit C
Mooresville NC 28117

INSPECTED BY
Alex Parr 3692
Above Parr Home
Inspections

INSPECTION DATE
📅 3/21/2023
🕒 02:00:00 PM

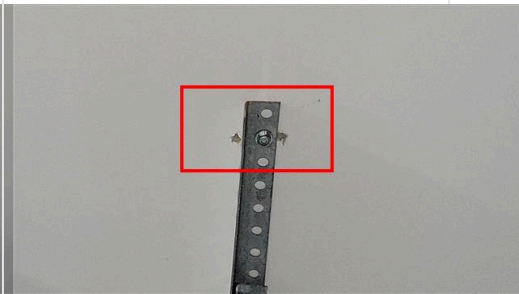
3.8 Item 1 (Picture)

1. The fire resistance sheathing in garage is damaged. This is considered unsafe until corrected. Further

investigation and repairs are needed.
A qualified person should correct for safety.

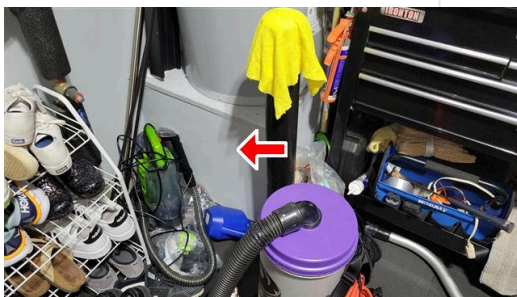
5.1 Item 1 (Picture)

1. The stand for the water heater is wood structure that does not appear to meet typical construction methods for a standard floor framing. Due to the unit's weight and safety related to a field water heater, water heater stands are typically required to be rated and labeled. Further investigation is needed.

A qualified contractor should inspect and repair as needed.

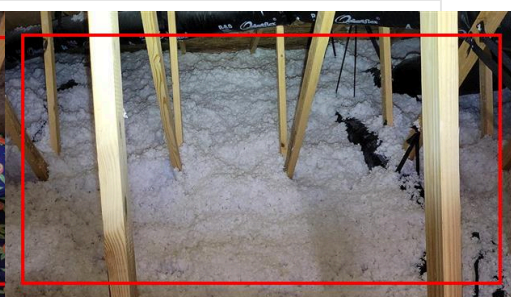
9.2 Item 1 (Picture)

1. Fiberglass (loose-fill) insulation is is compressed in areas of the attic due to foot traffic or storage in attic. Heat loss can occur more on this home than one that is properly insulated. Repairs are recommended .

A qualified person should repair or replace as needed.

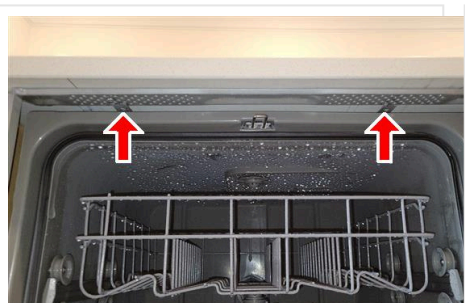
10.0 Item 1 (Picture)

1. The dishwasher is loose and needs securing to underside of countertop (using a proper length screw). I recommend repair as necessary.

I recommend contacting appliance repair company.

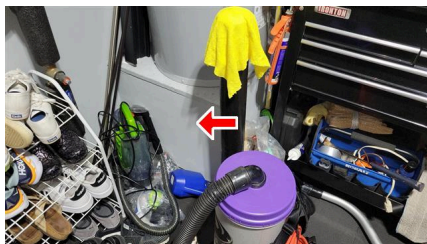
5.0 Item 1 (Picture)

The main shut off is the blue lever located in the garage. This is for your information.

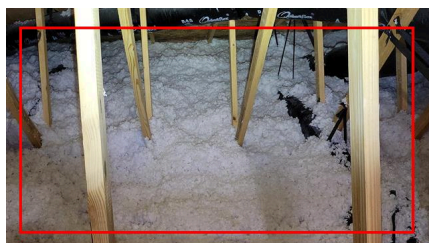
9.2 Item 1 (Picture)

1. Fiberglass (loose-fill) insulation is is compressed in areas of the attic due to foot traffic or storage in attic. Heat loss can occur more on this home than one that is properly insulated. Repairs are recommended .

A qualified person should repair or replace as needed.

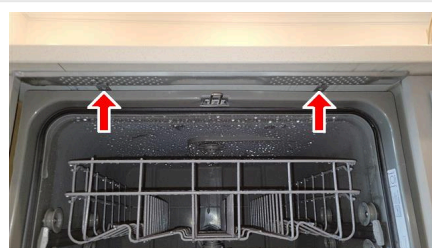
10.0 Item 1 (Picture)

1. The dishwasher is loose and needs securing to underside of countertop (using a proper length screw). I recommend repair as necessary.

I recommend contacting appliance repair company.
