INSPECTION REPORT
150 Glade Vly Ave
Mooresville NC 28117

INSPECTED BY
Alex Parr 3692
Above Parr Home
Inspections

INSPECTION DATE
📅 7/17/2023
🕒 02:00:00 PM

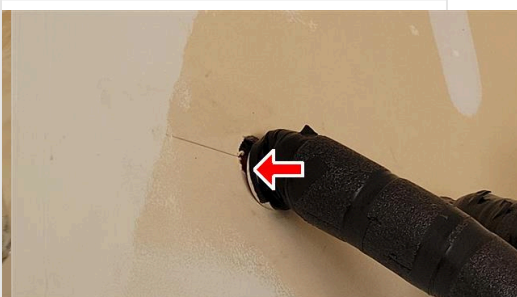
3.8 Item 1 (Picture)

1. The fire resistance sheathing that separates garage from heated space is compromised. This is considered unsafe until corrected. Repairs are needed.

A qualified person should correct for safety.

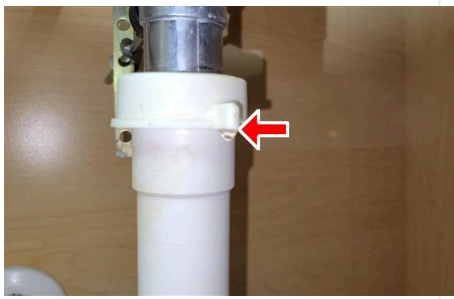
5.3 Item 1 (Picture)

1. The plumbing waste line leaks at the Master Bath sinks. Repairs are needed to prevent water damage from occurring to the home. Further investigation and repairs are needed.

A qualified licensed plumber should repair or correct as needed.

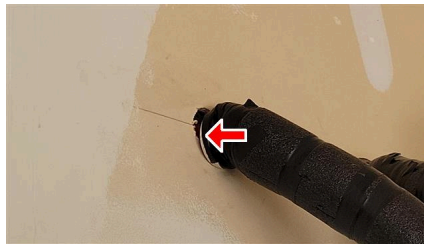
3.8 Item 1 (Picture)

1. The fire resistance sheathing that separates garage from heated space is compromised. This is considered unsafe until corrected. Repairs are needed.

A qualified person should correct for safety.

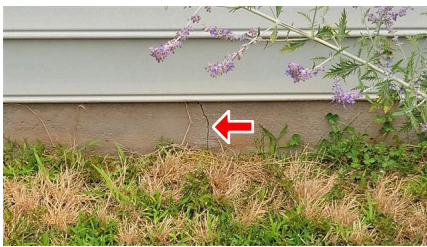
4.0 Item 1 (Picture)

1. The concrete slab at the exterior is cracked due to the natural shrinkage that occurs when concrete cools after it heats up and expands as it cures. The pad surface was even and no evidence of differential movement was noted. Repairs are recommended.

I recommended contacting a qualified handyman or qualified person regarding these conditions to seal the crack to prevent water penetration.

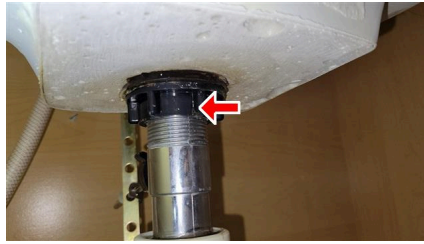
5.3 Item 1 (Picture)

1. The plumbing waste line leaks at the Master Bath sinks. Repairs are needed to prevent water damage from occurring to the home. Further investigation and repairs are needed.

A qualified licensed plumber should repair or correct as needed.

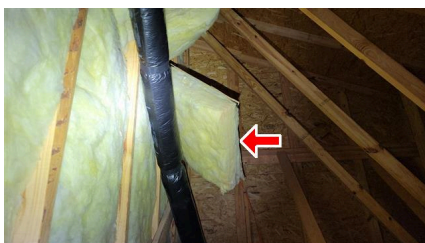
1. Fiberglass (Batts) insulation in attic is loose/fallen. Heat loss can occur more on this home than one that is properly insulated. Repairs are needed..

A qualified person should repair or replace as needed.

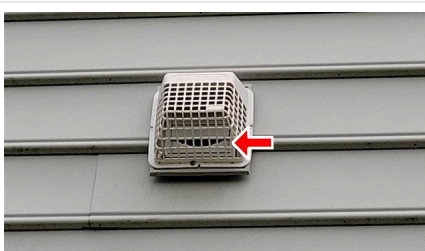
9.5 Item 1 (Picture)

1. The Exhaust fan vent cove is damaged at the left side of the home. This may allow insects or critters to enter home. Repairs are needed.

A qualified person should repair or replace as needed.

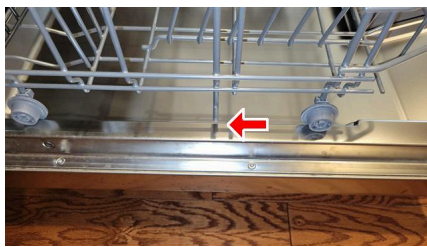
1. The dishwasher rack is missing a wheel. Therefore it does not function as intended. Repairs are needed.

I recommend contacting appliance repair company.
