INSPECTION REPORT
443 Preston Rd
Troutman NC 28166

INSPECTED BY
Alex Parr 3692
Above Parr Home
Inspections

INSPECTION DATE
📅 3/20/2024
🕒 02:00:00 PM

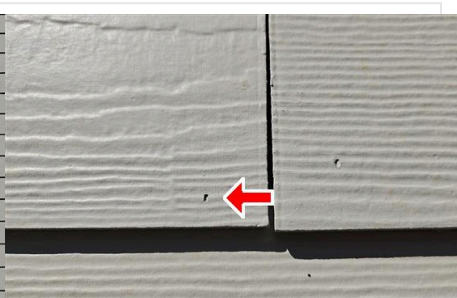
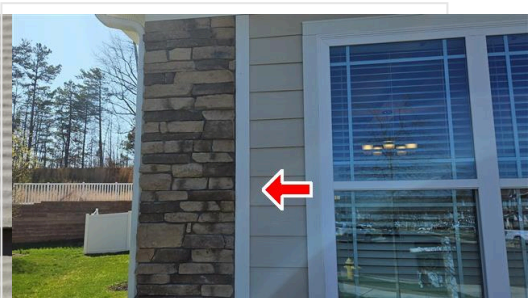
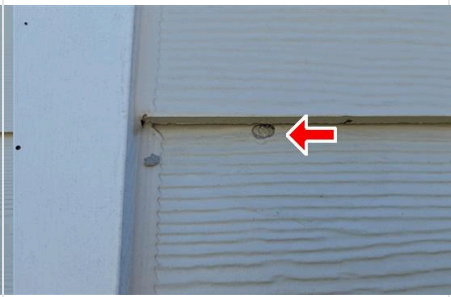
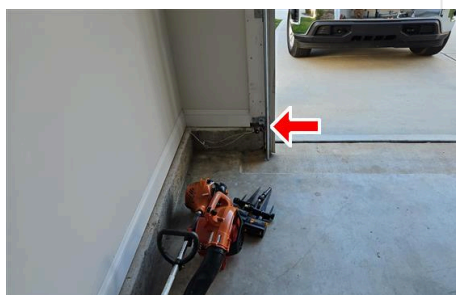
3. EXTERIOR

1. The cement board at the exterior in areas needs to be sealed. Deterioration can eventually occur if not corrected. Further investigation and repairs are needed.

A qualified contractor should inspect and repair as needed.

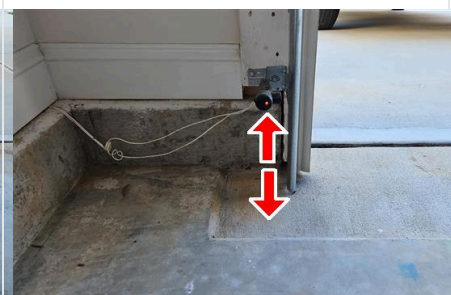
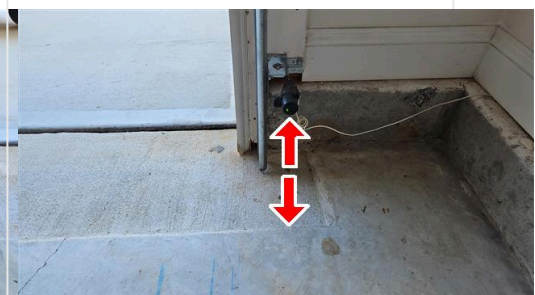
3.6 GARAGE DOOR (S)

1. The two-door garage at the front of home has electronic sensors located higher than six inches off floor which may not be installed according to manufacturers specification. This is considered unsafe and needs correcting. A repair or replacement is needed.

A qualified person should repair or replace as needed.

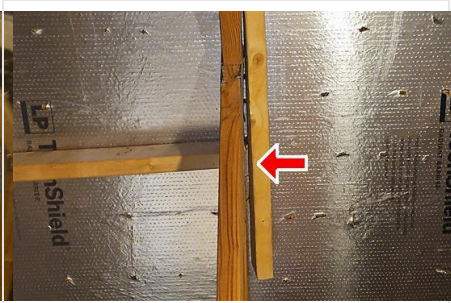
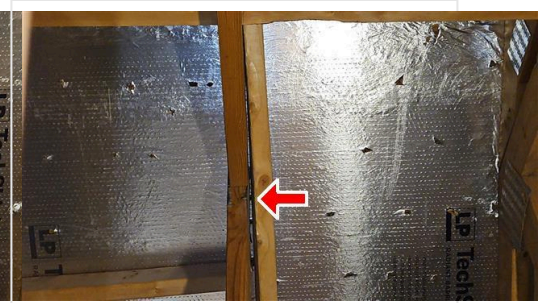
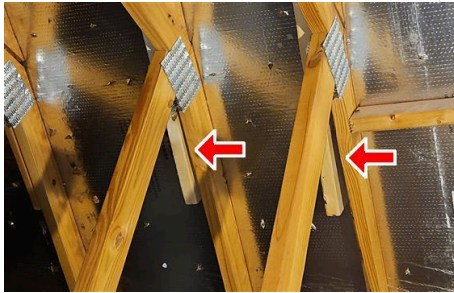
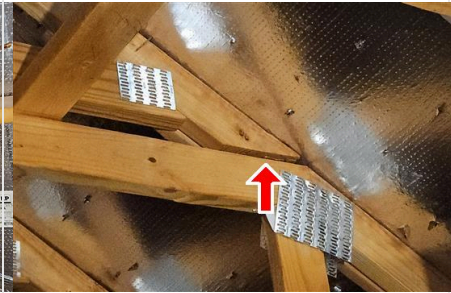
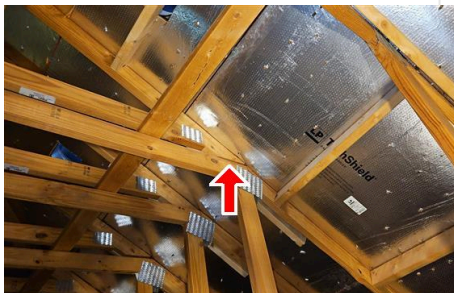
4.4 ROOF STRUCTURE AND ATTIC

1. The roof trusses braces and loose and several trusses are not in contact with each other. Repairs may be needed to maintain roof stability. Further investigation and repairs are needed.

Truss repairs should be approved by an engineer or qualified architect before performing the work involved.

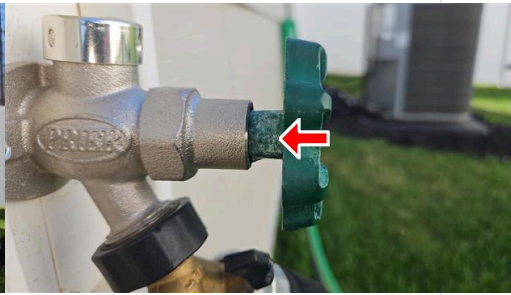
5.2 PLUMBING WATER SUPPLY, DISTRIBUTION SYSTEM AND FIXTURES

1. The knob for outside water faucet drips when off at the right side (facing front). Repairs are needed to prevent water damage from occurring to the home. Repairs are needed.

1. The controls are loose throughout the home. Further deterioration may occur. Further investigation and repairs are needed.

A qualified licensed plumber should repair or correct as needed.

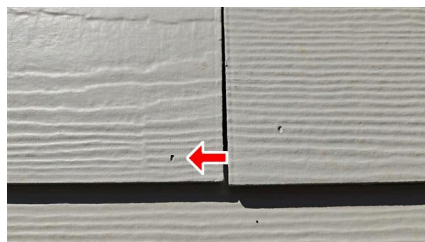
3.0 WALL CLADDING FLASHING AND TRIM

1. The cement board at the exterior in areas needs to be sealed. Deterioration can eventually occur if not corrected. Further investigation and repairs are needed.

A qualified contractor should inspect and repair as needed.

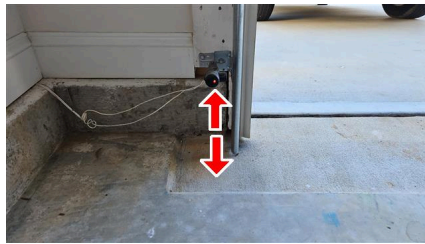
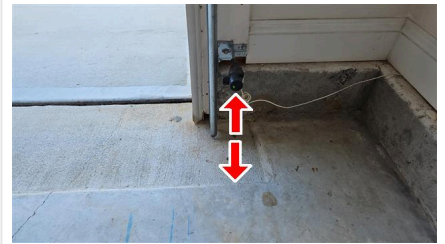
3.6 GARAGE DOOR (S)

1. The two-door garage at the front of home has electronic sensors located higher than six inches off floor which may not be installed according to manufacturers specification. This is considered unsafe and needs correcting. A repair or replacement is needed.

A qualified person should repair or replace as needed.

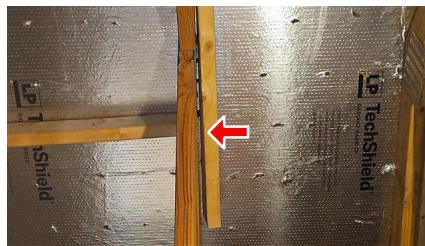
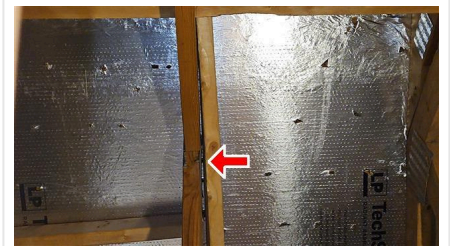
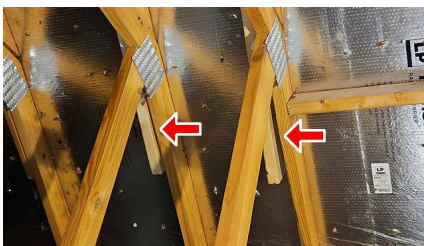
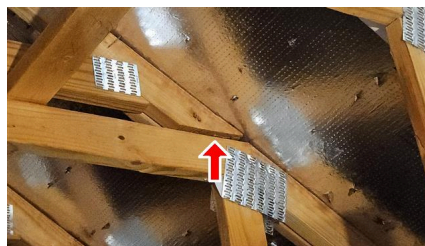
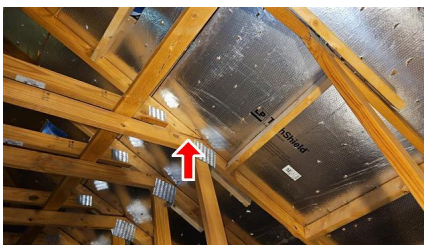
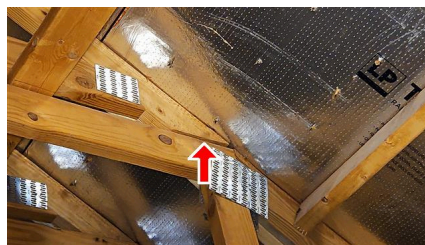
4.4 ROOF STRUCTURE AND ATTIC

1. The roof trusses braces and loose and several trusses are not in contact with each other. Repairs may be needed to maintain roof stability. Further investigation and repairs are needed.

Truss repairs should be approved by an engineer or qualified architect before performing the work involved.

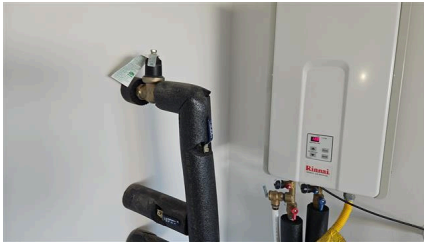
Water Source: Public	Water Filters: None	Plumbing Water Supply (into home): Pex
Plumbing Water Distribution (inside home): PEX	Washer Drain Size: 2" Diameter	Plumbing Waste: PVC
Water Heater Power Source: Gas (quick recovery)	Water Heater Capacity: Tankless	Manufacturer: RINNAI
Water Heater Location: Garage

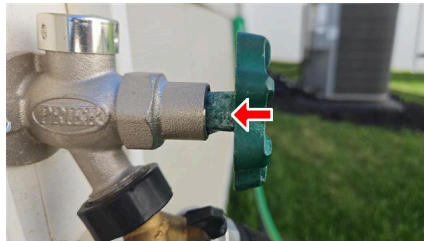
5.2 PLUMBING WATER SUPPLY, DISTRIBUTION SYSTEM AND FIXTURES

1. The knob for outside water faucet drips when off at the right side (facing front). Repairs are needed to prevent water damage from occurring to the home. Repairs are needed.

A qualified licensed plumber should repair or correct as needed.

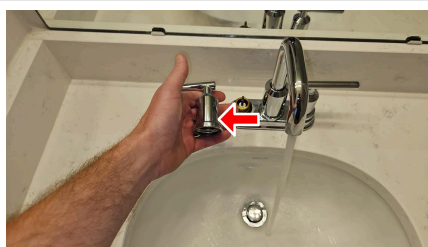
1. The control are loose throughout the home. Further deterioration may occur. Further investigation and repairs are needed.

A qualified licensed plumber should repair or correct as needed.

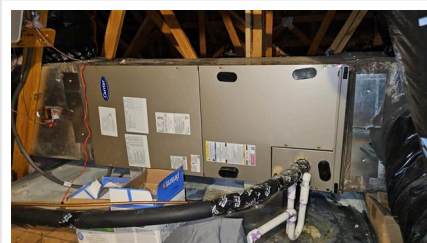
Complimentary photo of the heat pump
