INSPECTION REPORT
109 Crossvine Dr
Mooreville NC 28117

INSPECTED BY
Alex Parr 3692
Above Parr Home
Inspections

Inspection Date: 4/30/2025
Report ID: 043025AP2

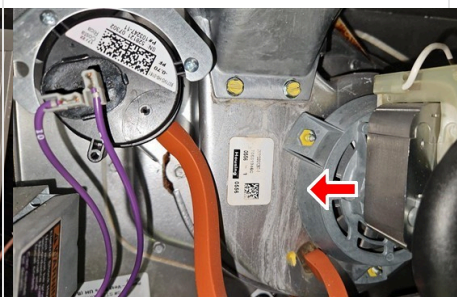
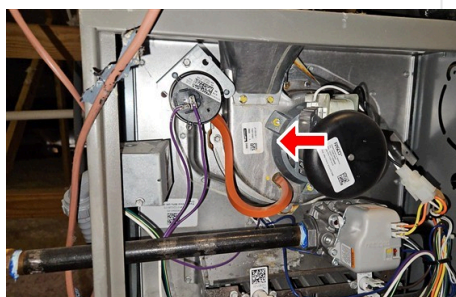
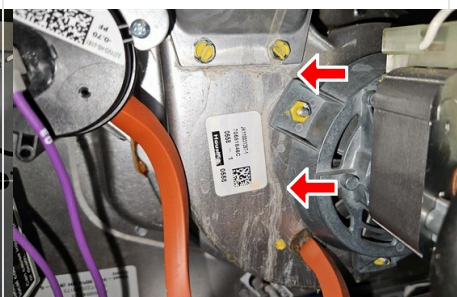
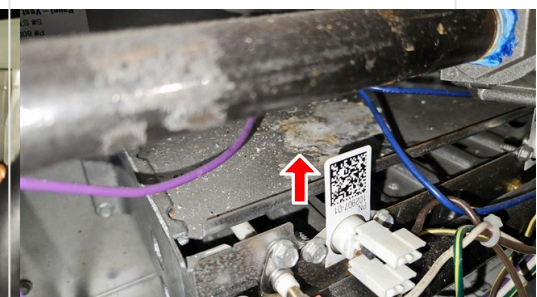
7.0 Item 1 (Picture)

1. The vent pipe for gas furnaces shows evidence of poor venting (white deposits). Leaks can cause damage to unit or home. Further investigation and repairs are needed.

I recommend a qualified licensed heat contractor inspect further and repair as needed.

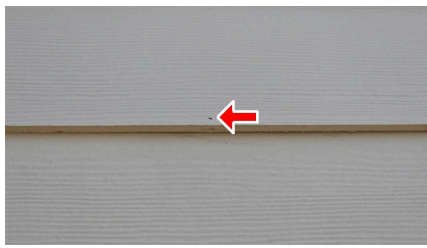
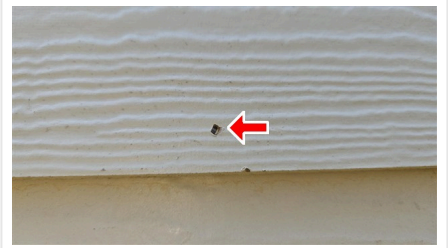
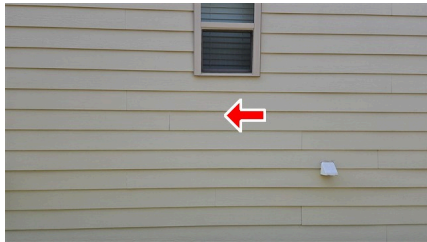
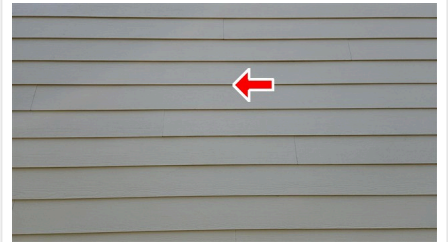
- (1)
1. The Cement board at the exterior in areas has exposed face nailing. Deterioration can eventually occur if not corrected. Further investigation and repairs are needed.

A qualified contractor should inspect and repair as needed.

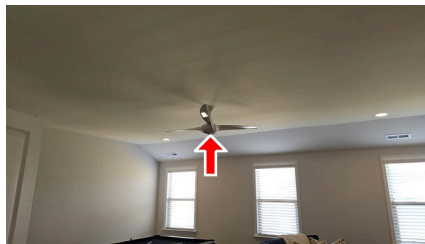
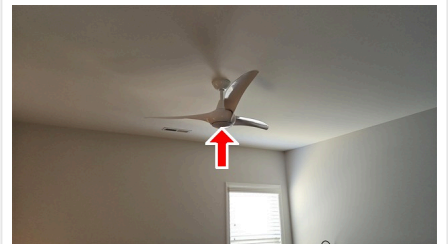
6.4 Item 1 (Picture)

1. Numerous fixtures are missing remotes at the throughout the home. Therefore I was unable to determine if the fixtures functioned properly. Further investigation is needed.

A qualified licensed electrical contractor should correct as needed.

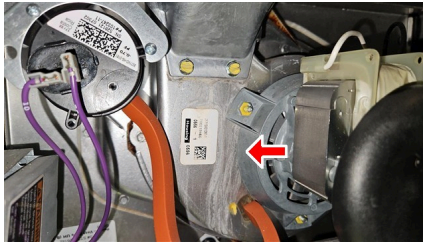
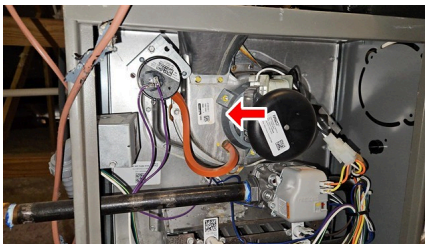
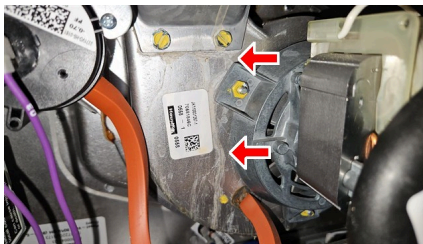
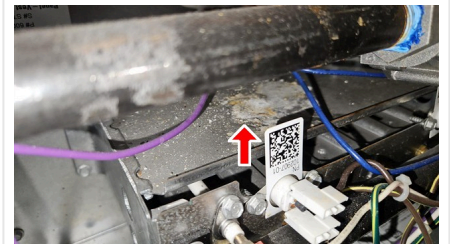
7.0 Item 1 (Picture)

1. The vent pipe for gas furnaces shows evidence of poor venting (white deposits). Leaks can cause damage to unit or home. Further investigation and repairs are needed.

I recommend a qualified licensed heat contractor inspect further and repair as needed.
