INSPECTION REPORT
110 Amber Ln
Statesville NC 28677

INSPECTED BY
Alex Parr 3692
Above Parr Home
Inspections

INSPECTION DATE
📅 4/16/2025
🕒 09:00:00 AM

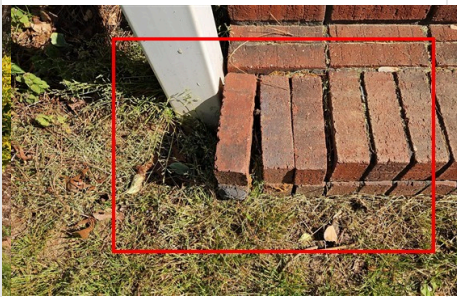
(1)

1. The brick steps at the front of home are loose. A fall or injury could occur if not corrected. A repair or replacement is needed.

A qualified contractor should repair or replace as needed.

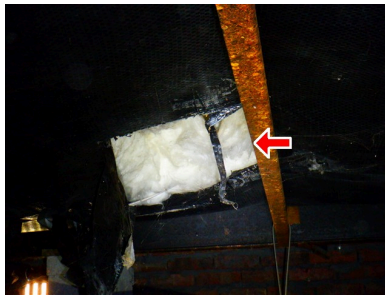
9.0 Item 1 (Picture)

1. The vapor barrier (plastic) on the crawlspace ground is damaged in areas. A vapor barrier provides added protection to the floor system from moisture or dampness that can enter from ground.

A qualified person should repair or replace as needed.

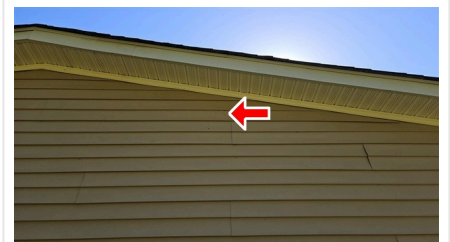
1. The Vinyl siding at the exterior in areas is damaged. Further deterioration can occur if not corrected. Repairs are needed.

A qualified person should repair or replace as needed.

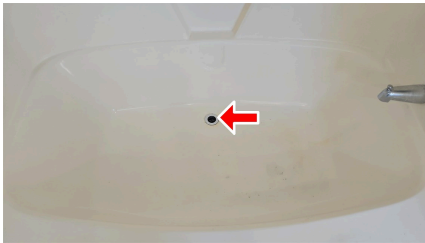
5.3 Item 1 (Picture)

1. The tub drain drains slowly at the master bath. Sometimes the drain can be partially clogged down line. I am unable to determine the cause of the slow drain. Further investigation and repairs are needed.

A qualified licensed plumber should repair or correct as needed.

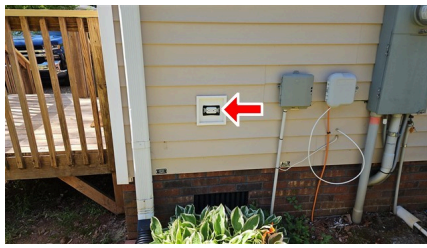
6.6 Item 1 (Picture)

1. The GFCI (Ground Fault Circuit Interrupter) outlets at the exterior wont "trip" when tested. Electrical issues are considered a hazard until repaired. Further investigation and repairs are needed.

A qualified licensed electrical contractor should correct as needed.

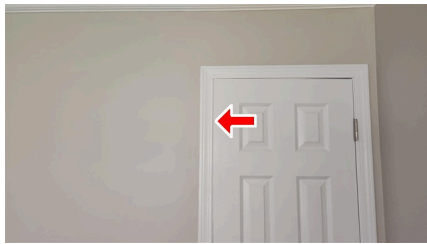
1. The Closet door rubs at jamb when closing at the guest Bedroom. As a result the door will not close properly. Repairs are needed.

A qualified person should repair or replace as needed.

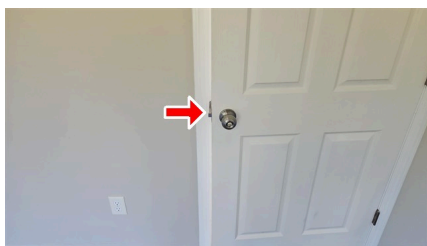
8.5 Item 2 (Picture)

1. The door at master bath will not latch properly. Evidence suggest that the door needs strike and latch adjustment to shut properly. This is a small repair.

A qualified person should repair or replace as needed.
