INSPECTION REPORT
110 Hillcrest St
Spencer NC 28159

INSPECTED BY
Alex Parr 3692
Above Parr Home
Inspections

INSPECTION DATE
📅 5/29/2024
🕒 02:00:00 PM

Inspection Date: 5/29/2024
Report ID: 052924AP2

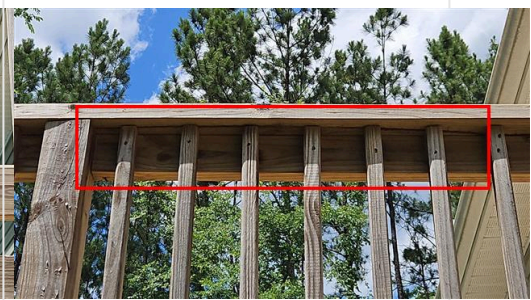
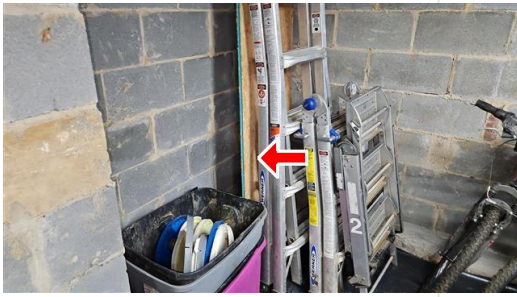
3.4 Item 1 (Picture)

1. The balusters on deck, rear of home are attached improperly. Attached balusters are top and bottom (1) #8 wood screw or (2) 8d post frame threaded nails. A repair is needed to ensure stability or an injury might occur. Repairs are needed.

A qualified person should repair or replace as needed.

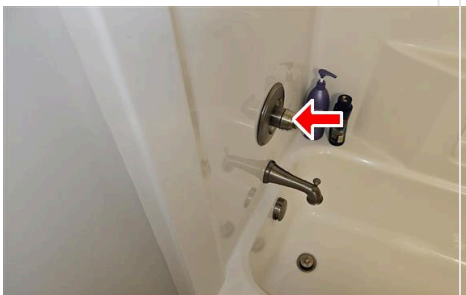
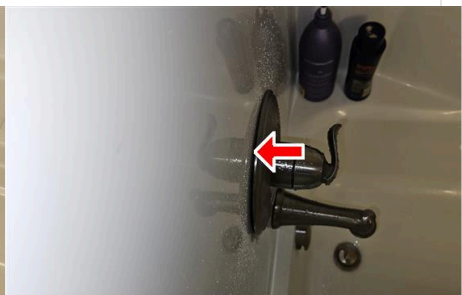
5.2 Item 1 (Picture)

1. The outside water faucet loose, and needs securing to wall at the rear of home. This can allow undue stress to occur on supply lines allowing leaks to occur. Repairs are needed.

1. The control lever and tub spout are not properly secured to the wall. Repairs are needed to prevent water damage from occurring to the home. Repairs are needed.

A qualified licensed plumber should repair or correct as needed.

I recommend contacting a licensed plumber.

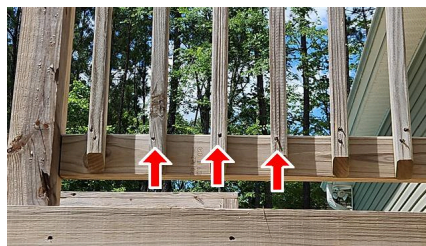
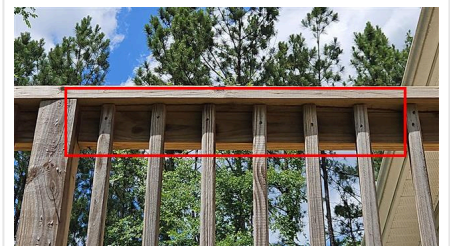
3.4 Item 1 (Picture)

1. The balusters on deck, rear of home are attached improperly. Attached balusters are top and bottom (1) #8 wood screw or (2) 8d post frame threaded nails. A repair is needed to ensure stability or an injury might occur. Repairs are needed.

A qualified person should repair or replace as needed.

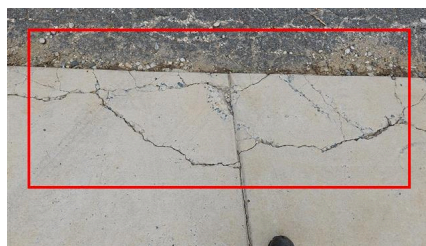
3.5 Item 1 (Picture)

1. The concrete driveway has cracks that should be sealed to prevent further damage, which is part of ongoing maintenance of a concrete driveway that will need to be performed on a regular basis. Repairs are recommended.

A qualified contractor should inspect and repair as needed.

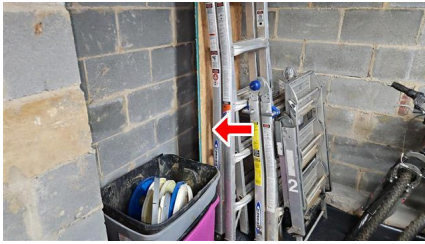
4.5 Item 1 (Picture)

1. Wood debris is in contact with the crawl space floor in numerous areas. This can attract wood destroying organisms. Removal is needed.

A qualified contractor should inspect and repair as needed.

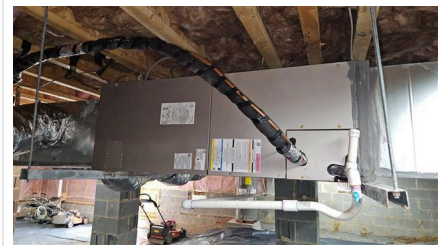
Complimentary photo of the heat pump
