INSPECTION REPORT
637 Williamson Rd
Unit # 209
 Mooresville NC 28117

INSPECTED BY
Alex Parr 3692
Above Parr Home
Inspections

INSPECTION DATE
📅 7/3/2023
🕒 09:00:00 AM

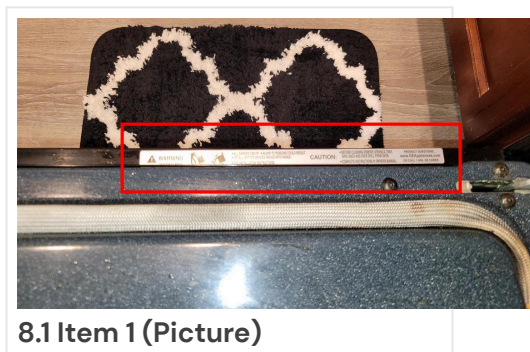
1. The range/oven needs to be properly attached/anchored to the structure as to keep it from tipping over when the oven door is opened and/or oven racks are pulled out during use. This is a safety issue. Repairs are needed.

I recommend contacting appliance repair company.

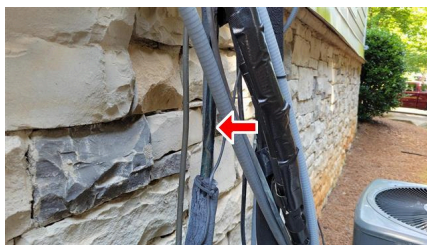
1. The foam sleeve on suction line is missing foam sleeve in area(s) at outside unit. Missing foam on suction line can cause energy loss and condensation. I recommend service or repair as needed.

A licensed HVAC contractor should service or repair unit.

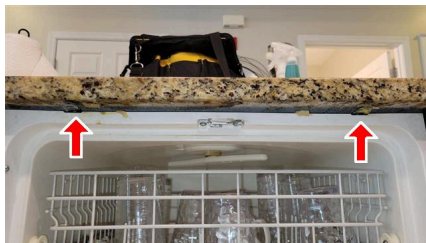
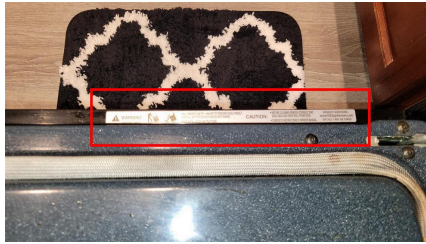
1. The dishwasher is loose and needs securing to underside of countertop (using a proper length screw). I recommend repair as necessary.

I recommend contacting appliance repair company.
