INSPECTION REPORT
17416 Saranita Ln
Charlotte NC 28278

INSPECTED BY
Alex Parr 3692
Above Parr Home
Inspections

INSPECTION DATE
📅 3/22/2023
🕒 02:00:00 PM

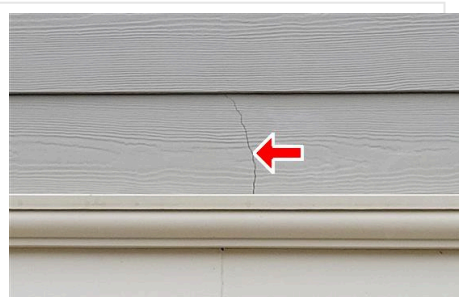
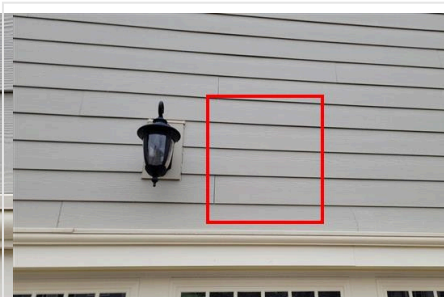
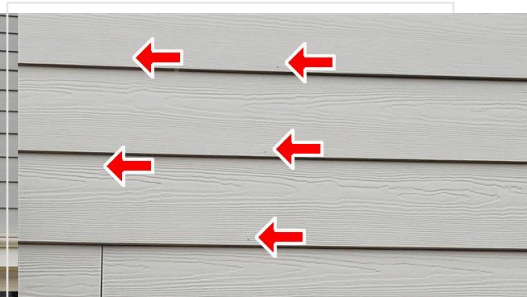
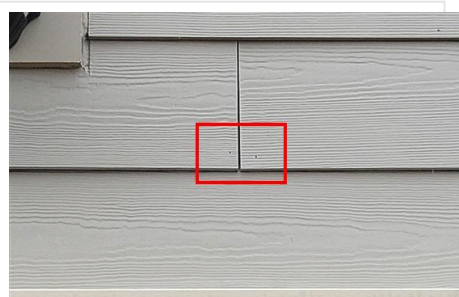
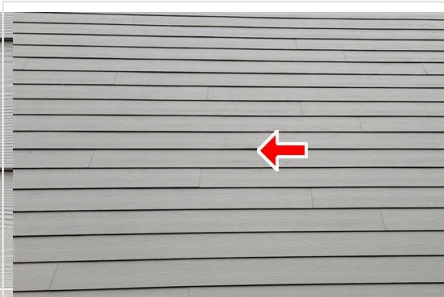
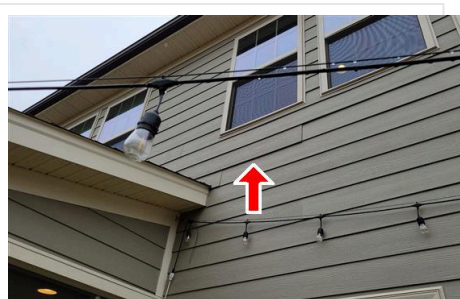
1. The cement board at the exterior in areas is damaged and not sealed properly. Deterioration can eventually occur if not corrected. Further investigation and repairs are needed.

A qualified person should repair or replace as needed.

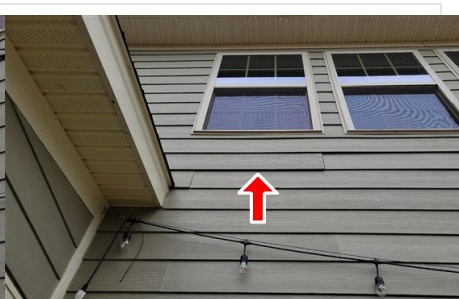
3.0 Item 16 (Picture)

1. The Cement board at the rear of home is loose. Deterioration can eventually occur if not corrected.
Repairs are needed.

A qualified person should repair or replace as needed.

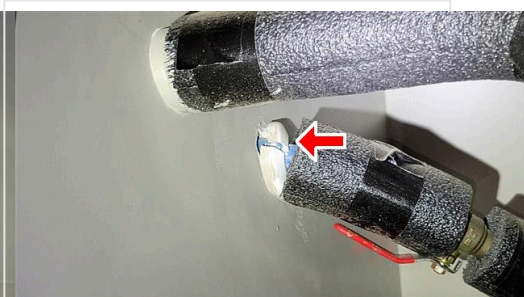
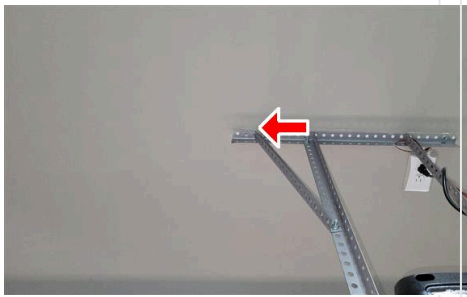
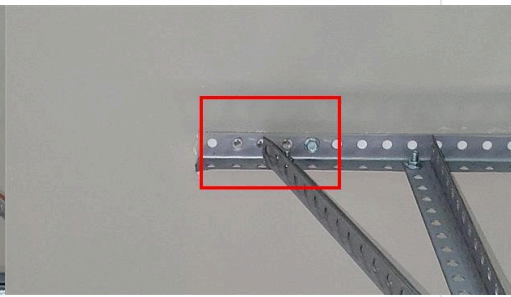
3.8 Item 1 (Picture)

1. The fire resistance sheathing in garage is compromised. This is considered unsafe until corrected.
Repairs are needed.

A qualified person should correct for safety.

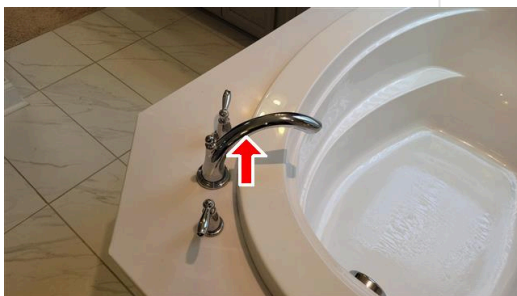
1. The tub faucets is loose at the master bath. Repairs are needed to prevent water damage from occurring to the home. Repairs are needed.

A qualified licensed plumber should repair or correct as needed.

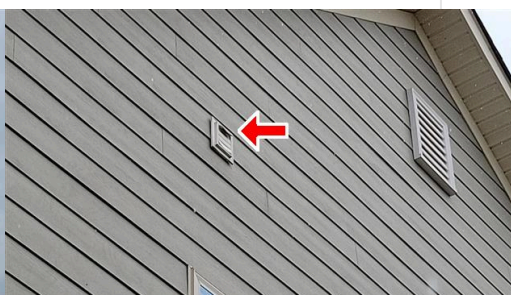
9.5 Item 1 (Picture)

1. The dryer vent piping has a damaged vent hood outside. This may allow insects or critters to enter home. Repairs are needed.

A qualified person should repair or replace as needed.

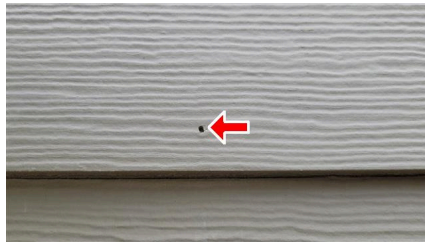
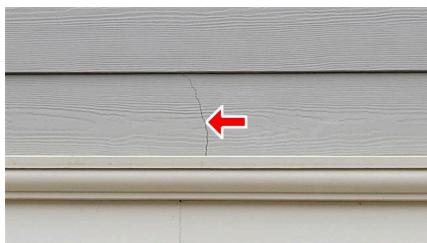
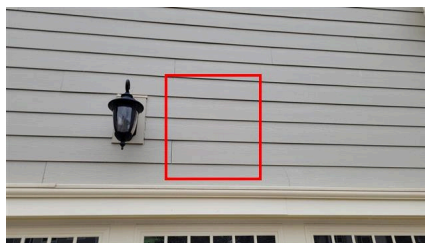
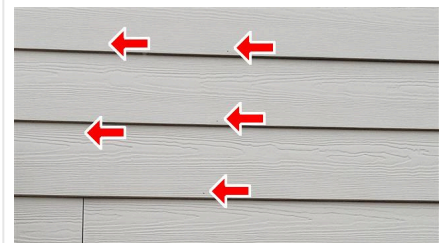
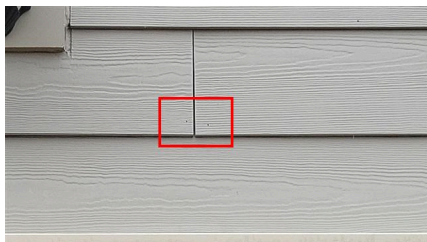
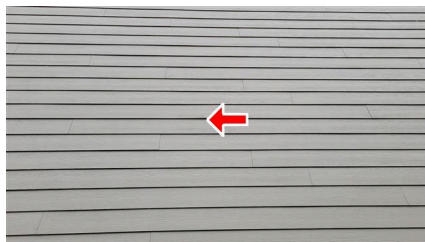
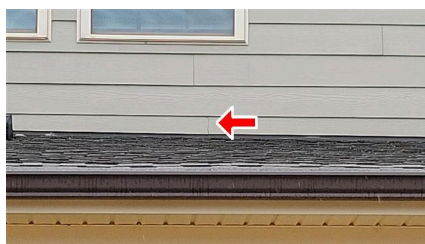
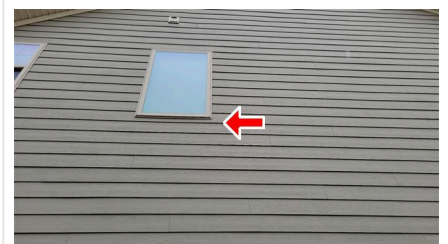
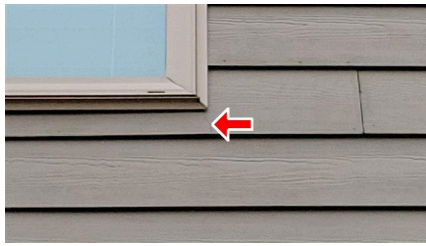
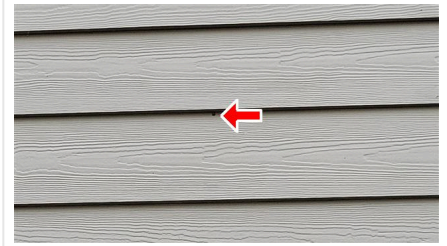
1. The cement board at the exterior in areas is damaged and not sealed properly. Deterioration can eventually occur if not corrected. Further investigation and repairs are needed.

A qualified person should repair or replace as needed.

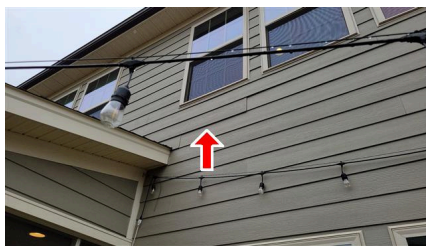
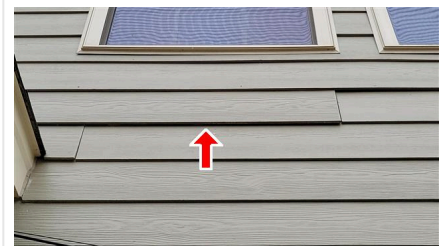
1. The Cement board at the rear of home is loose. Deterioration can eventually occur if not corrected.
Repairs are needed.

A qualified person should repair or replace as needed.

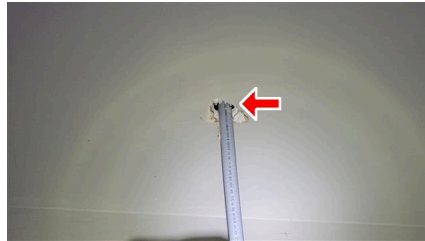
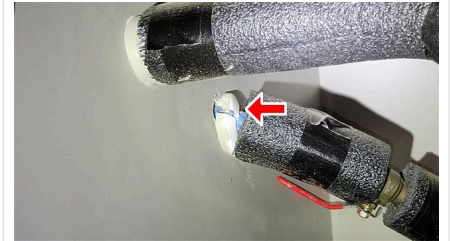
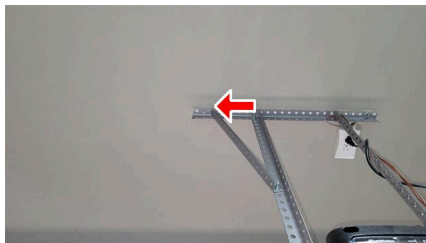
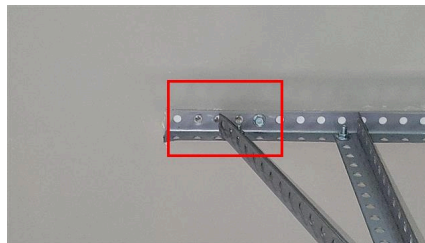
1. The fire resistance sheathing in garage is compromised. This is considered unsafe until corrected.
Repairs are needed.

A qualified person should correct for safety.

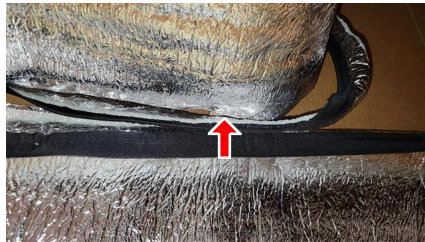
1. The attic tent is damaged at the pull downstairs. Heat loss can occur more on this home than one that is properly insulated. Repairs are recommended .

A qualified person should repair or replace as needed.

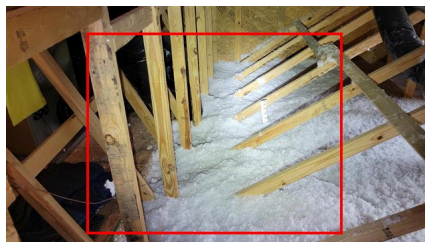
1. Fiberglass (loose-fill) insulation is is compressed in areas of the attic due to foot traffic or storage in attic. Heat loss can occur more on this home than one that is properly insulated. Repairs are recommended .

A qualified person should repair or replace as needed.

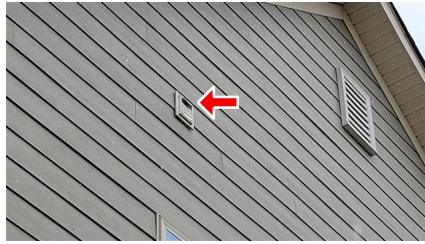
1. The dryer vent piping has a damaged vent hood outside. This may allow insects or critters to enter home. Repairs are needed.

A qualified person should repair or replace as needed.
