TOTAL LOSS REPORT

RE: Road traffic Accident: Miss Alexandra Chirea: 10/05/2026

Make	TOYOTA	Registration	VX12AZB
Model	YARIS TR VVT-I	Status	T/Loss
Category	S	Salvage Value	£68.50
Repair Cost	£6,652.49	Legal Status	Unroadworthy
Engineer Value	£3,425.00	Impact Magnitude	Moderate to Heavy

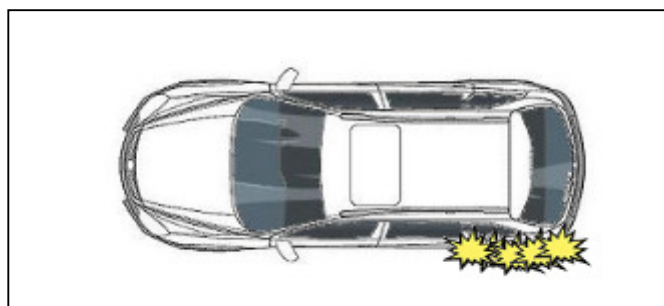
Impact Area

The vehicle has suffered moderate to heavy collision/impact damage to the left hand rear.

Please note the vehicle is unroadworthy due to the extent of panel distortion sustained to the nearside. and the wheel, possible suspension and tyre damage.
