Our Ref: htu26011

Your Ref: YP15 OKF

TOTAL LOSS REPORT

RE: Road traffic Accident: Ali Nasser Hashem Hassan : 06/02/2026

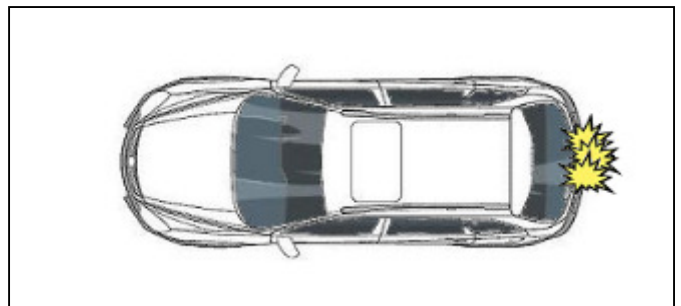
Impact Area

The vehicle has suffered moderate collision/impact damage to the rear.
