TOTAL LOSS REPORT

RE: Road traffic Accident: Mrs Leticia Gomes: 12/05/2026

Make	HYUNDAI	Registration	BN68LZT
Model	I10 SE	Status	T/Loss
Category	S	Salvage Value	£516.30
Repair Cost	£5,427.97	Legal Status	Unroadworthy
Engineer Value	£5,163.00	Impact Magnitude	Moderate

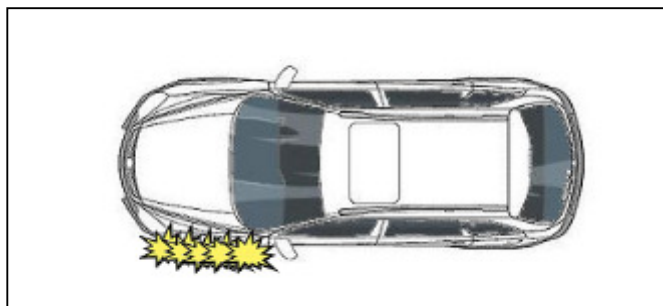
Impact Area

The vehicle has suffered moderate collision/impact damage to the left hand front.

Please note the vehicle is unroadworthy due to the extent of panel distortion sustained to the nearside. and the wheel, possible suspension and tyre damage.
