TOTAL LOSS REPORT

RE: Road traffic Accident: Focus UK One Ltd: 20/08/2022

Make	SKODA	Registration	DK66LRL
Model	OCTAVIA SE L TDI	Status	T/Loss
Category	S	Salvage Value	£680.00
Repair Cost	£9,148.07	Legal Status	Unroadworthy
Engineer Value	£6,800.00	Impact Magnitude	Moderate to Heavy

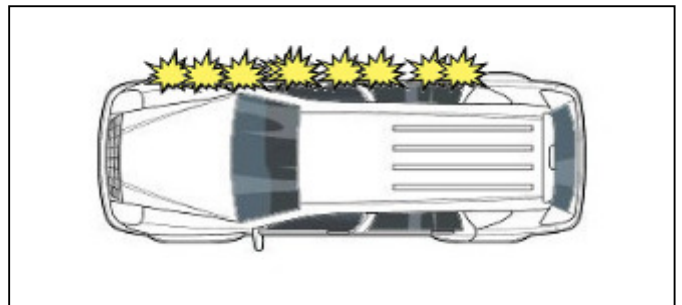
The vehicle has suffered moderate to heavy collision/impact damage to the right hand side.

24/08/2022 - Please note the vehicle is unroadworthy due to the extent of panel distortion sustained to the offside. Mileage calculated from on line MOT data.
