TOTAL LOSS REPORT

RE: Road traffic Accident: MD Islam: 10/12/2024

Make	NISSAN	Registration	OU06YHC
Model	NOTE SVE	Status	T/Loss
Category	N	Salvage Value	£62.50
Repair Cost	£2,625.49	Legal Status	Unroadworthy
Engineer Value	£1,250.00	Impact Magnitude	Moderate

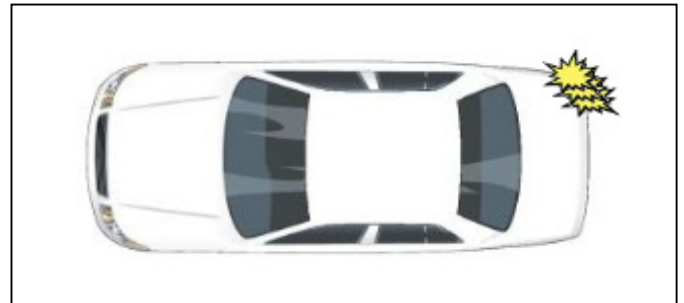
Impact Area

The vehicle has suffered moderate collision/impact damage to the left hand side.

17/12/2024 - Please note the vehicle is unroadworthy due to the broken rear bumper.
