TOTAL LOSS REPORT

RE: Road traffic Accident: Miss Camilla Lawson-Hall: 03/08/2025

Make	AUDI	Registration	PN16ROH
Model	A3 SE TECHNIK ULTRA	Status	T/Loss
Category	N	Salvage Value	£855.00
Repair Cost	£5,541.64	Legal Status	Unroadworthy
Engineer Value	£5,700.00	Impact Magnitude	Moderate

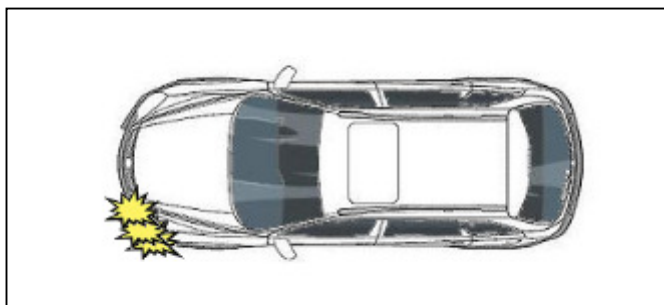
Impact Area

The vehicle has suffered moderate collision/impact damage to the left hand front.

05/08/2025 - Please note the vehicle is unroadworthy due to the deployed bonnet pedestrian protection system.
