TOTAL LOSS REPORT

RE: Road traffic Accident: Patel Prashant: 12/01/2025

Our Ref: black25026

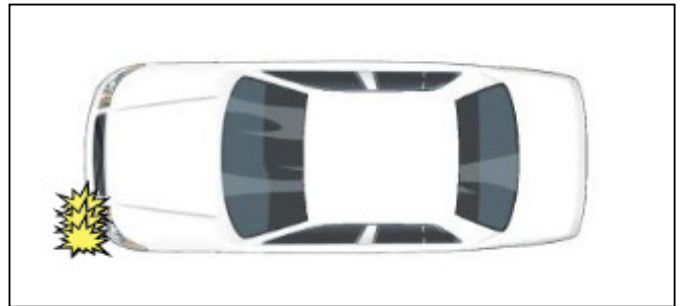
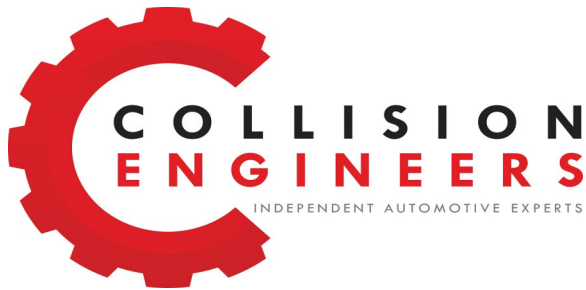
The vehicle has suffered moderate collision/impact damage to the front.

28/01/2025 - Please note the vehicle is unroadworthy due to the extent of panel distortion sustained to the nearside front.
