REPAIRABLE REPORT

RE: Road traffic Accident: Tony Ross: 19/08/2022

Make	FORD	Registration	BL19XPO
Model	TRANSIT CUSTOM 280	Status	Repair
Category		Salvage Value	
Repair Cost	£3,625.43	Legal Status	Unroadworthy
Engineer Value	£20,337.00	Impact Magnitude	Moderate

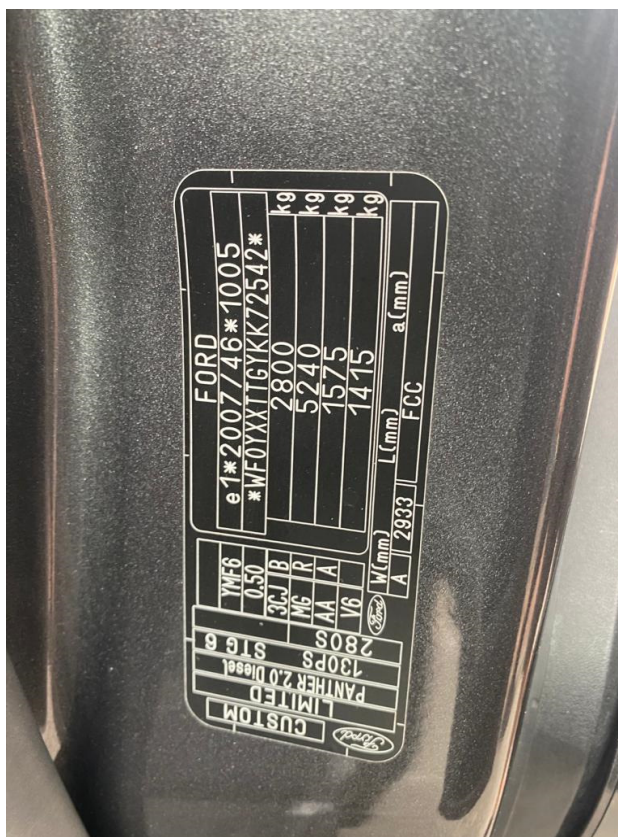
The vehicle has suffered moderate collision/impact damage to the left hand front.

23/08/2022 - Please note the vehicle is unroadworthy due to the broken/insecure nearside headlamp.

Front Bumper
L/F Lwr Bumper Cap
L/F Bumper Bracket
Inn Bumper Reinforce
Left Headlamp Assy
L/F Bracket
Sundry Parts

Front Lower Bumper
Frt Bumper Trim Cap
L/F Air Duct
Mounting Clamp
L/F Fog Lamp
Car Care Kit

L/F Wing

L/F W-House Reinf
