REPAIRABLE REPORT

Date: 16/07/2026**Our Ref:** ap.qdos261789**Your Ref:** MFI/ND/46885/1**Matter:** Road Traffic Accident: Mrs Gurdip Kaur: 13/07/2026**REPAIRABLE****ROADWORTHY**

Make	KIA	Registration	PK12 TMZ
Model	PICANTO HALO ECODYNAMICS	VIN	KNABX312LCT122784
Odometer	50,500 miles	Engine / Fuel	1,248 cc · Petrol
Pre-Incident Condition	Good	Impact Magnitude	Moderate — right rear

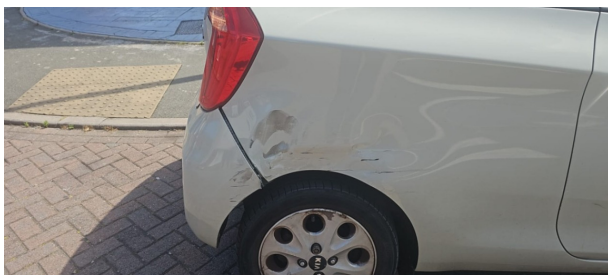
The vehicle has suffered moderate collision/impact damage to the right rear.

This vehicle is considered a repairable proposition and we have calculated a repair cost of £4,405.73.
