THE NEWEST TIDE SENSOR HAS BEEN DEPLOYED AT F.O.B.H. IN THE SHARK RIVER ON FRIDAY, OCTOBER 30, 2026 AROUND NOON. STRONG BREEZE CONVINCED MATT & I THAT PADDLING OUT ON A DINGHY MAY NOT BE A GOOD IDEA, SO WE STRAPPED THE SENSOR TO A PIER WE COULD REACH FROM THE FOBH FLOATING DOCK

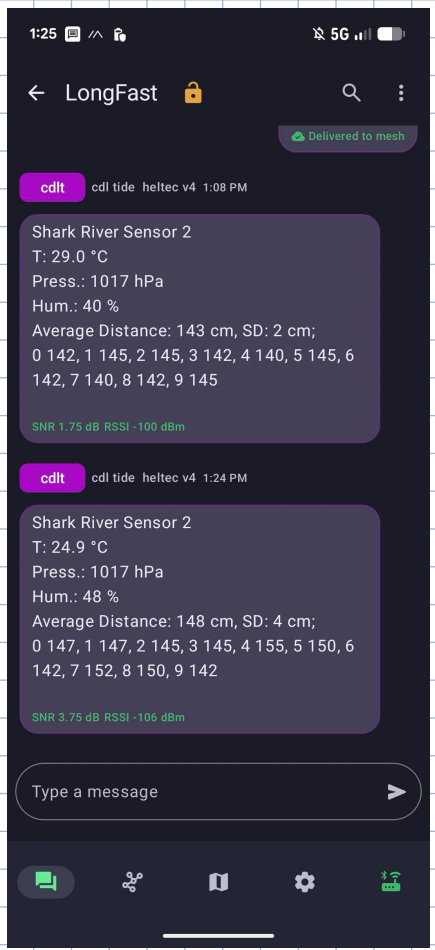
MATT DONOVAN & I STRAPPED THE NEW TIDE SENSOR TO PIER POLE

MARKED POSITION OF STRAP TO CHECK FOR SLIPPING

SENSOR IS HERE, REACHABLE BY FLOATING DOCK

TAPE MEASURE OF 58" TO WATER ~ 147 cm
