JOURNEY RISK MANAGEMENT (JRM) STUDY

Salem Terminal to ABS ENTERPRISESS

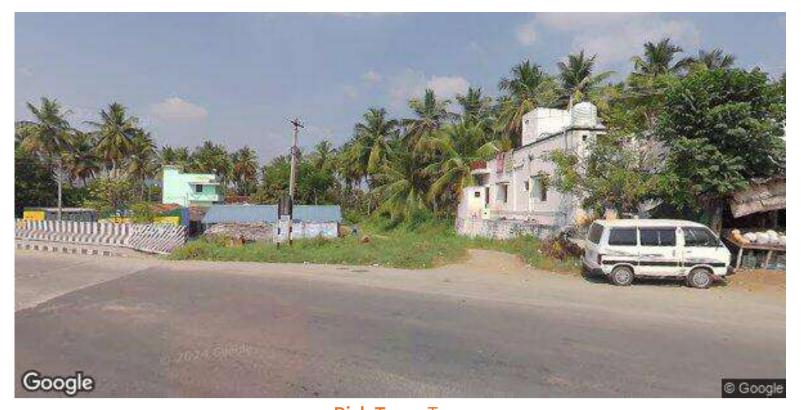
Coordinates: 11.37086, 77.74828

Risk Type: Roundabout
Risk Level: High
Speed Limit: 15 KM/Hr
