Quality Assurance Management, Inc.

Oxygen Test Report

Moisture Test Report

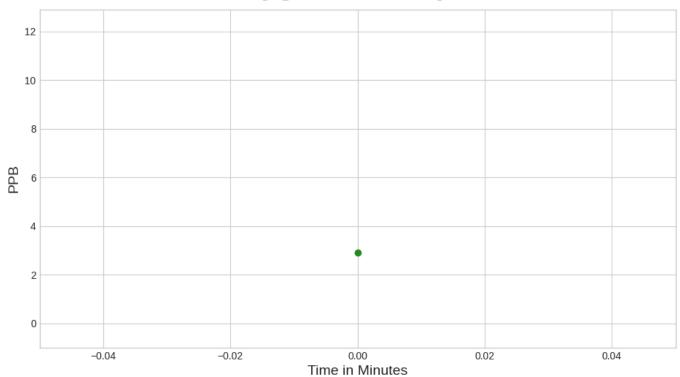
Client:	TEST CLIENT		Analyzer:	Delta F	
Facility:	QAM HQ		Serial Number:	PT-26818-V6	
Tool / Equipment ID:			Calibration Due:	08/06/2022	
System:			Instrument Flow:	2.0	SCFH
Source ID:			Start Time/Date:	14:48 01/20/22	
Test Point ID:			Stop Time/Date:	14:48 01/20/22	
Test Gas:			Test Duration:	0 minutes	
Test Flow:	4.3	SCFH	Average:	2.9	PPB
Technician:			Final:	2.9	PPB
			Specification:	20	PPB

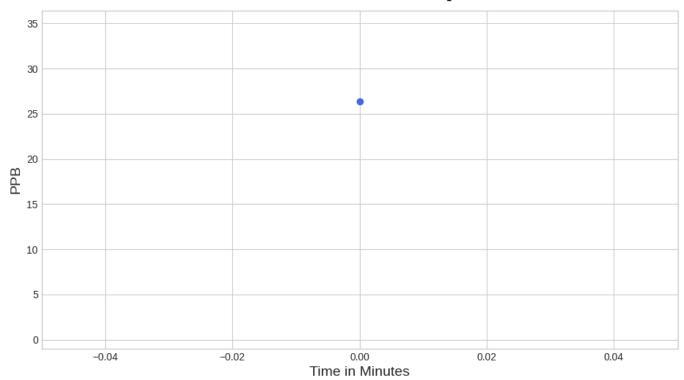
Client:	TEST CLIENT	Analyzer:	Tracer 2	
Facility:	QAM HQ	Serial Number:	17481-44-1	
Tool / Equipment ID:		Calibration Due:	02/23/2023	
System:		Instrument Flow:	2.3 SCFH	
Source ID:		Start Time/Date:	14:48 01/20/22	
Test Point ID:		Stop Time/Date:	14:48 01/20/22	
Test Gas:		Test Duration:	0 minutes	
Test Flow:	4.3 SCFH	Average:	26.4 PPB	
Technician:		Final:	26.4 PPB	
		Specification:	20 PPB
