## **Oxygen Test Report**

Client:	TEST CLIENT		Analyzer:	Delta F	
Facility:	QAM HQ		Serial Number:	PT-18690-V6	
Tool / Equipment ID:	TST123		Calibration Due:	7/2021	
System:	PN2		Instrument Flow:	2.0	SCFH
Source ID:	TST-SRC-ID		Start Time/Date:	13:15 02/26/21	
Test Point ID:	PN2 POC		Stop Time/Date:	14:02 02/26/21	
Test Gas:	Nitrogen		Test Duration:	46 minutes	
Test Flow:	4.3	SCFH	Average:	0.0	PPB
Technician:	JCH		Final:	0.0	PPB
			Specification:	20	PPB

## **Moisture Test Report**

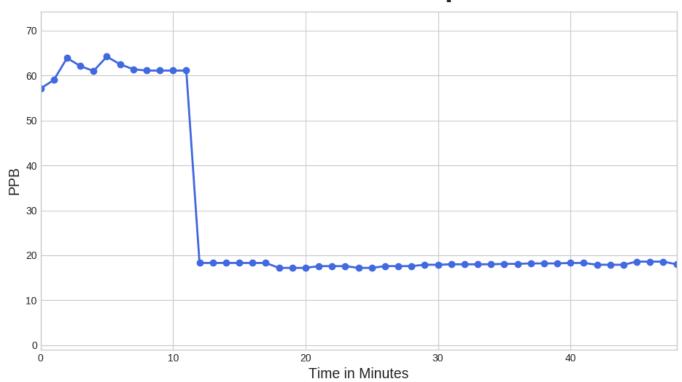
Comments: OVERALL TEST OF COMPLETE FUNCTIONALITY
