Quality Assurance Management, Inc.

Oxygen Test Report

Moisture Test Report

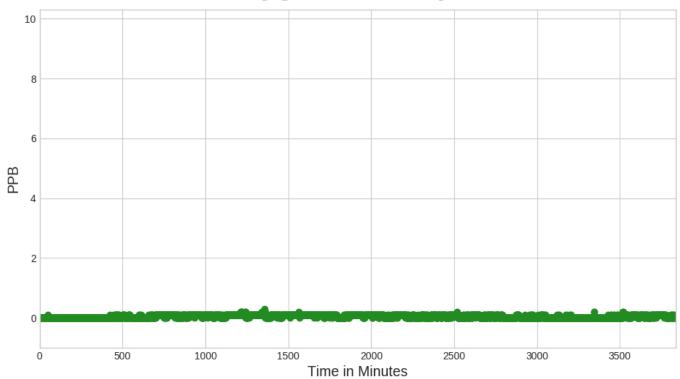
Client:	TEST CLIENT		Analyzer: Delta F		
Facility:	QAM HQ		Serial Number:	PT-18690-V6	
Tool / Equipment ID:	TEST123		Calibration Due:	7/2021	
System:	PN2		Instrument Flow:	2.0	SCFH
Source ID:	TST-SRC-ID		Start Time/Date:	15:14 02/26/21	
Test Point ID:	PN2 POC		Stop Time/Date:	07:08 03/01/21	
Test Gas:	Nitrogen		Test Duration:	15 hours 53 minutes	
Test Flow:	4.3	SCFH	Average:	0.0	PPB
Technician:	JCH		Final:	0.0	PPB
			Specification:	20	PPB

Comments: vveekend test	Comments:	Weekend test
-------------------------	-----------	--------------

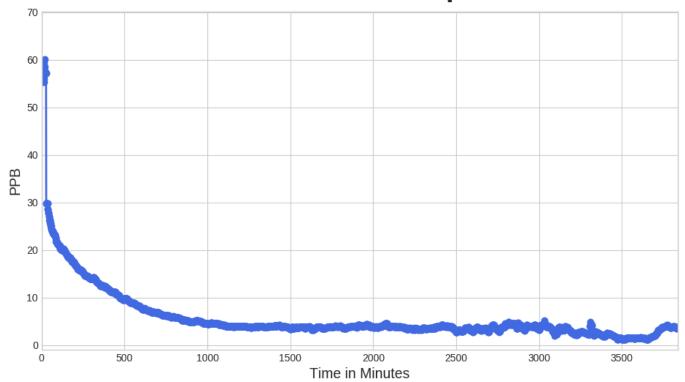
Average: 5.9 PPB

Final: 3.7 PPB
Specification: 20 PPB

Comments: Weekend test
