Oxygen Test Report

Moisture Test Report

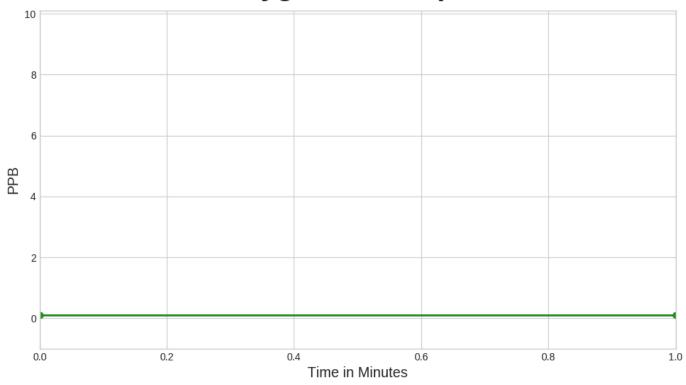
Client:	TEST CLIENT		Analyzer:	Delta F	
Facility:	QAM HQ		Serial Number:	PT-18690-V6	
Tool / Equipment ID:			Calibration Due:	7/2021	
System:			Instrument Flow:	2.0	SCFH
Source ID:			Start Time/Date:	09:40 02/25/21	
Test Point ID:			Stop Time/Date:	09:41 02/25/21	
Test Gas:		Test		1 minutes 11 seconds	
Test Flow:	4.3	SCFH	Average:	0.1	PPB
Technician:			Final:	0.1	PPB
			Specification:	20	PPB

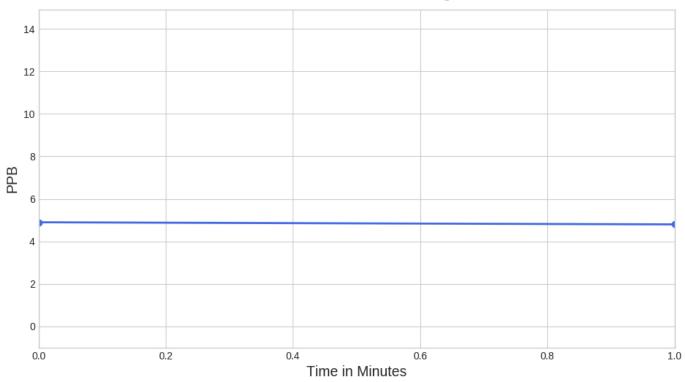
1 .		
TEST CLIENT		Analyzer:	Tracer 2	
QAM HQ		Serial Number:	17367-44-1	
		Calibration Due:	8/2021	
		Instrument Flow:	2.3	SCFH
		Start Time/Date:	09:40 02/25/21	
		Stop Time/Date:	09:41 02/25/21	
		Test Duration:	1 minutes 11 second	
4.3	SCFH	Average:	4.8	PPB
		Final:	4.8	PPB
		Specification:	20	PPB
	TEST CLIENT QAM HQ 4.3	QAM HQ	QAM HQ Serial Number: Calibration Due: Instrument Flow: Start Time/Date: Stop Time/Date: Test Duration: 4.3 SCFH Average: Final:	QAM HQ Serial Number: 17367-44- Calibration Due: 8/2021 Instrument Flow: 2.3 Start Time/Date: 09:40 02/2 Stop Time/Date: 09:41 02/2 Test Duration: 1 minutes
