Telemetered GA01SUMO-RII11-02-CTDMOR018 Deployments GA01SUMO GA01SUMO-RID16 GA01SUMO-RII11 GA01SUMO-RII11-02-CTDMOR018 ctdmo_ghqr_imodem_instrument practical_salinity ctdmo_seawater_temperature ctdmo_seawater_pressure ctdmo_seawater_conductivity conductivity

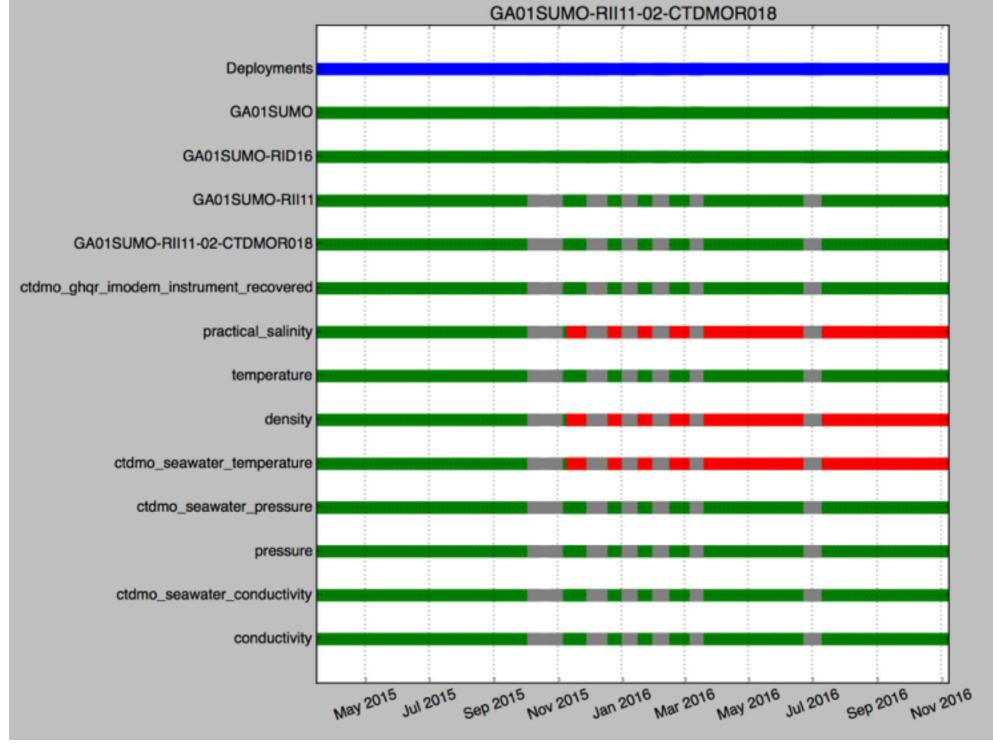
FAIL

density	D00002	2015-11-14T21:07:31Z	2016-11-08T10:07:31Z	Pressure values are registering around 200 dbar when the instrument is deployed at 750 m. UPDATE: calibration values were fixed and pressure values are now reasonable. However, temperature values are offset from the recovered_instrument dataset so data are suspect. Investigation pending.	FAIL	12250
ctdmo_seawater_temperature	D00002	2015-11-14T21:07:31Z	2016-11-08T10:07:31Z	Values are offset from the recovered_instrument dataset so data are suspect. Investigation pending.	FAIL	12250
ctdmo_seawater_pressure	D00002	2015-11-14T21:07:31Z	2016-11-08T10:07:31Z	Pressure values are registering around 200 dbar when the instrument is deployed at 750 m. UPDATE: calibration values were fixed and pressure values are now reasonable.		12250
practical_salinity	D00003	2016-10-27T01:47:00Z	2017-04-24T14:07:31Z	Pressure values are registering around 200 dbar when the instrument is deployed at 750 m. UPDATE: calibration values were fixed and pressure values are now reasonable. However, temperature values are offset from the recovered_instrument dataset so data are suspect. Investigation pending.	FAIL	12250

density	D00003	2016-10-27T01:47:00Z	2017-04-24T14:07:31Z	Pressure values are registering around 200 dbar when the instrument is deployed at 750 m. UPDATE: calibration values were fixed and pressure values are now reasonable. However, temperature values are offset from the recovered_instrument dataset so data are suspect. Investigation pending.	FAIL	12250

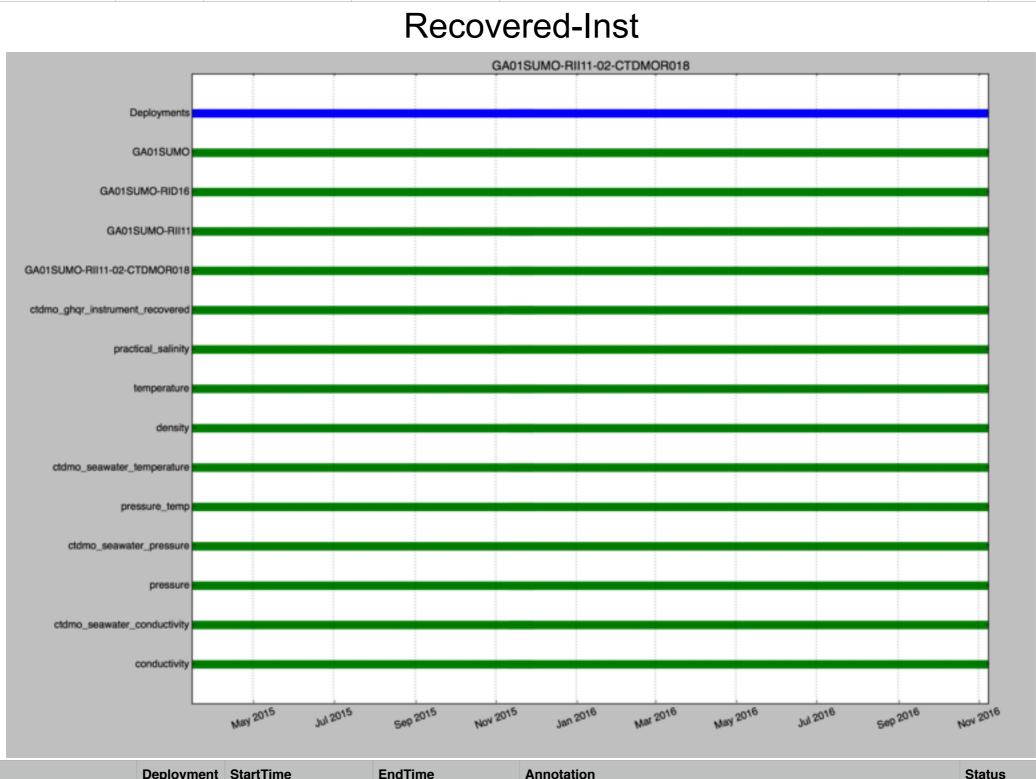
ctdmo_seawater_temperature	D00002	2015-11-14T21:07:31Z	2016-11-08T10:07:31Z	Values are offset from the recovered_instrument dataset so data are suspect. Investigation pending.	FAIL	12250	
ctdmo_seawater_pressure	D00002	2015-11-14T21:07:31Z	2016-11-08T10:07:31Z	Pressure values are registering around 200 dbar when the instrument is deployed at 750 m. UPDATE: calibration values were fixed and pressure values are now reasonable.		12250	
Recovered-Inst
