Telemetered

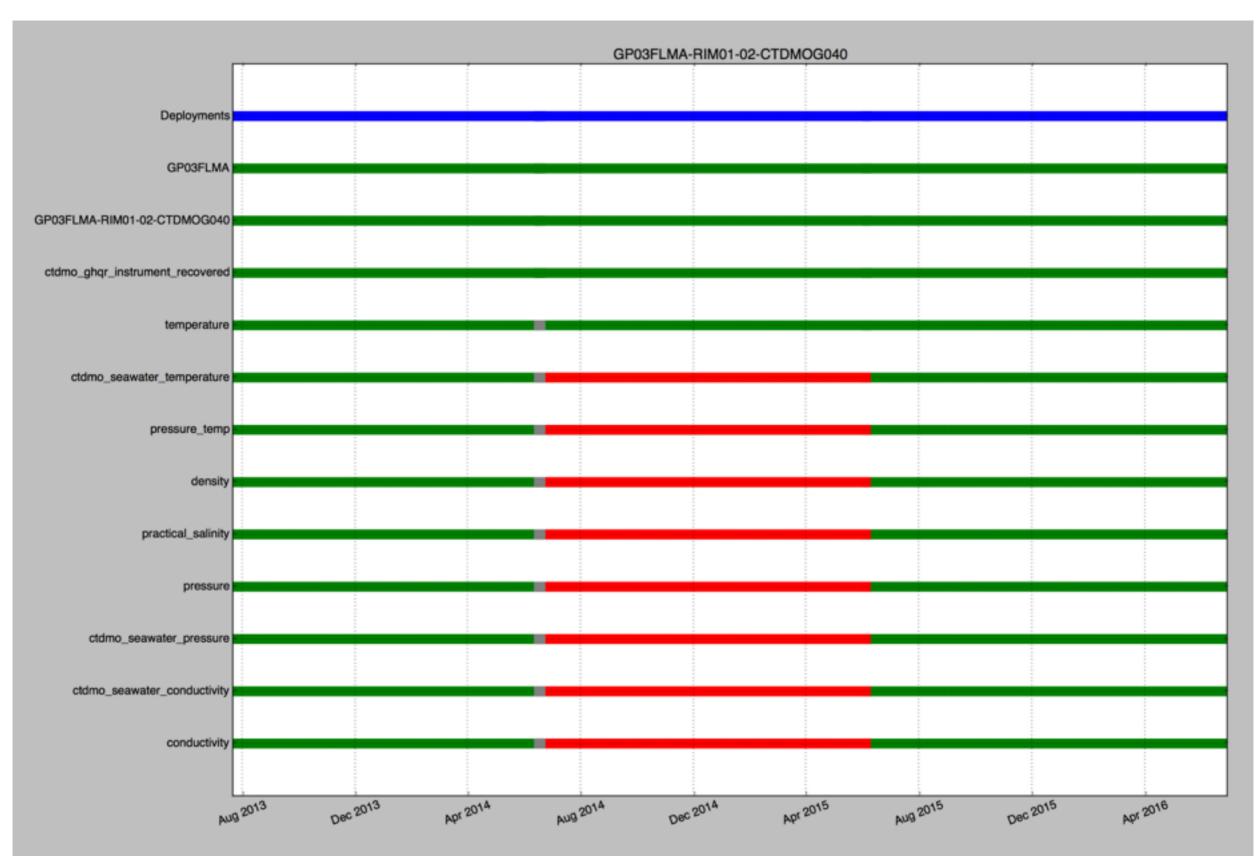
i	i		<u> </u>	
		Jan 2014	Jul 2014 Jan	015 Jul 2015 Jan 2016 Jul 201	16 Jan 2017 Jul 2017	
Level	Deployment	StartTime	EndTime	Annotation	Status Red	edmine
GP03FLMA	D00001	2013-07-21T22:44:00Z	2014-06-15T00:00:00Z	Platform was deployed 10m shallower than intended. Telemetered for this deployment.	data are not available	
ctdmo_ghqr_sio_mule_instrument	D00001	2013-07-21T22:44:00Z	2014-06-15T00:00:00Z	Telemetered data are not available for this deployment.	NOT_AVAILABLE	
GP03FLMA	D00002	2014-06-17T06:00:00Z	2015-06-05T00:00:00Z	Platform was deployed 15-20m shallower than intended.		
GP03FLMA-RIM01-02-CTDMOG040	D00002	2014-06-17T06:00:00Z	2015-06-05T00:00:00Z	Upon recovery of the instrument, a shield that guards the sensor a couling was missing.	and holds the anti-	
GP03FLMA	D00003	2015-06-06T22:40:00Z	2016-06-28T19:10:00Z	Platform was deployed 10-15m deeper than intended.		
GP03FLMA	D00004	2016-07-01T01:07:00Z	2017-04-05T00:00:00Z	Consistent issues with data telemetry have persisted for this deplo ailures on 1/27/2017, there will be no telemetered data from this p

ctdmo_ghqr_sio_mule_instrument	D00004	2016-07-01T04:00:01Z	2016-07-10T12:00:01Z	Very sparse data available due to consistent issues with data teler	metry. AVAILABLE	
ctdmo_ghqr_sio_mule_instrument	D00004	2016-07-10T12:00:01Z	2017-07-13T00:00:00Z	ssues with data telemetry. See platform level annotation for details	ls. NOT_AVAILABLE	
GP03FLMA	D00005	2017-07-07T00:00:00Z	2017-07-25T00:00:00Z	Gliders were not deployed, so telemetered data from this platform	will not be available
