Home Safety Improvement Report

Generated using AI Recommendations

Date: April 27, 2025

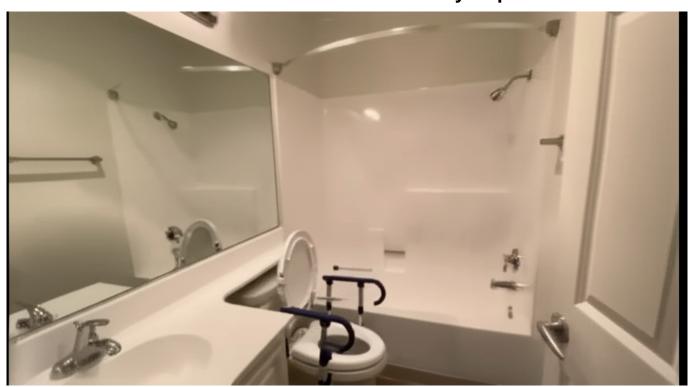
A standard height toilet can be difficult to sit down on and stand up from for individuals with reduced leg strength, mobility limitations, or balance problems. A taller toilet reduces the distance and effort required, making transfers safer and easier, conserving energy, and decreasing fall risk during toileting.

Replace the standard height toilet with an ADA-compliant 'comfort height' toilet (typically 17-19 inches high from floor to seat) OR add a raised toilet seat with integrated armrests to the existing toilet.

Replacing the toilet involves shutting off water, draining, removing the old toilet, setting a new wax ring, installing the new toilet, and reconnecting the water supply. A raised seat simply clamps onto the existing bowl. Adding grab bars (separate suggestion, but often done concurrently) involves

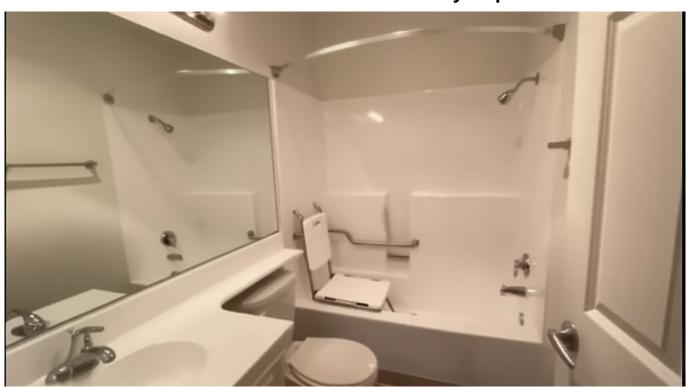
A handheld shower head allows the user to direct water flow while seated or standing, accommodating varying mobility levels and improving bathing independence and thoroughness. The adjustable bar allows positioning for different heights. An anti-scald valve prevents burns, crucial for those who may have slower reaction times or difficulty adjusting controls quickly.

Replace the fixed shower head with a handheld shower head mounted on an adjustable vertical slide bar. Ensure the controls incorporate an anti-scald valve.

Typically involves unscrewing the old shower head/arm and screwing in the new slide bar and handheld unit components. May require minor plumbing adjustments depending on existing connections. Anti-scald valve installation is more involved, often requiring plumber access behind the wall.
