DI2BA-02

DTC	B1255 / 55	Body No.2 P1 switch malfunction
-----	------------	---------------------------------

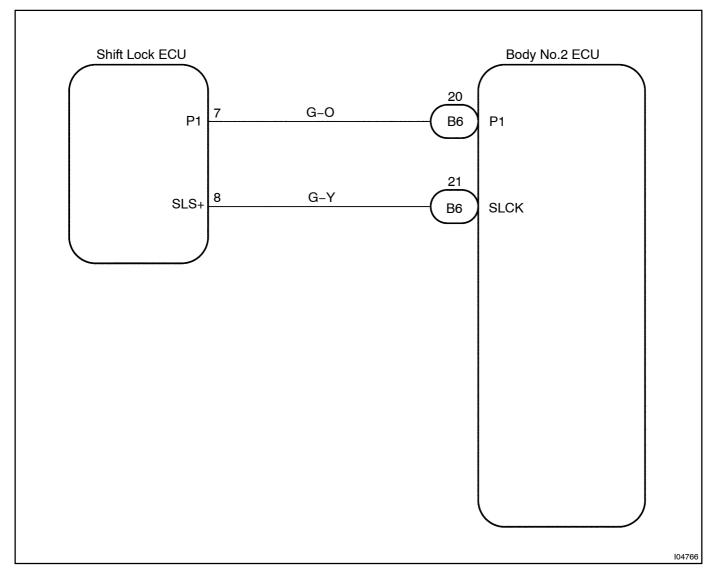
WIRING DIAGRAM

This DTC is output when failure of P1 switch is detected.

DTC No.	DTC Detecting Condition	Trouble Area
B1255/55	ON stick of P1 switch	P1 switch Wireharness

1 Check[the[P1[switch.[See[page[AT-13])

Replace the P1 switch.

2 Check wireharness and connector.

Repair or replace wireharness and connector.

Replace the body No.2 ECU.
