DI1AV-04

DTC	B2798/99	Communication malfunction No.2
-----	----------	--------------------------------

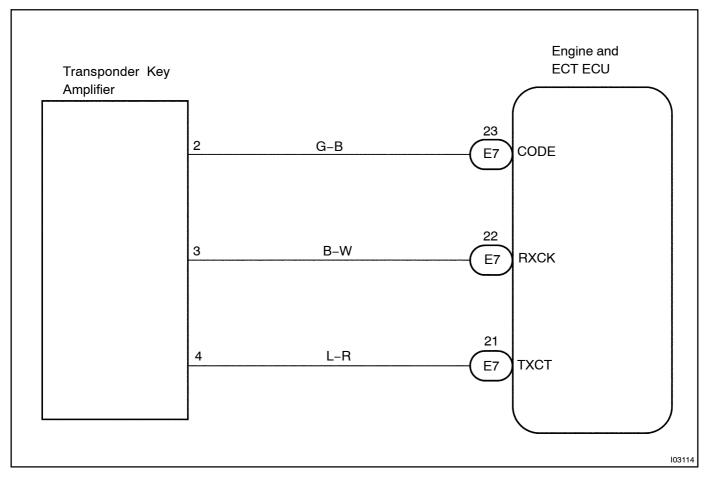
WIRING DIAGRAM

DTC No.	DTC Detecting Condition	Trouble Area
B2798/99		Key Transponder Key Coil
	Communication error	Transponder Key Amplifier
		Wire harness
		Engine and ECT ECU

1[Check[transponder[key[coil[(See[page[BE-253).
	NG Replace transponder key coil
ОК	
2	Check harness and connector between transponder key amplifier and ECU.
	NG Repair or replace harness and connector
ОК	
3	Does the system operate normally after replacement of transponder key amplifier?
	Yes Replace transponder key amplifier.
No	
Repla	ce ECU.
