DI2SB-02

DTC	P0335/12, 13	Crankshaft Position Sensor Circuit Malfunction
-----	--------------	--

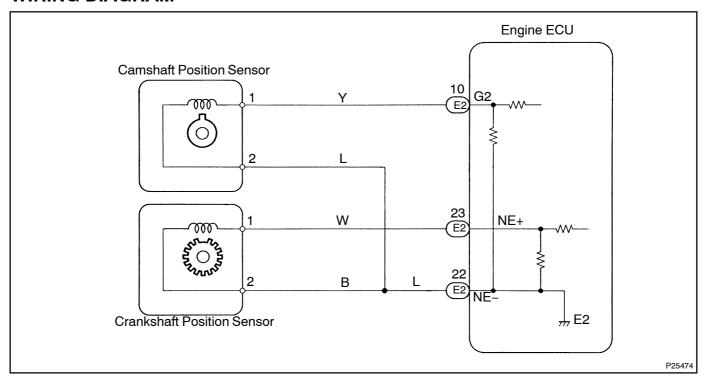
CIRCUIT DESCRIPTION

The crankshaft position sensor, which detects the engine speed and crankshaft angle signal (NE signal), has been installed on the oil pump body.

The NE signal plate has 34 teeth. The NE signal sensor generates 34 signals of every engine revolution. The engine ECU detects the standard crankshaft angle based on the G2 signals, and the actual crankshaft angle and the engine speed by the NE signals.

DTC No.	DTC Detecting Condition	Trouble Area
P0335/12, 13	No crankshaft position sensor signal to engine ECU during cranking.(2 trip detection logic)	Open or short in crankshaft position sensor circuit Crankshaft position sensor
	No crankshaft position sensor signal to engine ECU with engine speed 600 rpm or more (2 trip detection logic)	Starter Engine ECU
