04.Chand Bibi's Tomb Place - Kalaburagi

District: Kalaburagi
Taluk: Kalaburagi
Locality: Dargah Sheriff

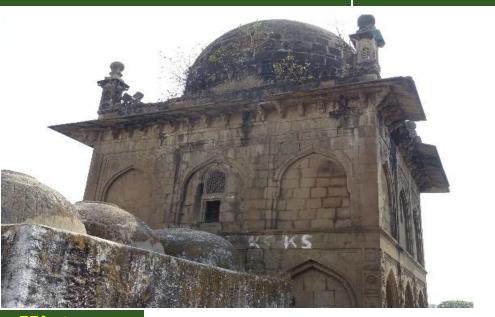
This tomb which was in a bad state of preservation, was later properly conserved. The deep crevices on the surface of the dome have been filled up with cement and concrete, toned to match with the original colour of the masonry. The turrets of the parapet have been restored. The floor under the dome was cleared of debris, leading to the discovery of old stone flooring in a well-preserved condition. No grave could be traced.
