Customer Complaint Notification — weld nut

Complaint no.	C-OEMN-2026-0331	Date issued	2026-09-23
Supplier	Componentes Arga S.L.	Supplier code	ARGA
Supplier part no.	AR-1010	OEM drawing no.	ON-121455 rev. C (fictitious)
Special characteristic	Weld nut torque (SC)	Quantity NOK (confirmed)	12
Supplier lot (label)	L26252-AR1010-01	Suspect qty delivered	2,760 pcs
Supplier delivery notes	AL-26-00572 — 1,380 pcs, shipped 2026-09-16 AL-26-00573 — 1,380 pcs, shipped 2026-09-14	Detected at	OEM Norte e-drive module line (inverter fixing, station ED-4)
Part description	Power inverter bracket	Repeat indicator	Not evaluated

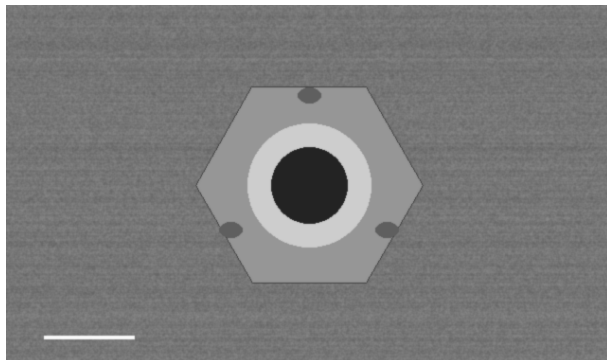
At the e-drive module line, the M8 inverter fixing bolt is tightened to 25 Nm. On 2026-09-22, **12 power inverter brackets** were found with the **M8 weld nut spinning** during tightening; the inverter could not be fixed and the modules were taken off-line. All NOK parts carry the supplier label **L26252-AR1010-01**.

Test (OEM Norte lab, report LAB-ON-26-4519)	Requirement	Result on 10 parts of the same lot
Torque-out of weld nut	≥ 40 Nm	7 parts at 19–31 Nm; 3 parts at 42–47 Nm
Push-out force of weld nut	≥ 4.0 kN	2.1–2.9 kN on the 7 low-torque parts
Interface after push-out	—	Projections flattened but not fused; bright metallic residue on the nut face

Fig. 1 — Nut face after push-out: flattened projections and bright residue (scale bar 5 mm).

- Containment within 24 h** (due 2026-09-24): block all suspect stock at the supplier and in transit, sort OEM Norte stock through your resident team or a third party, and confirm the suspect scope from your own traceability (production lots, material lots and delivery notes), not only from the lot on the label. Certified parts must carry a clean-point label.
- 8D report within 10 working days** (due 2026-10-07) using the **OEM Norte 8D Report v3** (form OEMN-SQ-8D rev. 3). D1–D4 must be uploaded to the supplier portal before the due date; the report must be signed by the supplier's Quality Manager.
- Provide the torque-out results of your in-process checks for the complained lot and the incoming inspection records of the weld nuts used.
- Sorting, line disruption and administration costs will be handled according to the Supplier Quality Agreement.

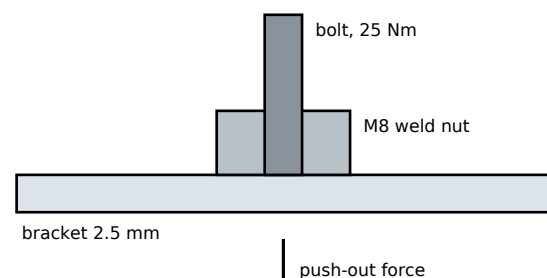
Fig. 2 — Test set-up: torque on the fixing bolt and push-out direction.
