# **Five-Year Review Report**

Fourth Five-Year Review Report  
for the  
**Tar Creek Superfund Site**  
**Ottawa County, Oklahoma**

**Region 6**  
**United States Environmental Protection Agency**  
**Dallas, Texas**

**September 2010**

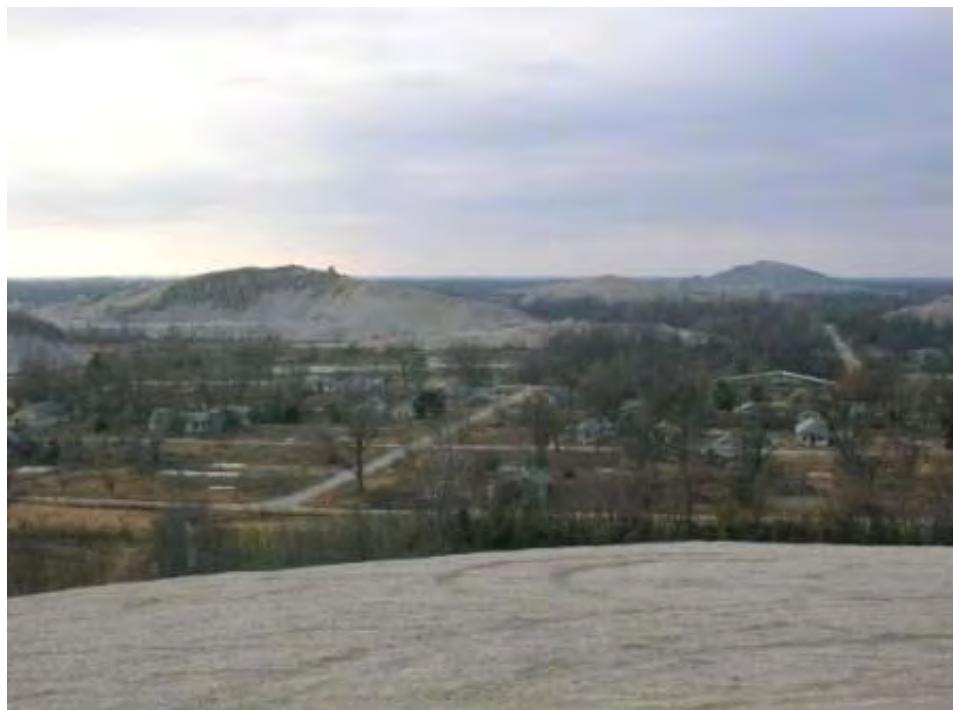
Filename: DSCN1728.JPG

Photo 32: View of Picher from the Fisher Chat Pile. View is to the west.

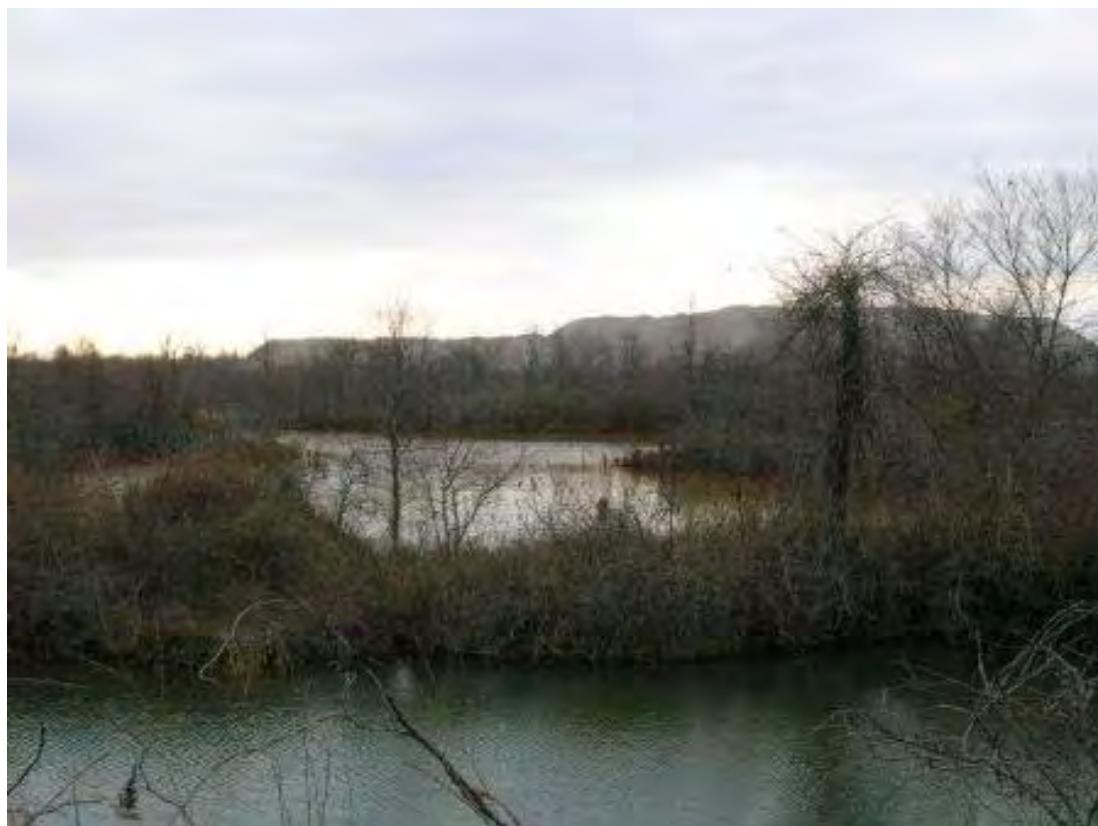
Filename: DSCN1737.JPG

Photo 40: View of water-filled collapse feature on southwest side of Admiralty diversion dike. Water discharges towards the southwest to Tar Creek. View is to the west.
