JOB NO. S67824

CLAIM No. NRP267404872

MR C JACKSON - 9 PASADENA ST, MONTEREY NSW 2217

S67824-JACKSON\FRONT\House

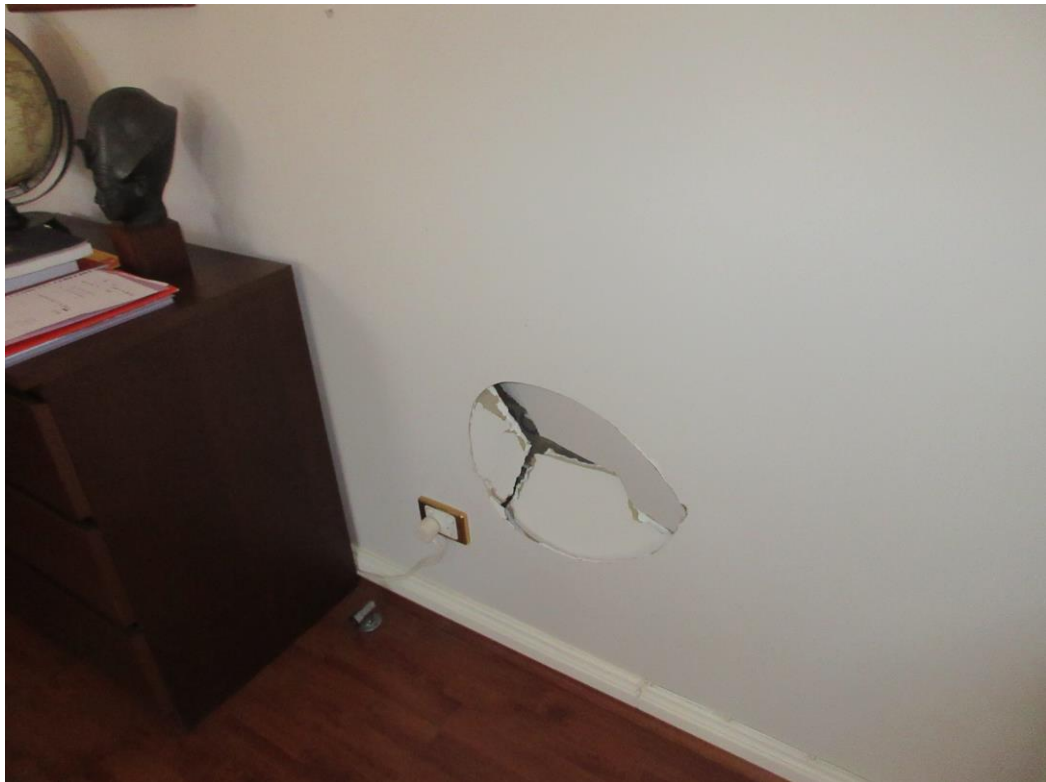
Estimator Mick met Mrs Jackson who explained how her husband tripped on a rug and put his head through the wall. This has created a hole in plaster wall.

Office - hole in plaster wall.

Accidental damage.

Accept

Repair Estimate (inc GST): \$2,522.44
